JR ROOFING CONTRACTS

Synthetic tender quotation

Project: Synthetic multi-roof tender

1 / Roof survey and access limitations

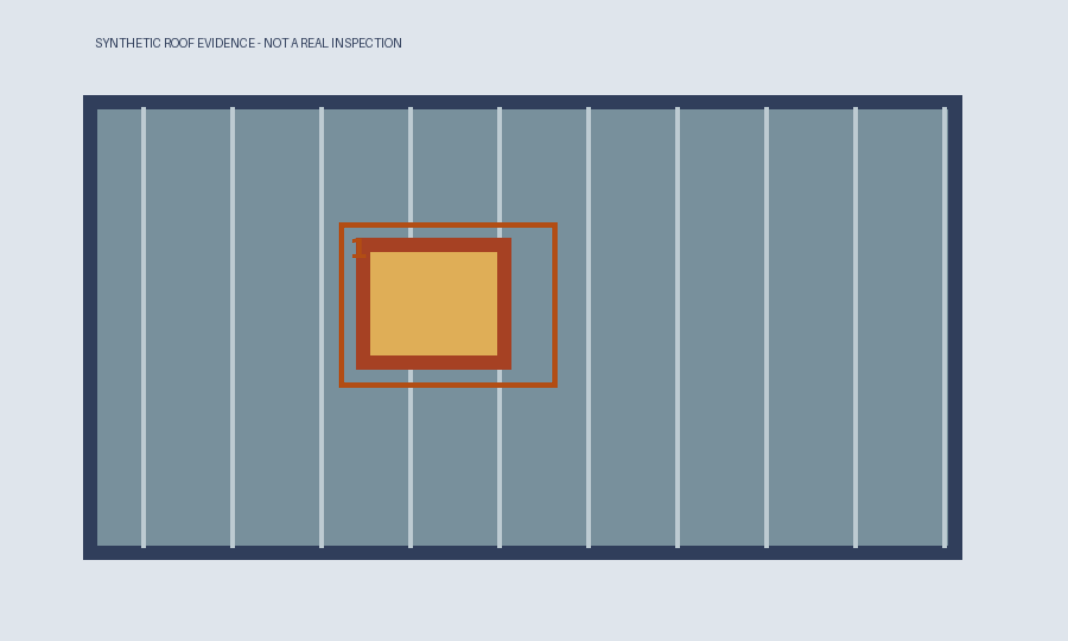
Synthetic roof image with marked defect

Corrosion / perforation - High

Roof / location: Main warehouse / Ridge grid A1

Observed evidence: Synthetic corrosion evidence

Marked area 1: Synthetic defect area

Recommended action / investigation: Investigate fragility before access; confirm repair design
