22 BOBCAT LANE
SECTION K–LOT 6
UTILITY LOCATION MAP

SURVEY: PAS	C.I.: 2'
DRAWN BY: P–L	JOB NO.: 0902011
SCALE: SHOWN	DATE: 9/9/11
SHEET:	K6

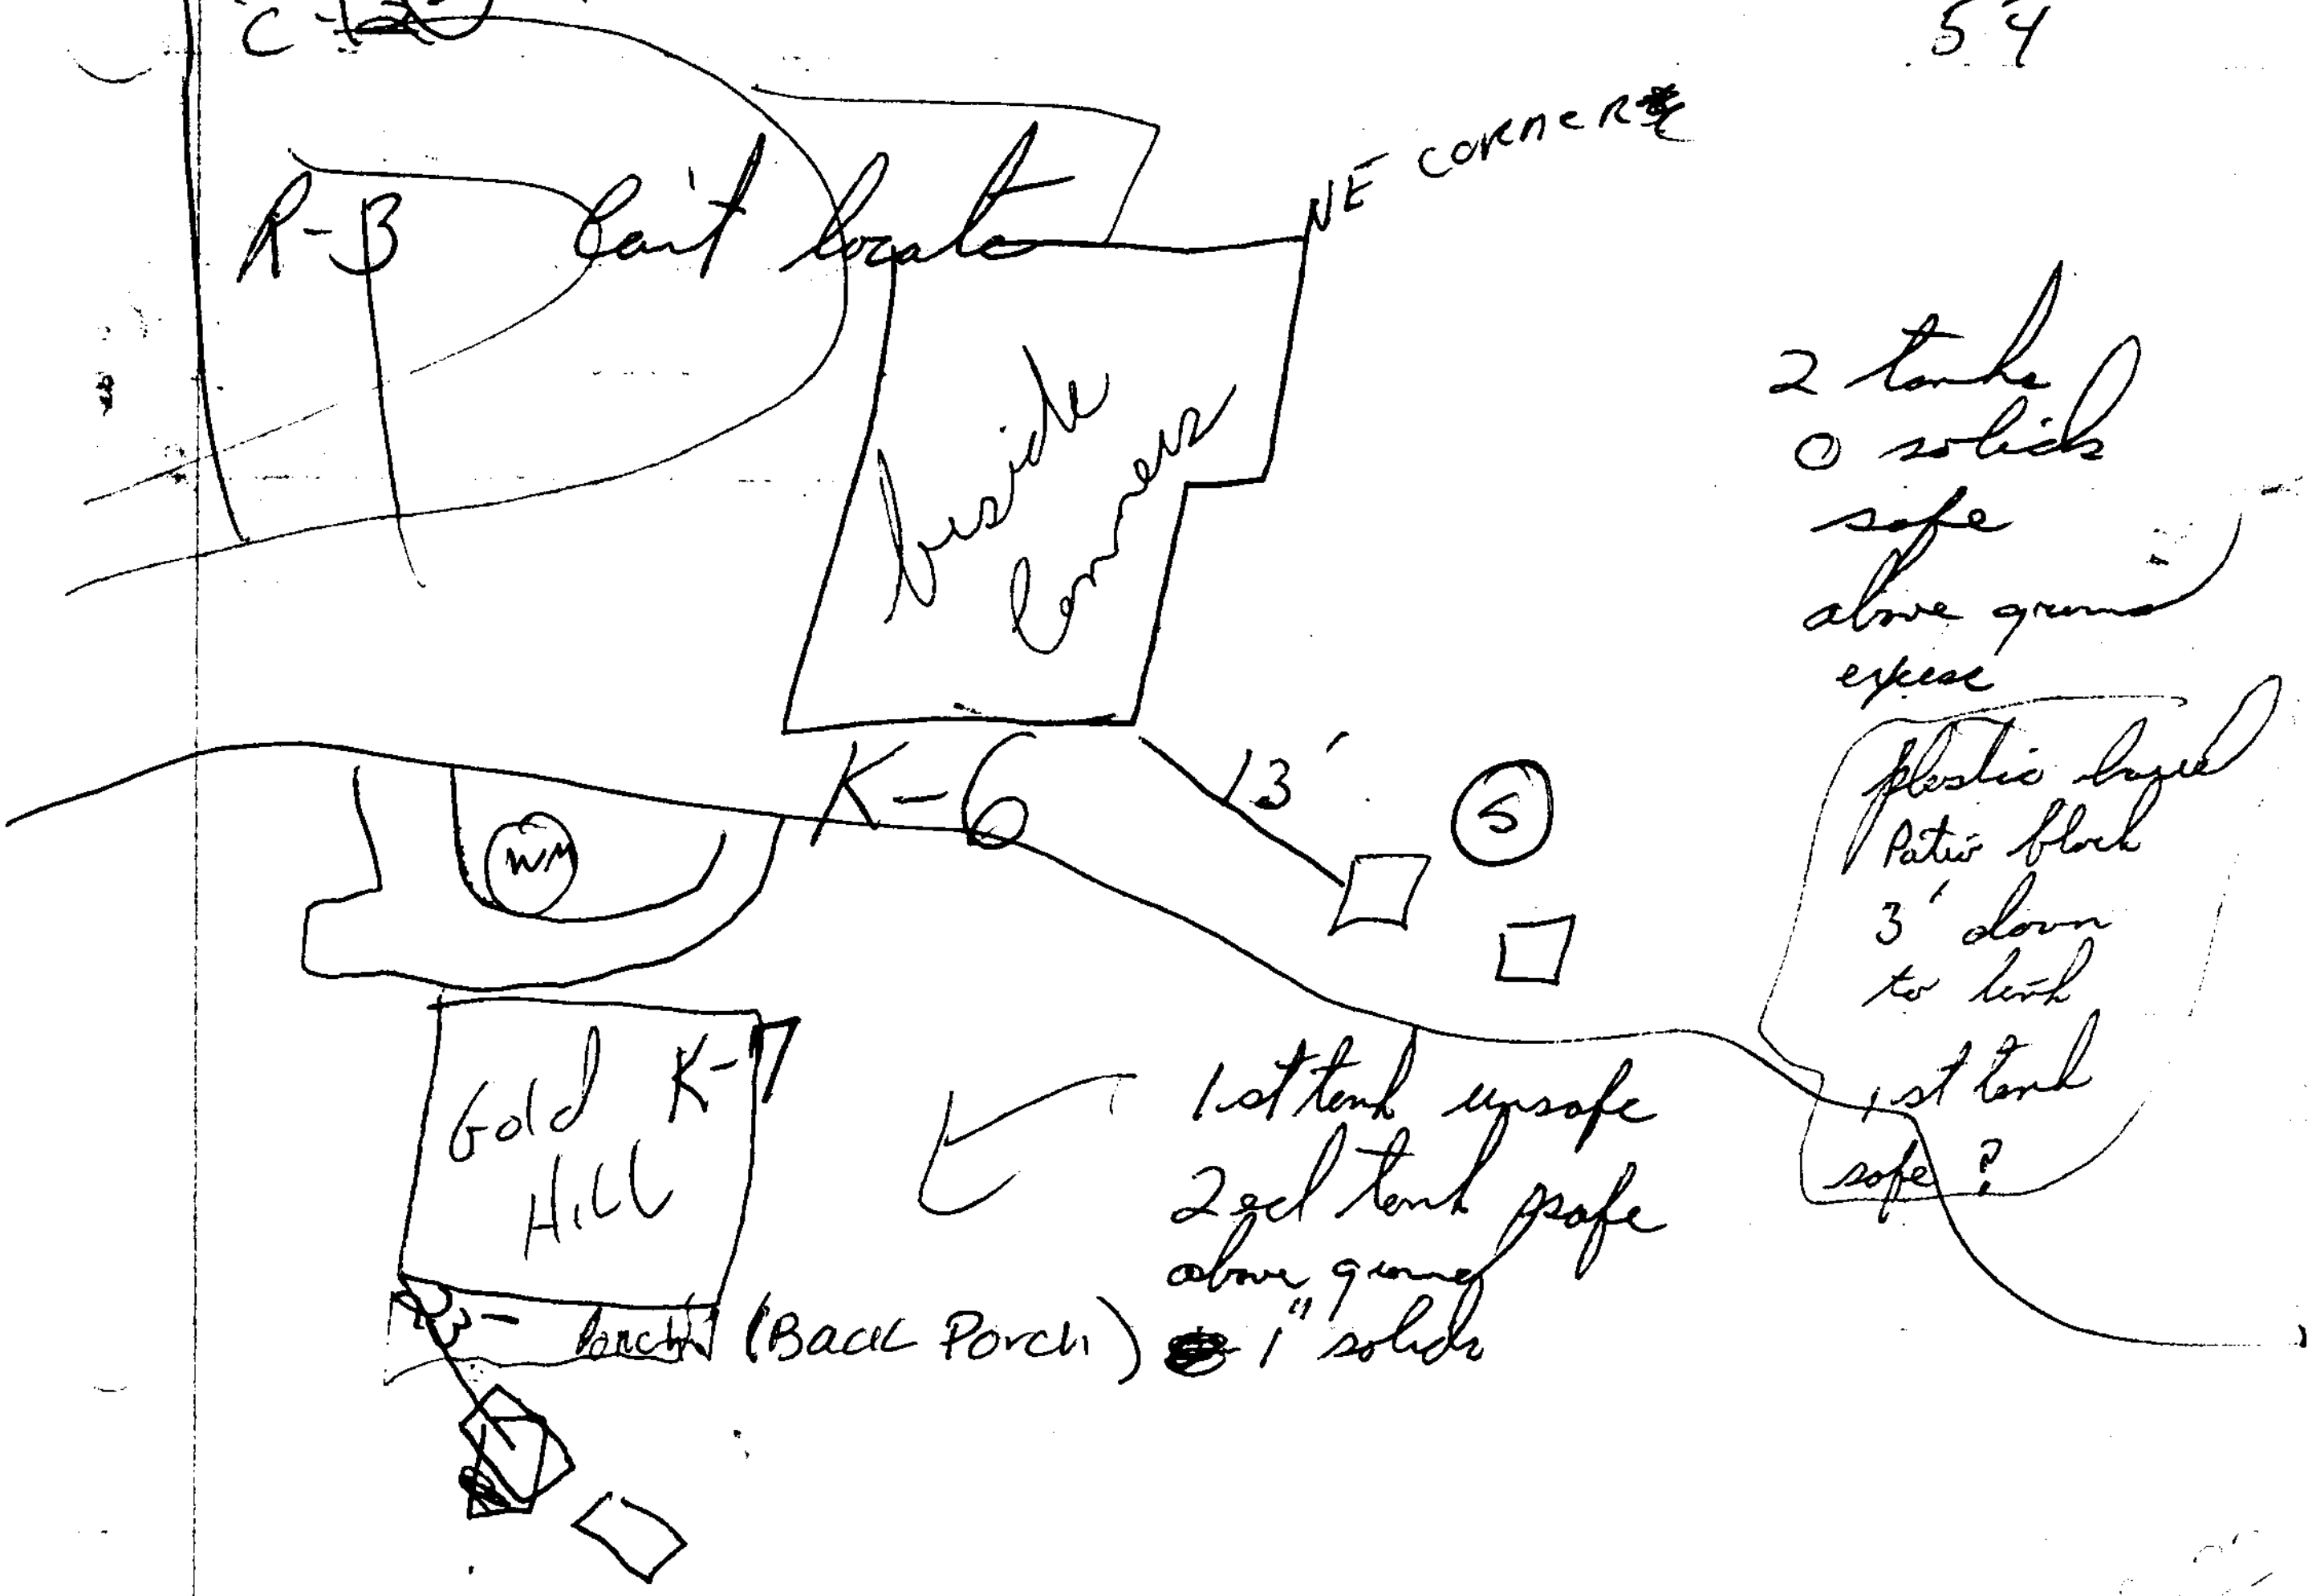
UNSafe
MeaNS LID aT
GrouND LeveL

Can't locate
M-4 under driveway

P-9 underground SW side

L-5 Amoroso underground NE side

B-6 Stentz under driveway

C-1 (WM) < Could not check
C-2

R-3 Can't locate

2 tanks
0 solids
safe
above ground
expose

plastic lined
Patio block
3' down
to tank
1st tank
safe ?

1st tank unsafe
2nd tank safe
above ground

B- porch (Back Porch) 1" solids
