Detailed Diagnostic Report (DDR)

This Detailed Diagnostic Report is prepared for the inspection of a residential flat.

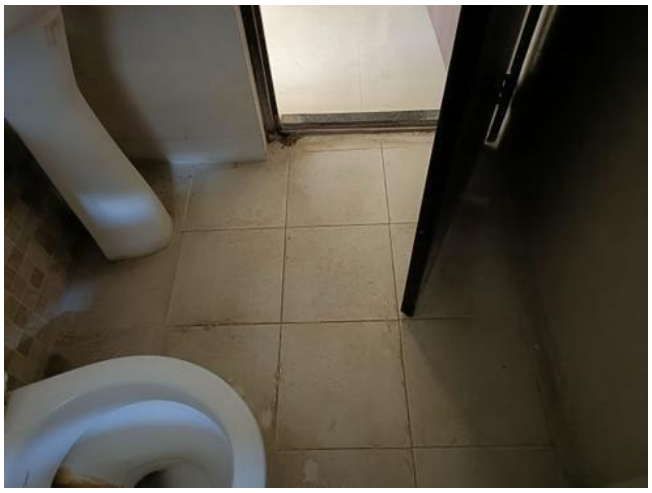
Area: Bedroom, Common Bathroom

Bedroom Skirting level Dampness

Common Bathroom tile hollowness

1. Address all identified tile joint gaps and hollowness in Common Bathroom and Master Bedroom Bathroom of Flat No. 103 immediately with epoxy injection grouting to prevent further seepage.

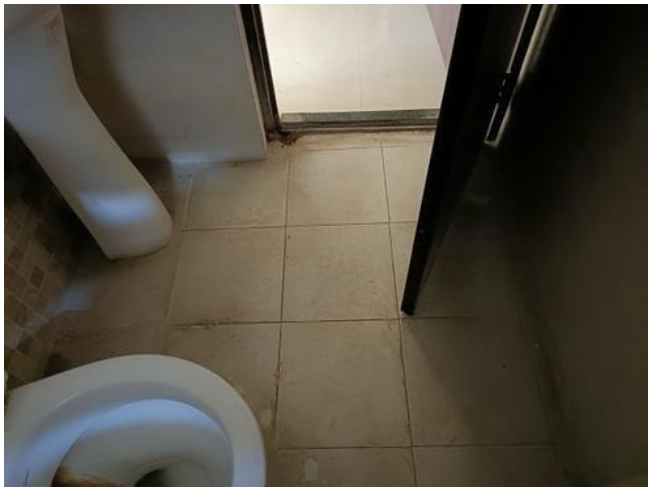
Area: Master Bedroom, MB Bathroom

Master bedroom Skirting level Dampness

MB Bathroom tile hollowness

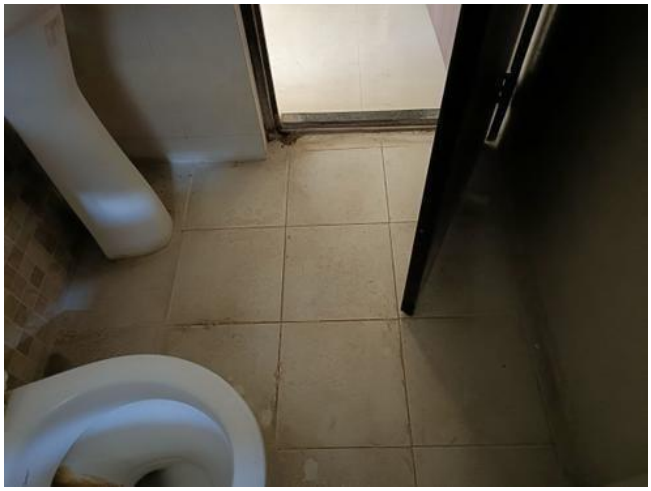
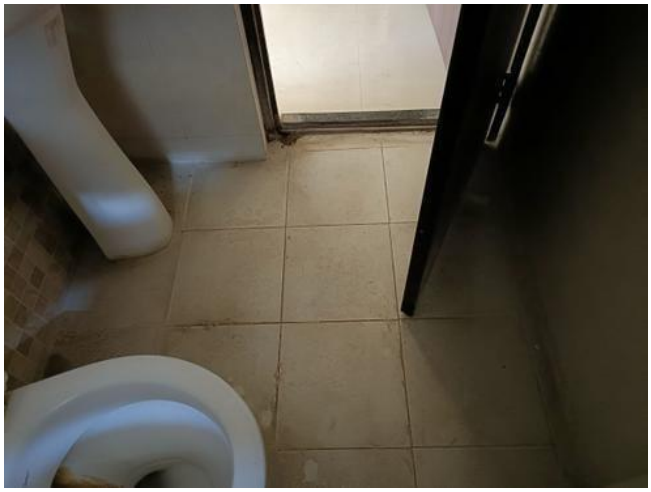
Area: Kitchen, Master bedroom bathroom

Kitchen Skirting level Dampness

Master bedroom bathroom

Kitchen of Flat No. 103	Observed dampness at the skirting level of Kitchen.	Gaps between the tile joints of Master Bedroom Bathroom of Flat No. 103, allowing water ingress.	**Medium**	Epoxy injection grouting of Master Bedroom Bathroom tile joints.
Master Bedroom of Flat No. 103 (Wall surface)	Observed dampness & efflorescence on the wall surface of Master Bedroom.	Cracks on the External wall of the building near Master Bedroom of Flat No. 103.	**Medium**	Repair and seal cracks on the external wall using appropriate waterproofing sealant. Address any duct issues identified.
Parking ceiling below Flat No. 103	Observed leakage at the Parking ceiling below Flat No. 103.	Plumbing issue and gaps between the tile joints of Common Bathroom of Flat No. 103, causing active water seepage.	**High**	Conduct plumbing leak detection and repair in Common Bathroom. Epoxy injection grouting for all tile joints in Common Bathroom. Assess for waterproofing membrane re-application.

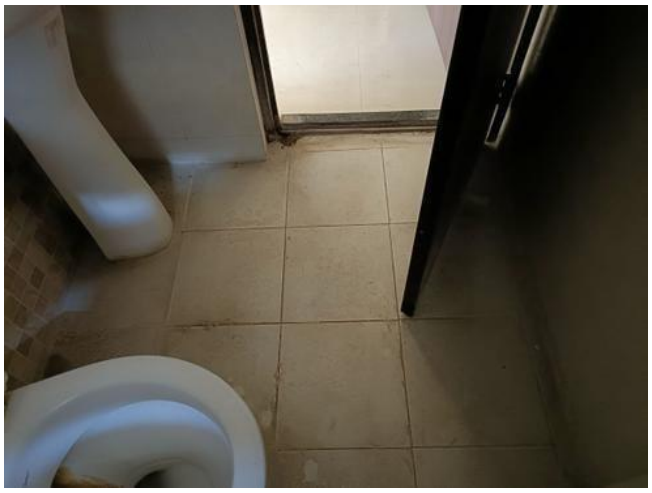
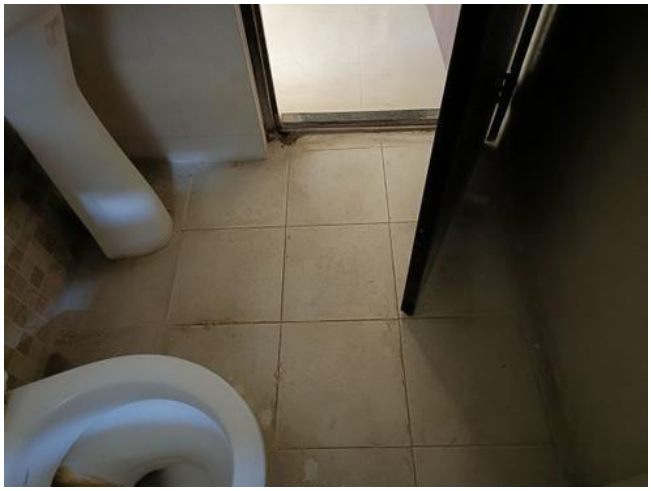
Area: Parking Area, Common Bathroom

Parking Area seepage

Common Bathroom tile hollowness and plumbing issue

2. Investigate and repair concealed plumbing issues in Common Bathroom of Flat No. 103 to stop active leakage impacting the parking area below.
3. Implement external wall crack repair using polyurethane sealants for the cracks observed near the Master Bedroom of Flat No. 103 to prevent water ingress and dampness.
