DamageTriage - Disaster Response Report

Event: 2023 Turkiye-Syria Earthquake - SAR + Optical

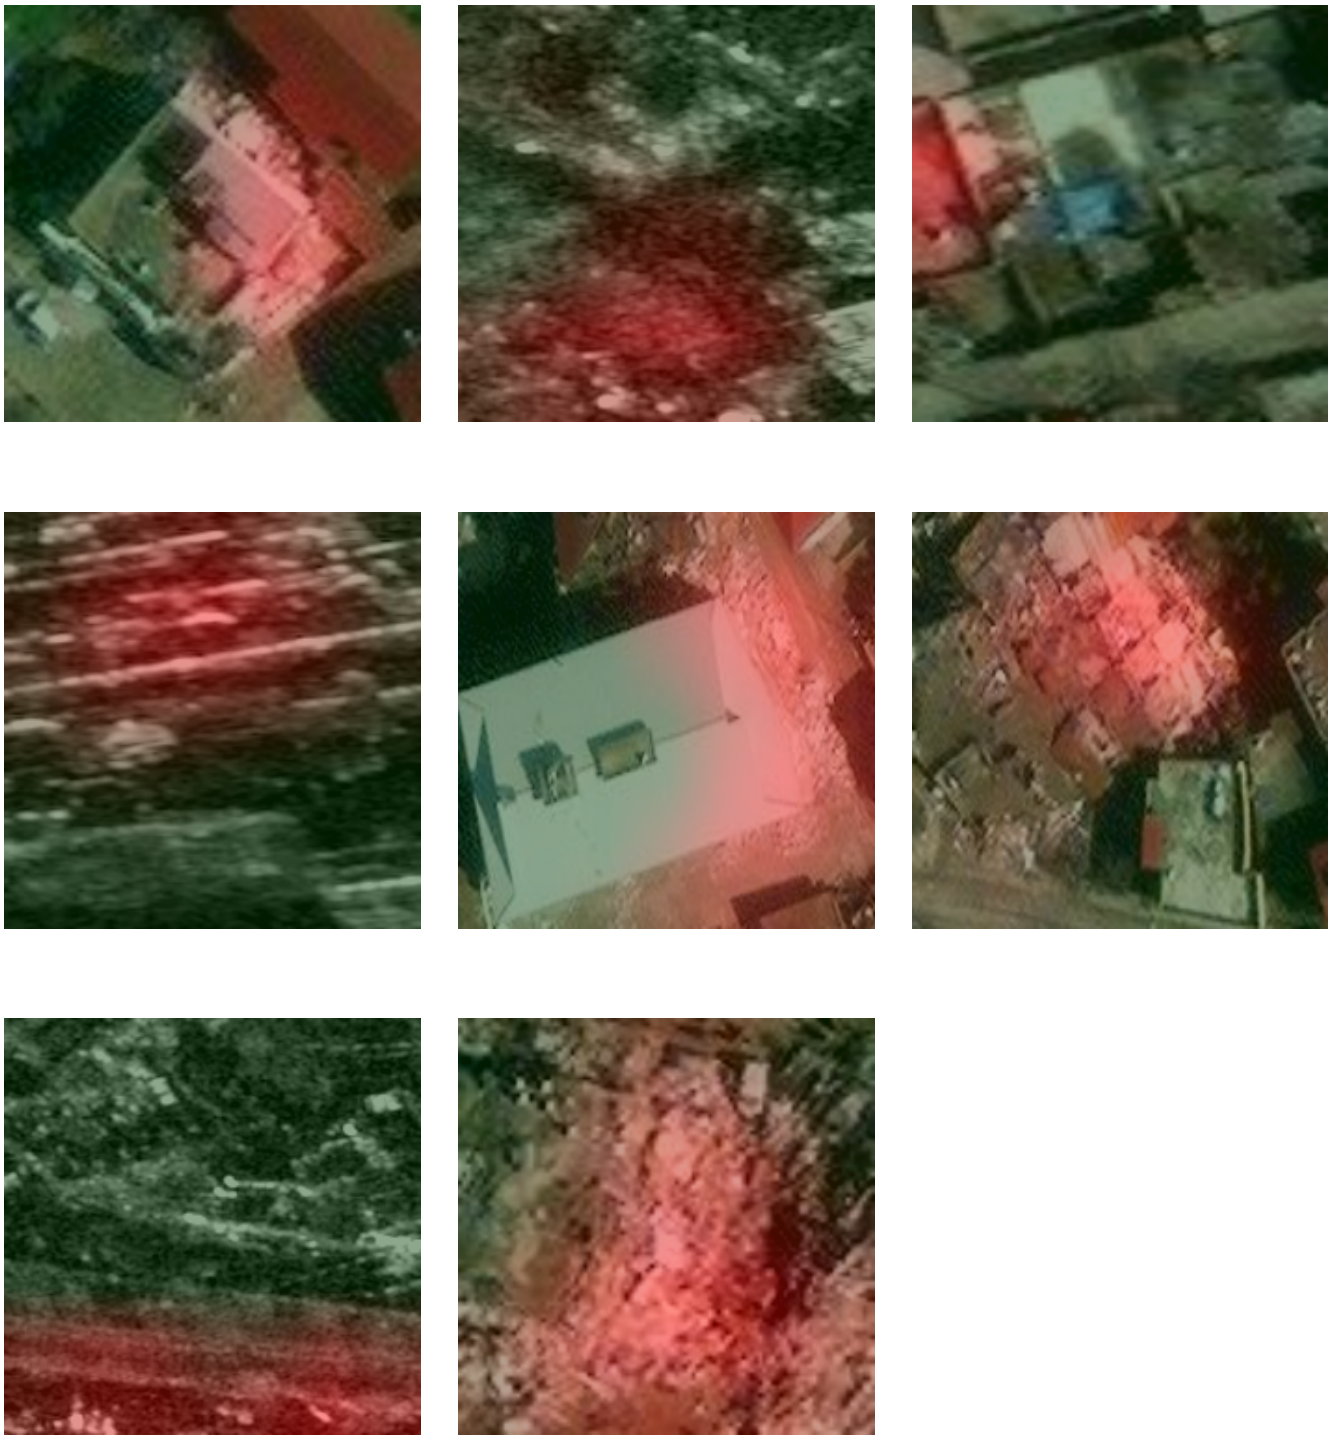
Top 15 Priority Buildings (highest damage probability)

Building ID (OSM)	P(damaged)	Confidence
damaged/1139266138	1.00	1.00
damaged/1139190939	1.00	1.00
damaged/1139190969	1.00	1.00
damaged/1139119038	1.00	1.00
damaged/1139283021	1.00	1.00
intact/1139263480	1.00	1.00
damaged/1139290381	1.00	1.00
damaged/1139179532	1.00	1.00
intact/1139093089	1.00	1.00
damaged/1139274282	1.00	1.00
damaged/1139299108	1.00	1.00
damaged/1139263478	0.99	0.99
damaged/1139114880	0.99	0.99
intact/1139293924	0.99	0.99
intact/1139183211	0.99	0.99
