DamageTriage - Disaster Response Report

Event: 2023 Turkiye-Syria Earthquake - SAR + Optical

Generated: 2026-09-24 17:24

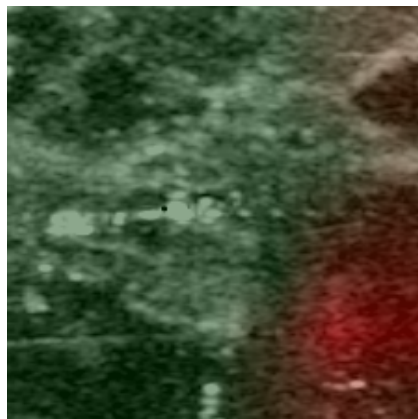
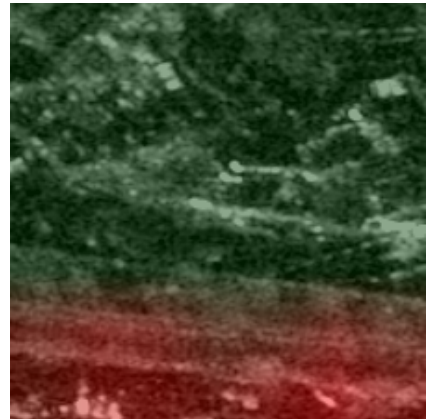
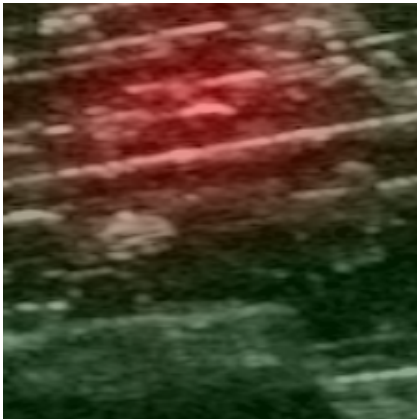
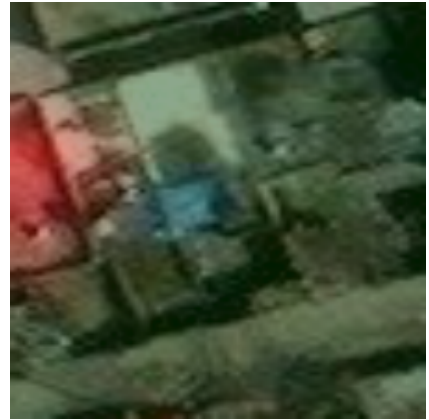
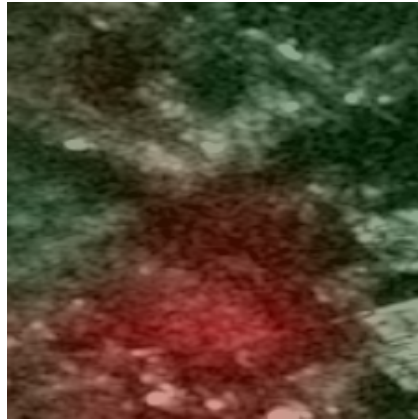
Sample Damage Heatmaps (Grad-CAM, SAR + Optical)

Red = region the model's decision relied on most, per modality.
