VMP - Autosoap

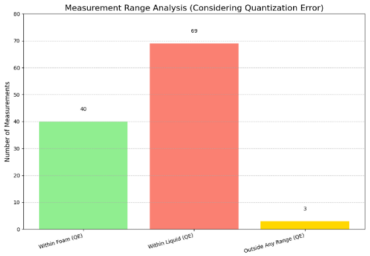
72 Tests Complete

***Note about values outside range**

The 3 tests that fell outside any range were the first iteration of tests for their respective part. Each part passed all other subsequent tests.

I believe the reason the system may have failed is that the tube connected to the pump being tested was not fully secure/pushed onto the pump output.

Its also possible the tube coming out of the sensor, and back into the water container, was blocked by the wall/bottom of the container.

The 3 tests that failed were all relatively early on in testing, and I resolved these operator-error issues in later tests, not encountering them again.

***1st iterations has lower readings**

The first iteration of testing on many of the parts seemed to have a lower reading than subsequent readings frequently.

I believe this may be due to the tube not being fully connected to the pump. I frequently secured the tube further after the first iteration.
