FARMERS INSURANCE

RE:	Insured:	Yibiao Lu
	Claim Number:	7007986837-1-1
	Policy Number:	0980554965
	Loss Date:	07/13/2024
	Location of Loss:	17756 George Moran Dr, Eden Prairie, MN
	Subject:	Appraisal

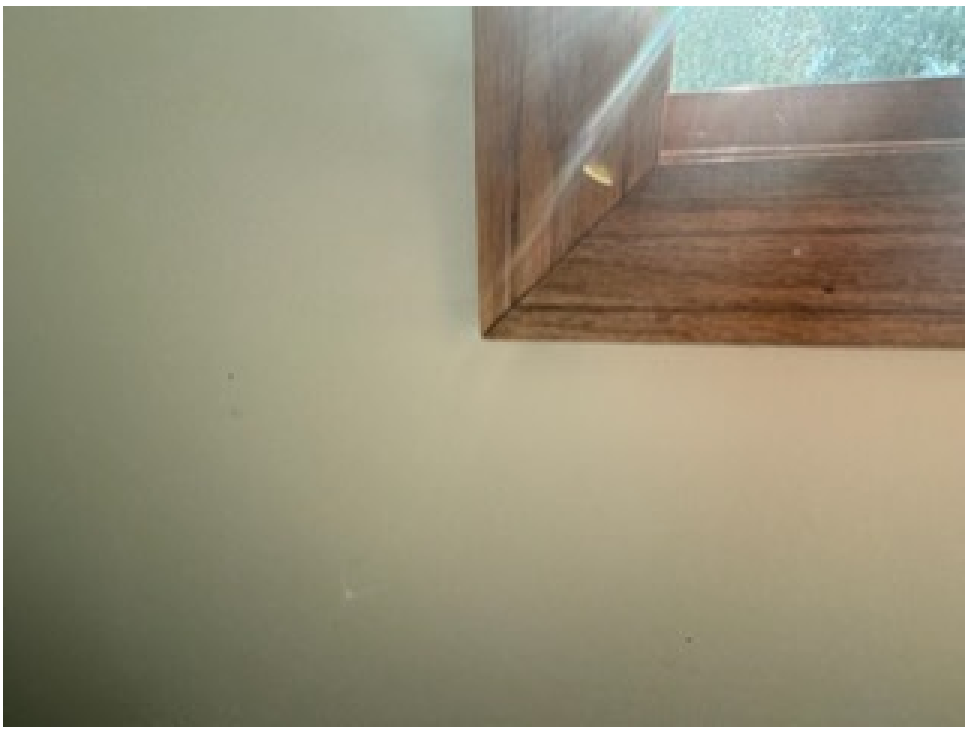
17. Window Wrap South Damaged - No_5

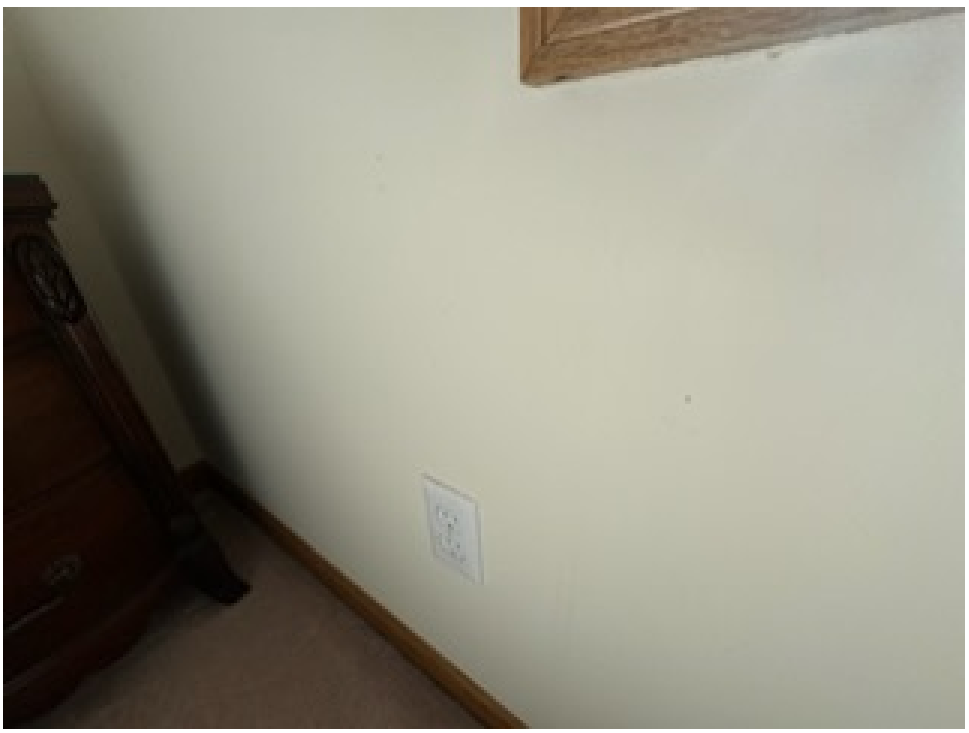
18. Window Wrap South Damaged - No_6

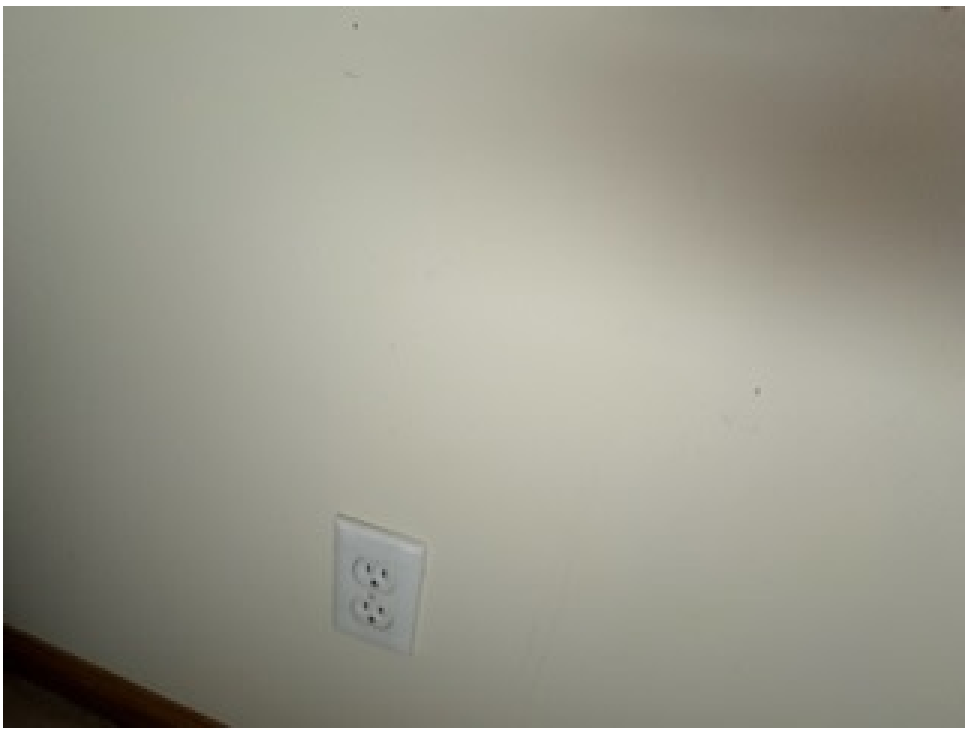
20. Window Wrap South Damaged - No_8

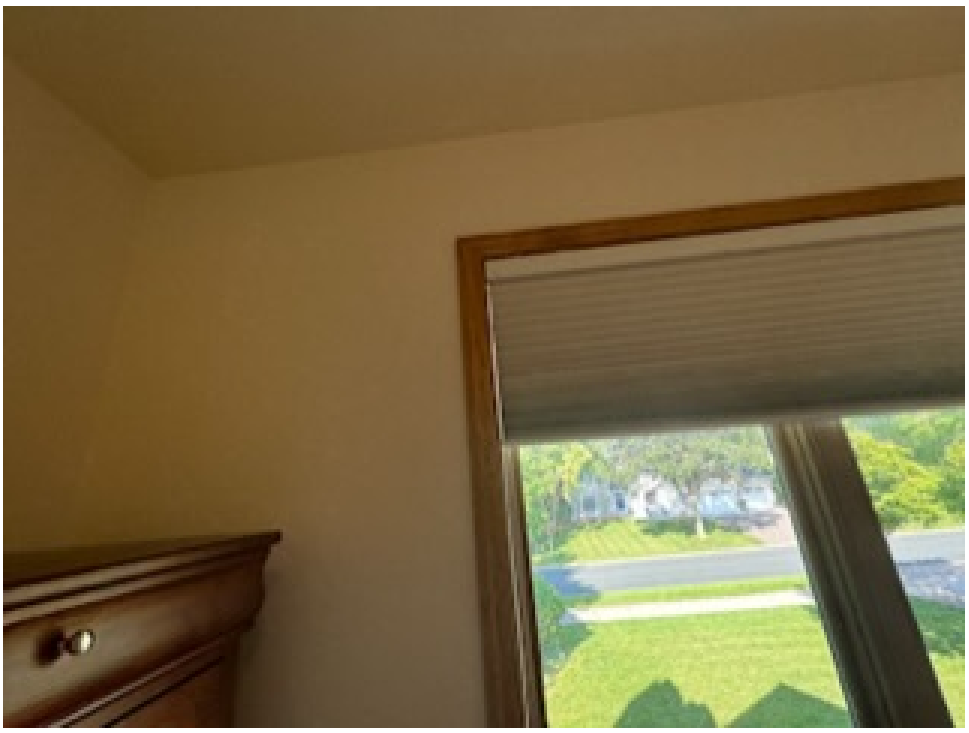
32. Window Wrap West Damaged - No_7

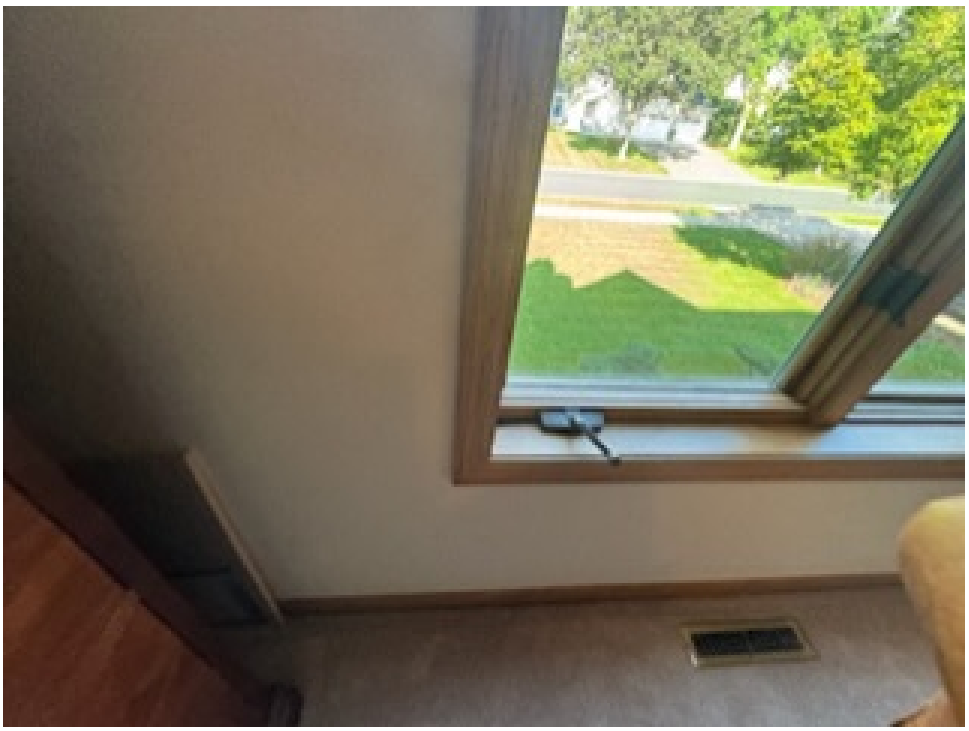
33. Window Wrap West Damaged - No_8

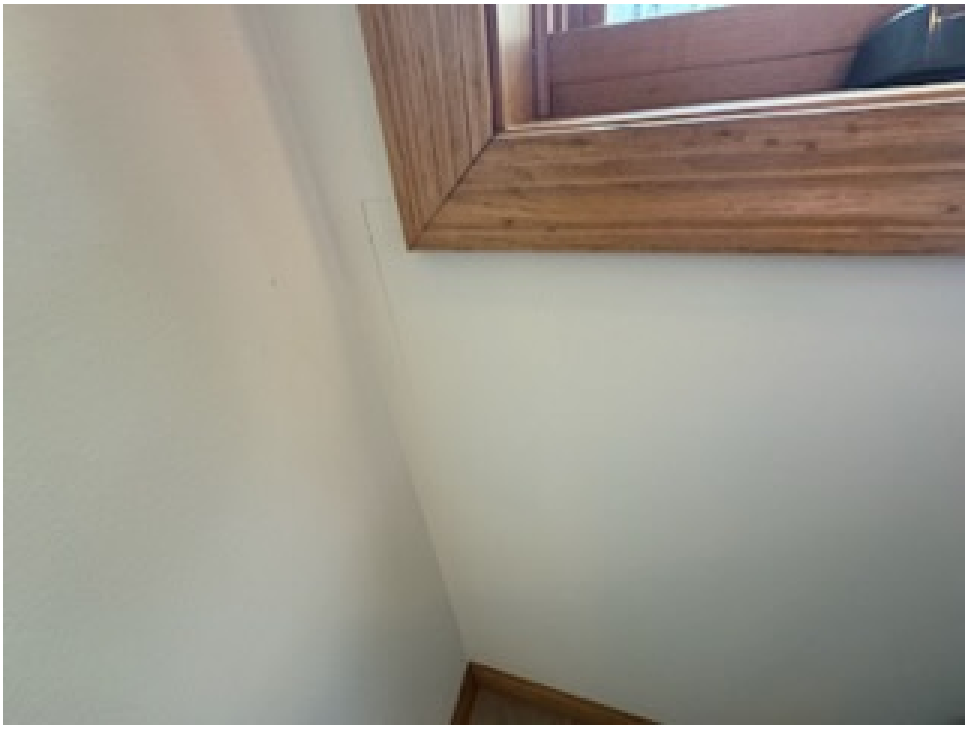
37. Window Wrap West Damaged - No_12

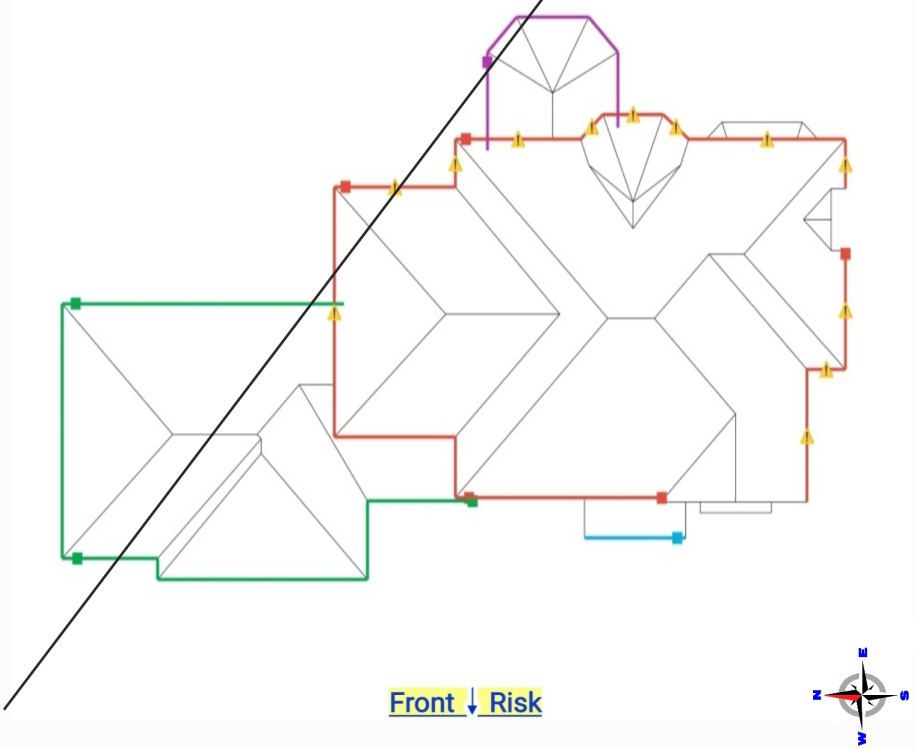
INSURED STATED ROOF DOES NOT NEED INSPECTION DUE TO CEDAR SHAKE ONKY BEING 2 YEARS OLD.

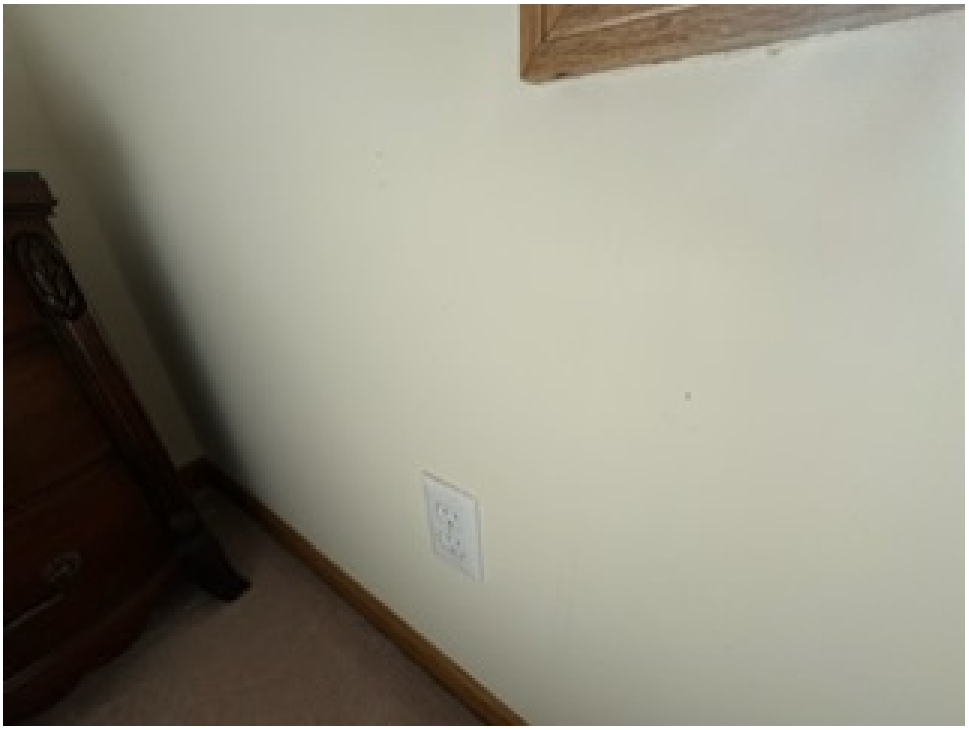
18. Window Wrap South Damaged - No_6

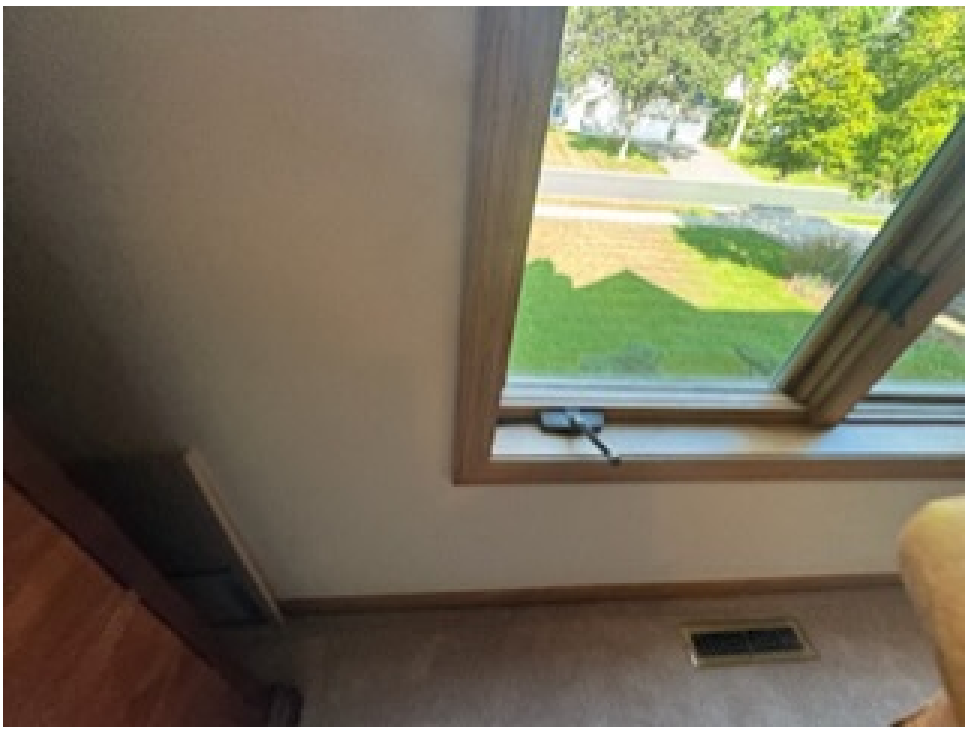
33. Window Wrap West Damaged - No_8

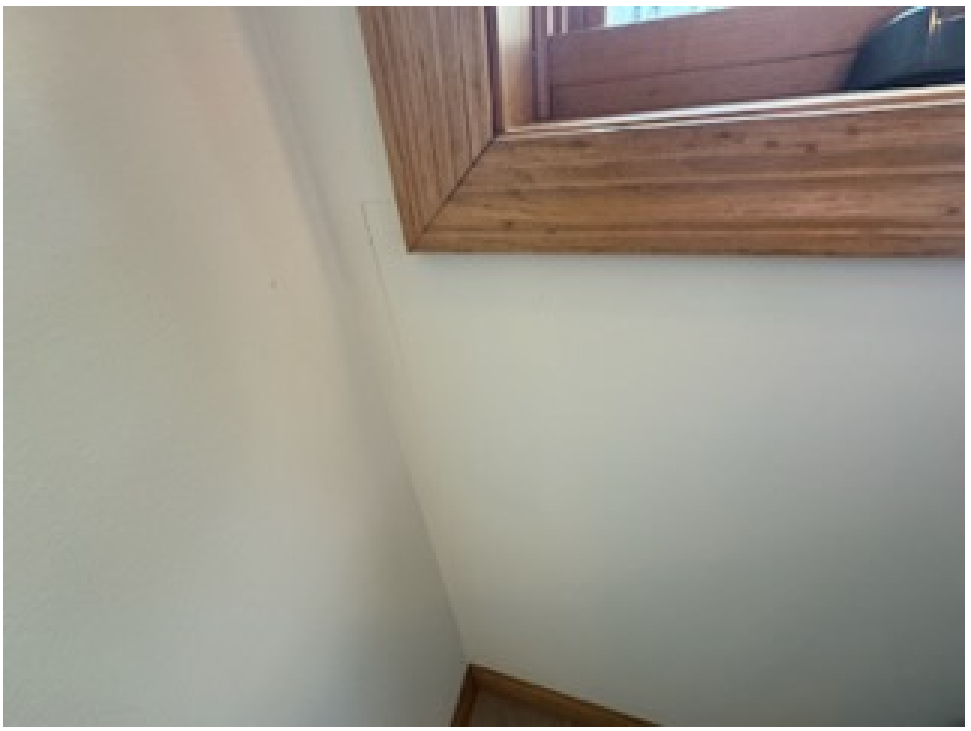
37. Window Wrap West Damaged - No_12

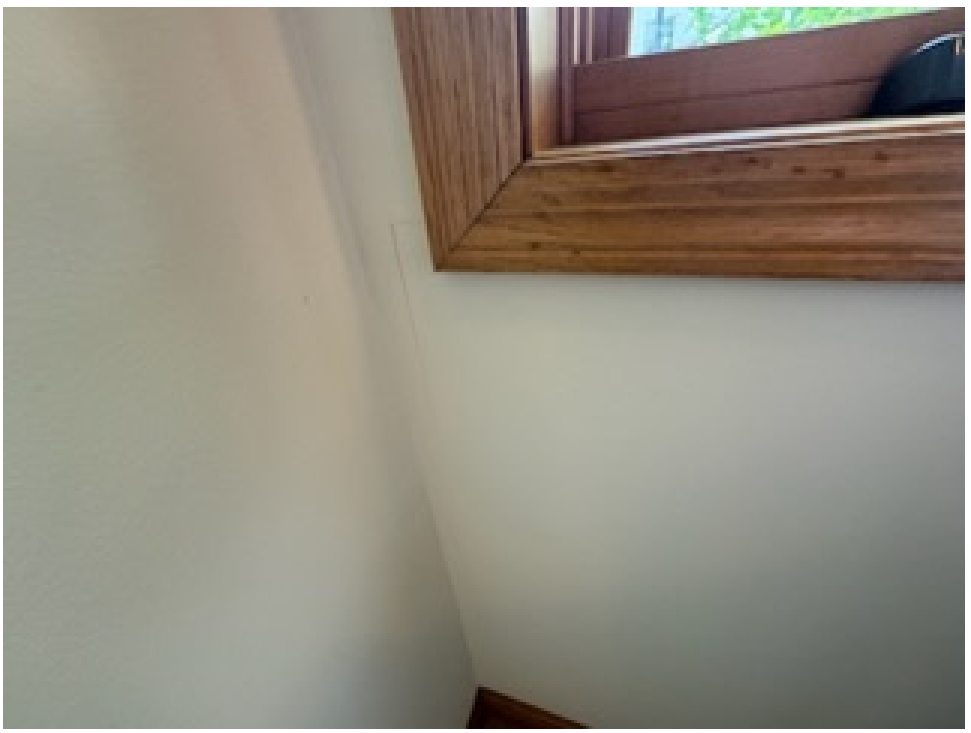
38. Window Wrap West Damaged - No_13

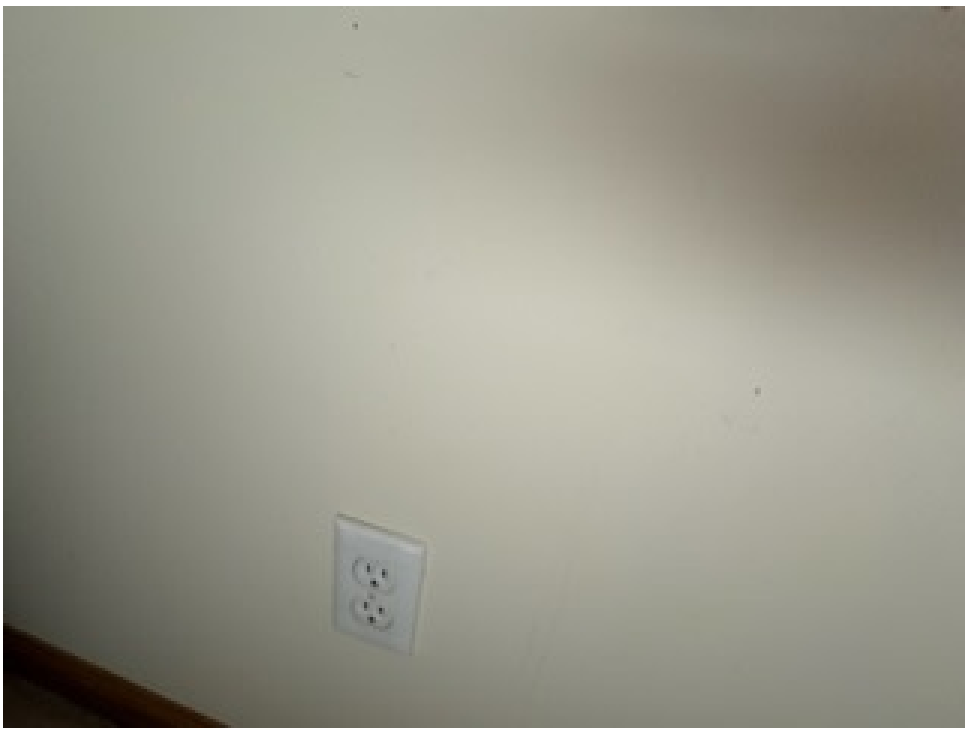
40. Window Wrap South Damaged - No_8

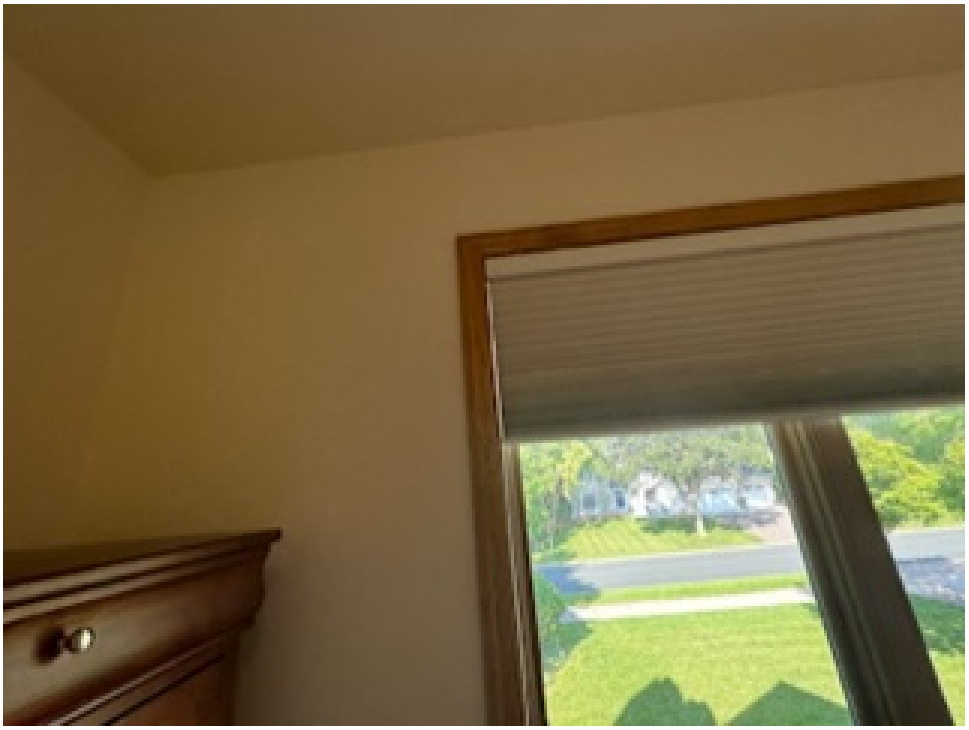
86. Window Wrap West Damaged - No_7

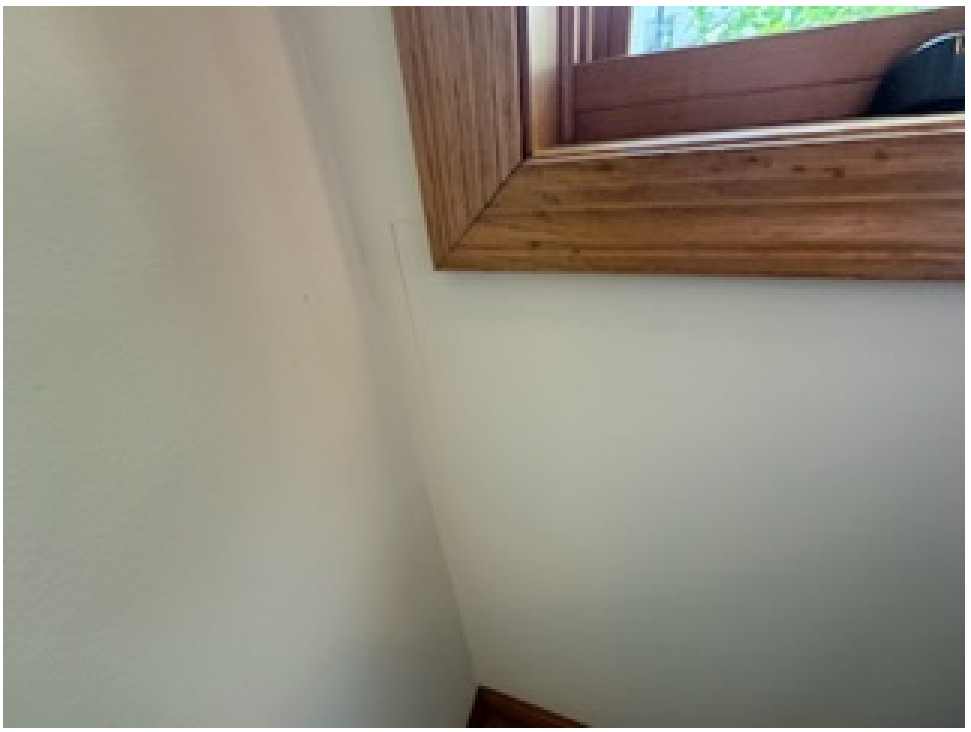
92. Window Wrap West Damaged - No_13

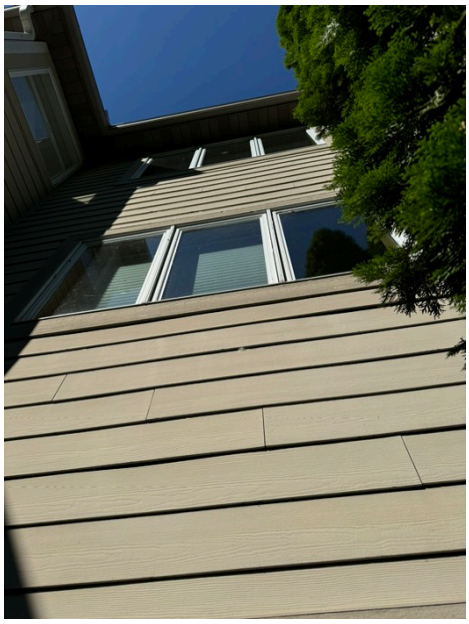
FIE 1398

Left elevation of home overview

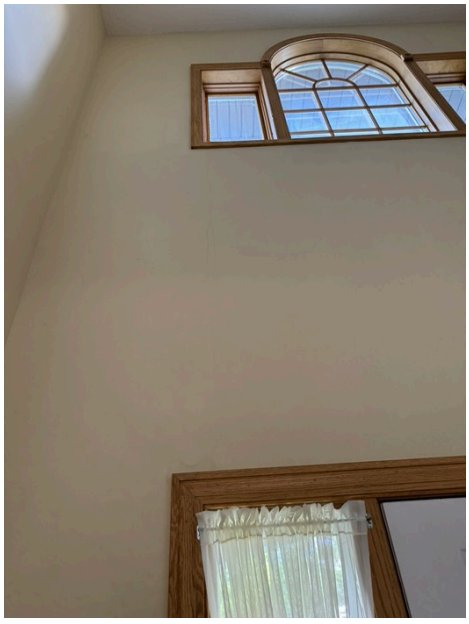
Homeowner has some water damage on interior not related to hail no penetrations or openings to cause this water there is somewhere in tear on caulking on the exterior of the windows and there was heavy wind driven rain around these areas

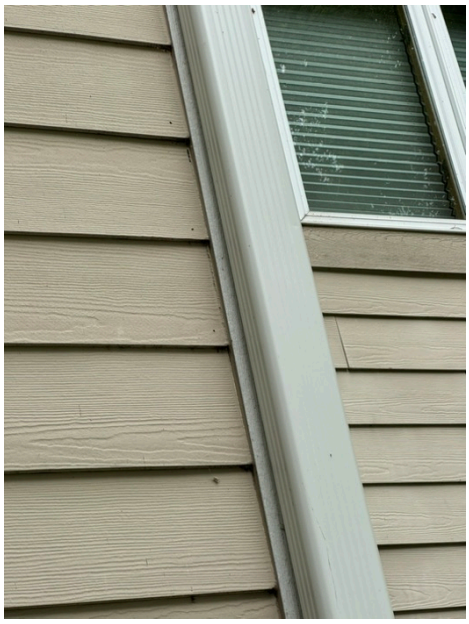
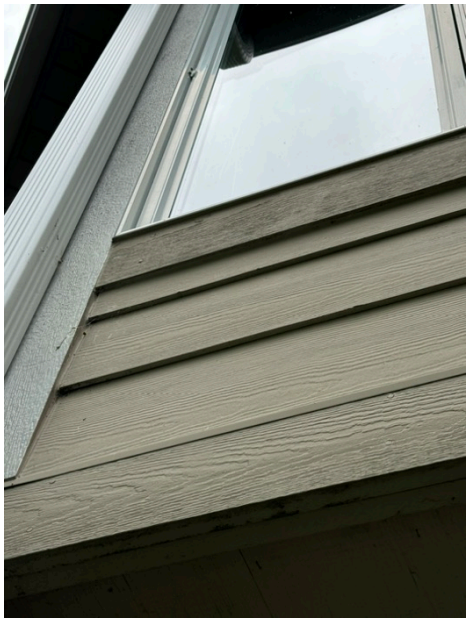
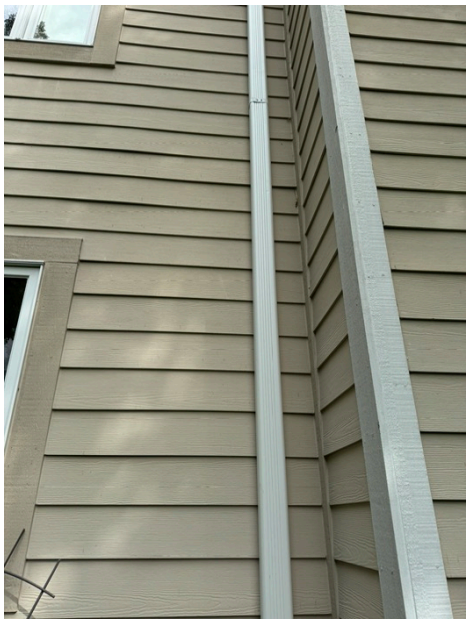
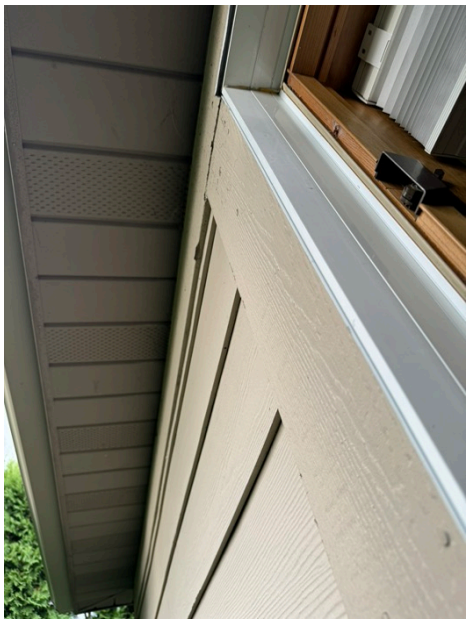
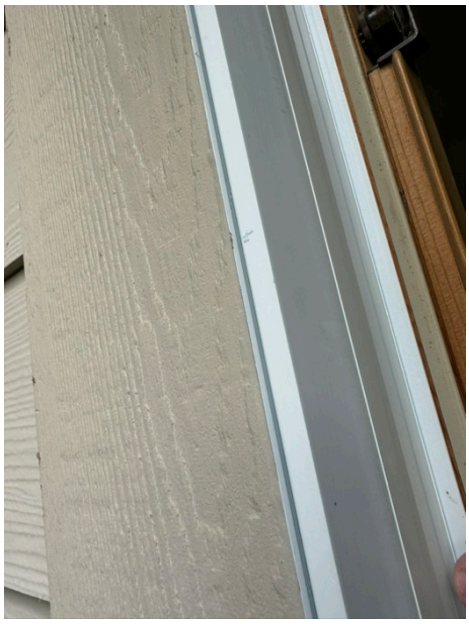
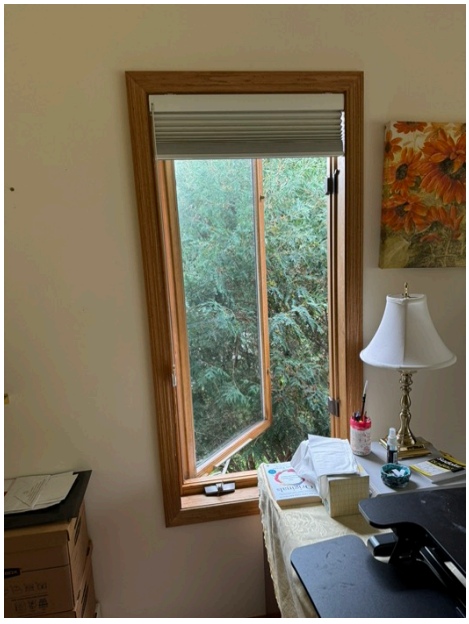
Falling photo show rear photos homeowners pointed these items out

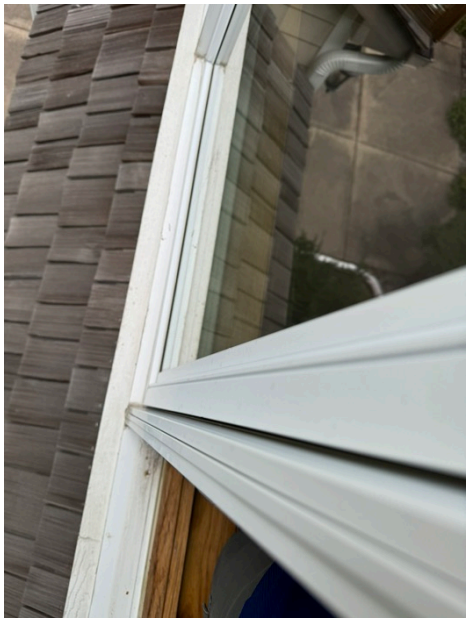
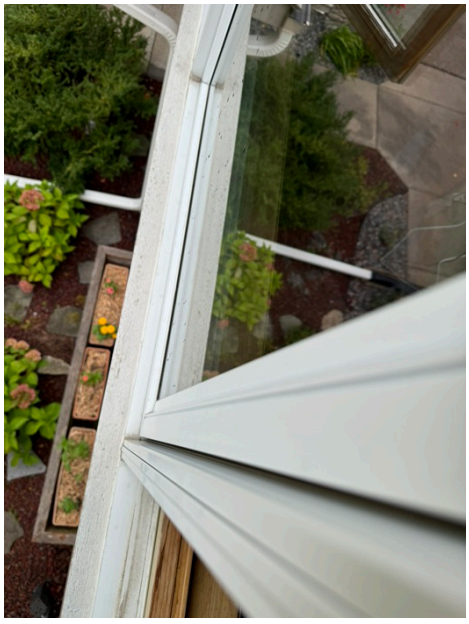
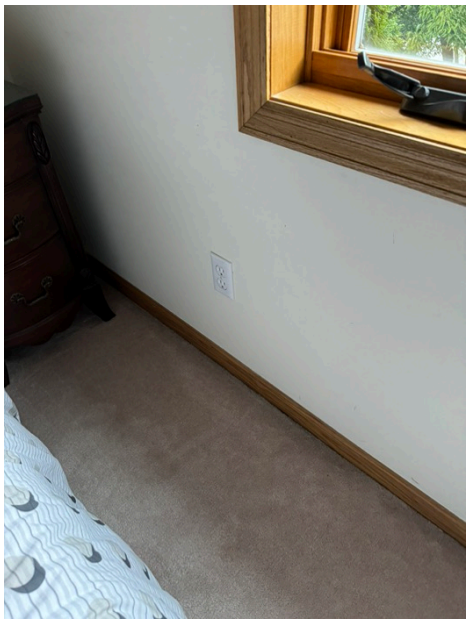
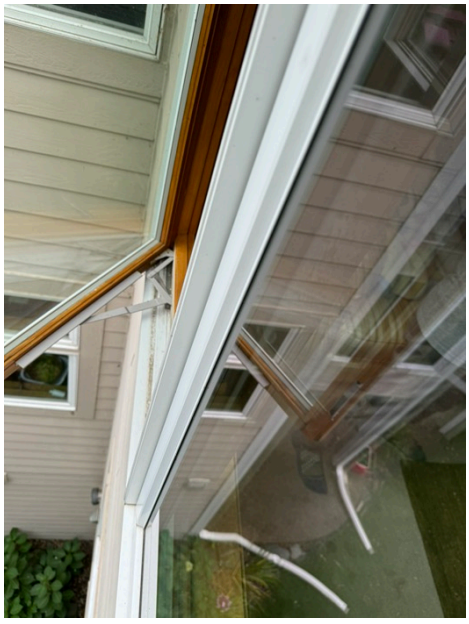
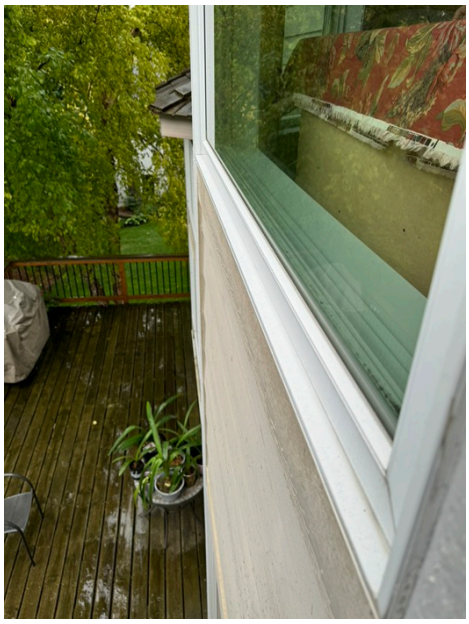
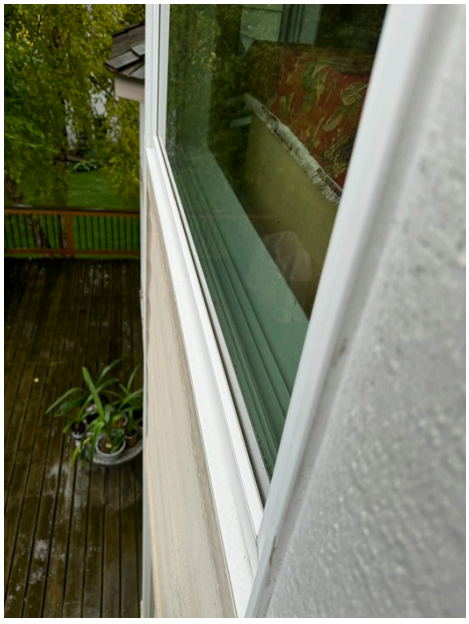
Fall photos show interior windows homeowners showed these items to me as well

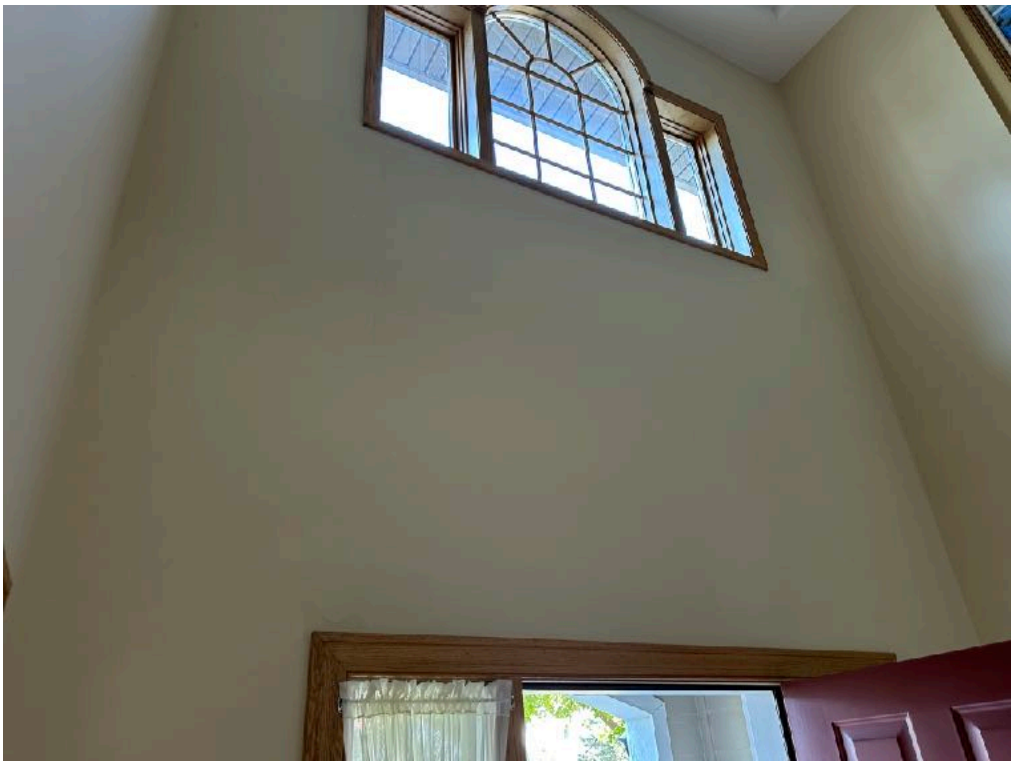
A-1: INTERIOR UPPER WINDOW ABOVE MAIN ENTRY

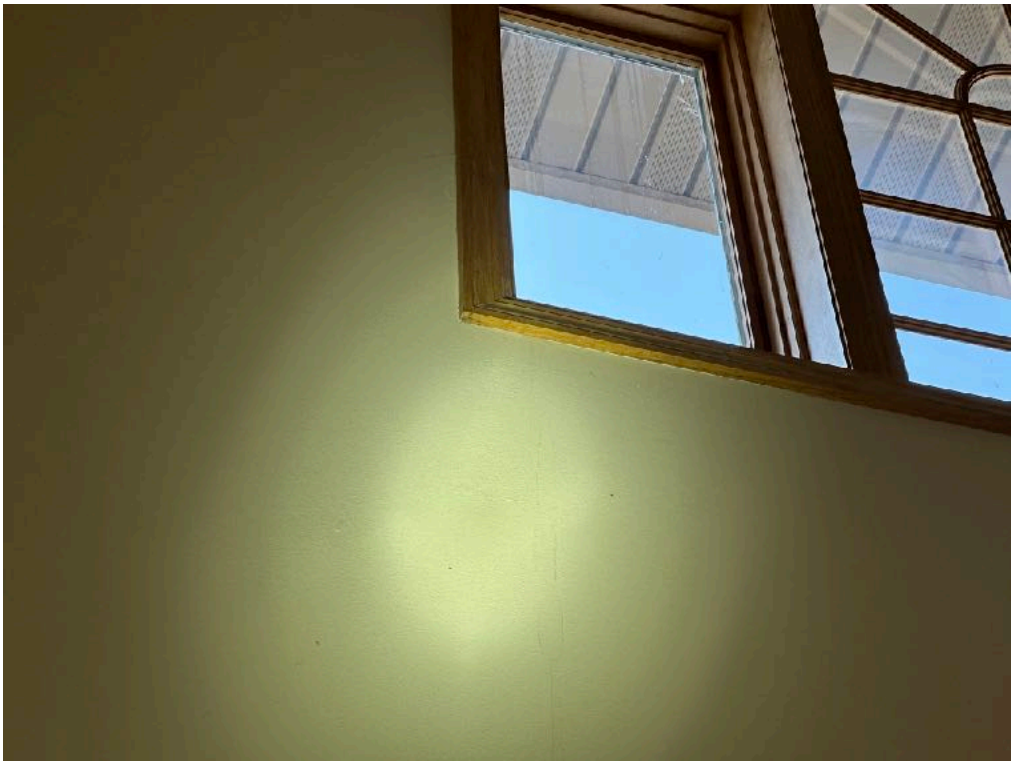
A-2: STAIN PATTERNS VISIBLE BELOW LEFT CORNER OF WINDOW

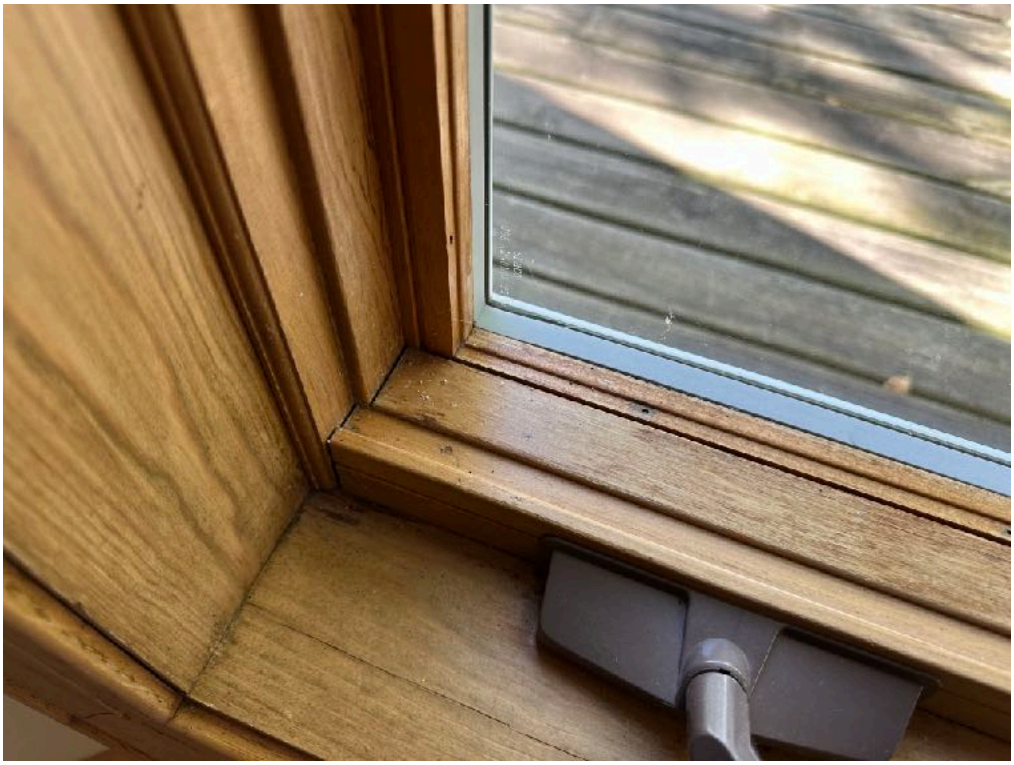
A-6: CENTER WINDOW GROUP, EAST WALL, VIEW OF LOWER LEFT CORNER

A-7: LOWER RIGHT CORNER AT SASH, STAINING PRESENT

A-8: LOWER LEFT CORNER OF MAIN CENTER WINDOW GROUP, FAMILY ROOM

A-9: LOWER RIGHT CORNER OF CENTER WINDOW GROUP AT EAST FAMILY ROOM WALL

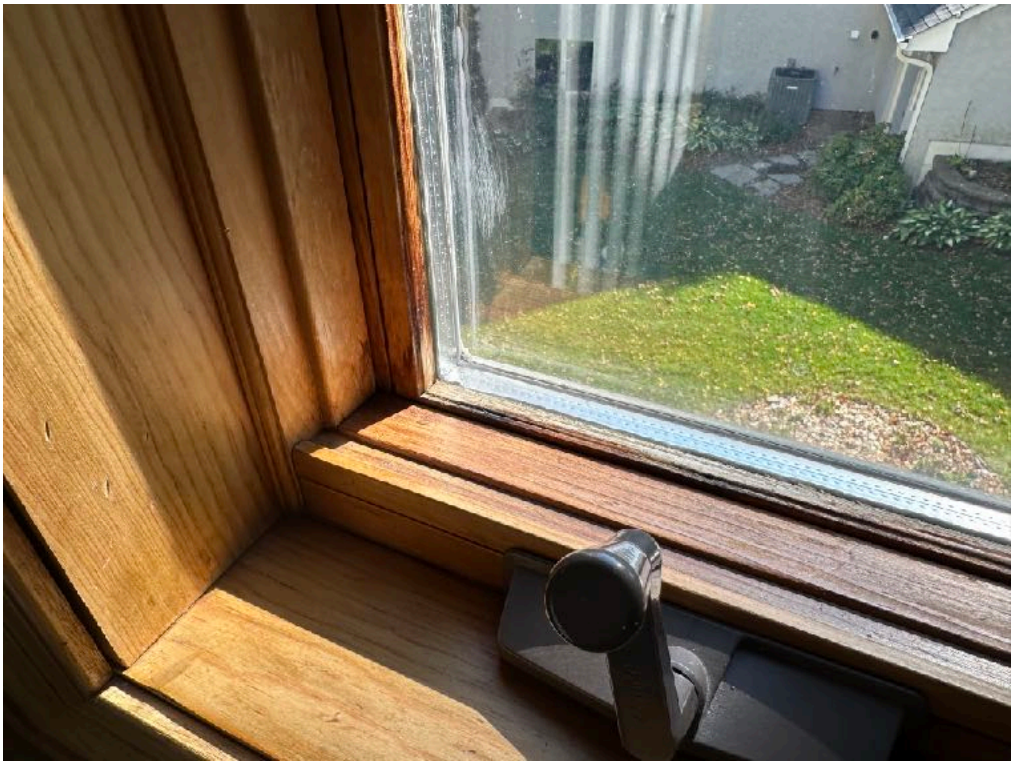
The upper stairway landing windows were observed at the south side, central quadrant of the home. Cracking appears in the wall at the lower left corner of the window unit in the south wall as shown in photograph A-15. The lower stairway landing windows were observed with units in the south and west walls. Cracking appears at the southwest wall corner between the lower corners of windows as shown in photograph A-18.

A-14: SOUTH STAIRWAY WINDOW, MAIN LEVEL TO UPPER LEVEL LANDING

A-15: LOWER LEFT CORNER OF WINDOW

A-16: LOWER CORNER OF WINDOW

A-17: SOUTHWEST WINDOWS AT LOWER STAIRWAY LANDING

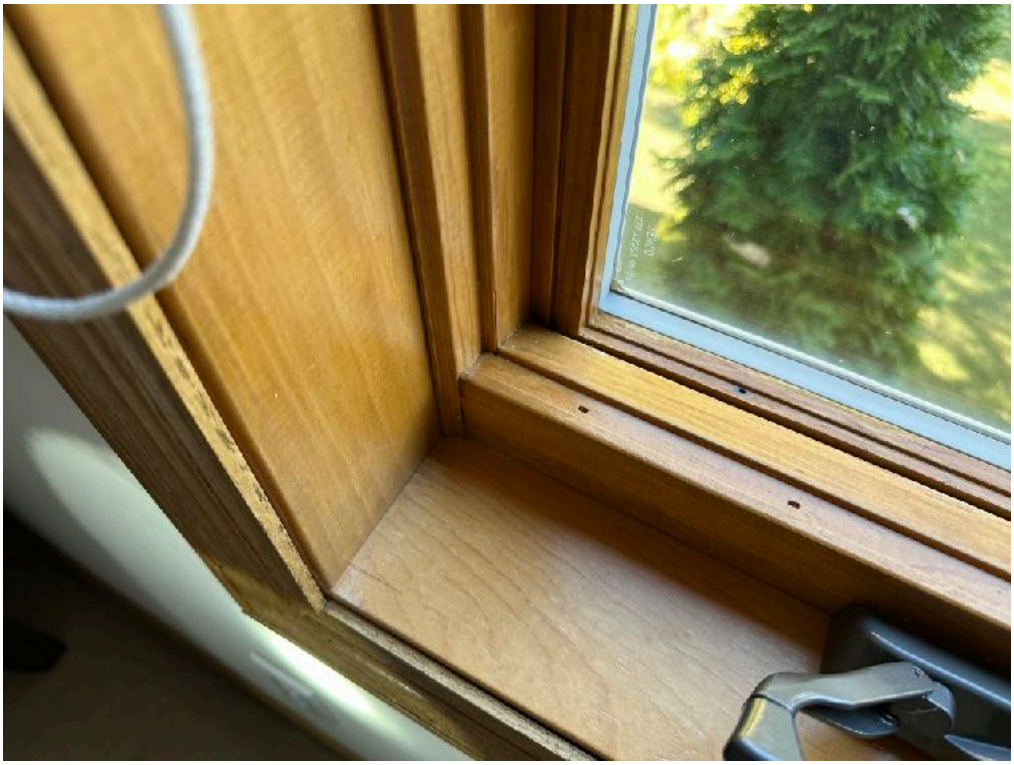
The rear 3 unit window at the upper level northeast bedroom was observed at the time of the site visit with leakage reported from the lower left corner. A penetration was observed in a siding panel below this window at the exterior with impact marks at the center of the penetration. Photographs A-26, A-27 and A-212 show conditions at the penetration in siding.

A-22: REAR NORTHEAST BEDROOM, EAST WINDOW

A-23: WALL BELOW LEFT SIDE OF WINDOW

A-24: LOWER LEFT CORNER OF WINDOW

A-25: EXTERIOR, VIEW OF SIDING BELOW UPPER BEDROOM WINDOW

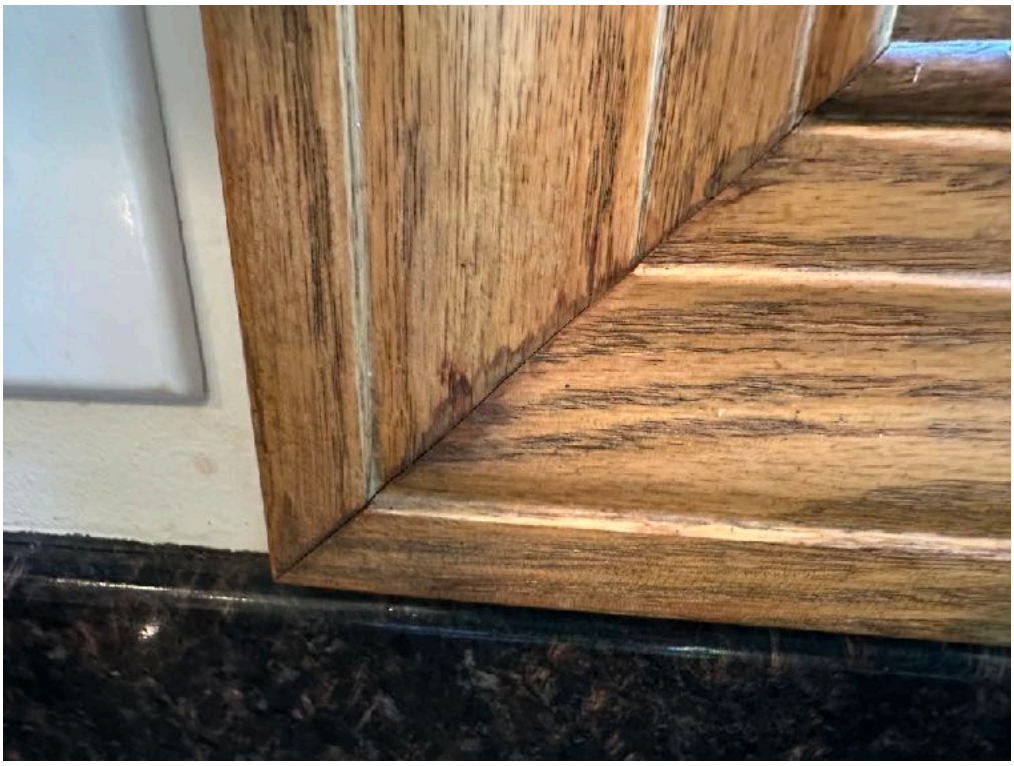
A-35: VIEW OF JOINT IN TRIM AT LOWER LEFT CORNER OF KITCHEN WINDOW

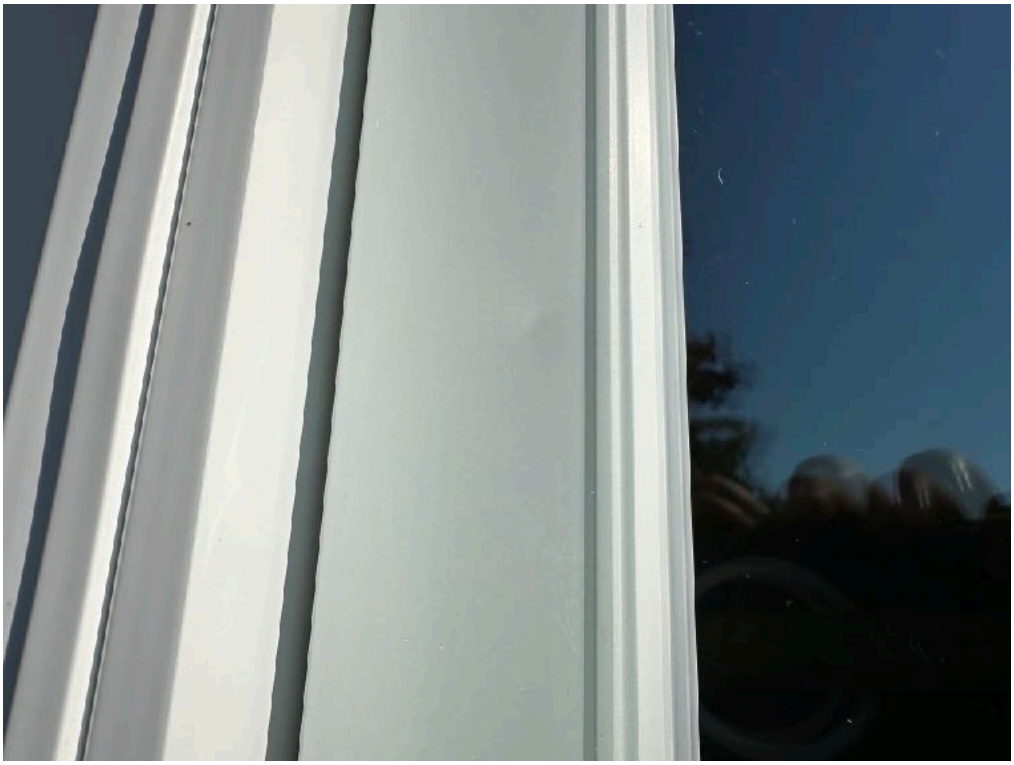
A-40: DENT IN SASH ALONG LEFT SIDE OF CASEMENT

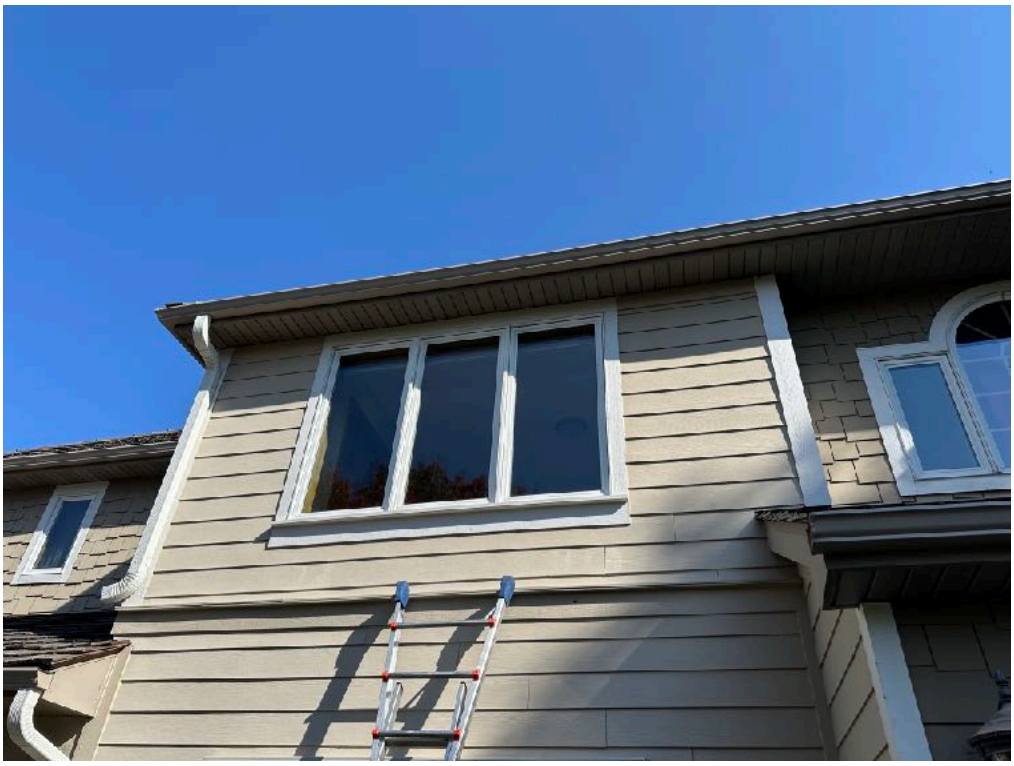
A-41: LEFT CASEMENT, VIEW OF DENT IN SASH

A-42: DOWNSPOUT EXTENSION AT FRONT, VIEW OF DENT AT UPPER EDGE

A-43: UPPER WINDOW, WEST SIDE NORTH OF ENTRY

A-44: VIEW ALONG BOTTOM OF WINDOW

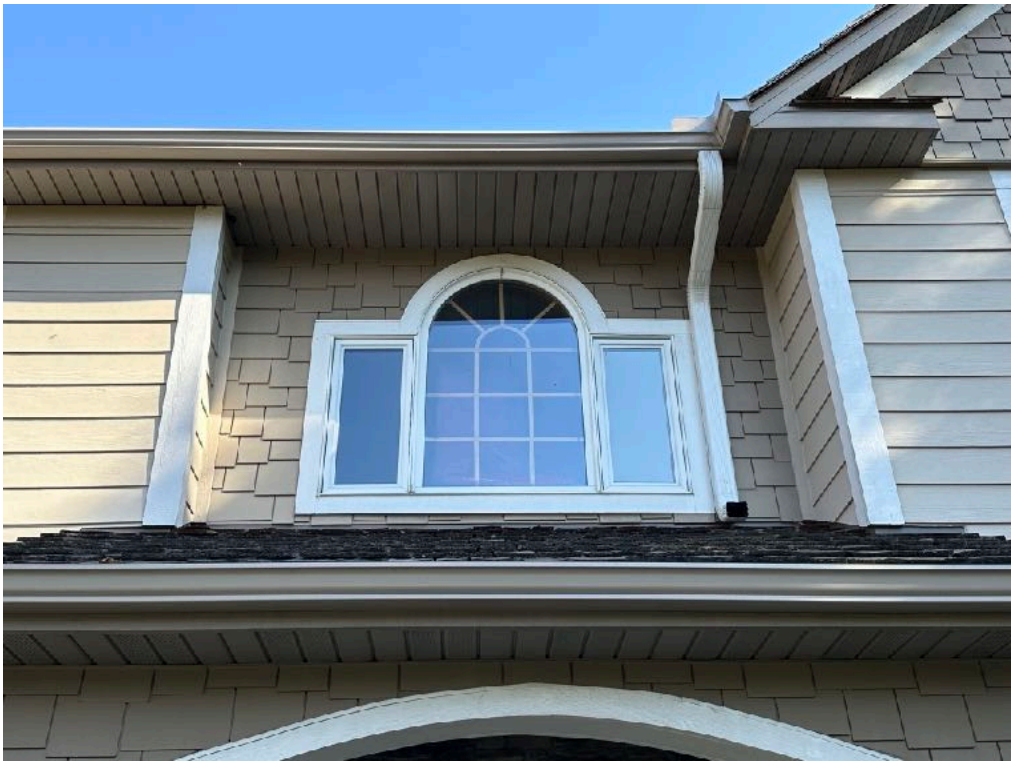
A-46: LOWER RIGHT CORNER OF SASH AT UPPER WINDOW

A-47: VIEW ALONG BOTTOM OF WINDOW, UPPER WEST BEDROOM

A-48: UPPER WINDOW ABOVE MAIN ENTRY

A-49: LOWER RIGHT CORNER OF CENTER FIXED SASH

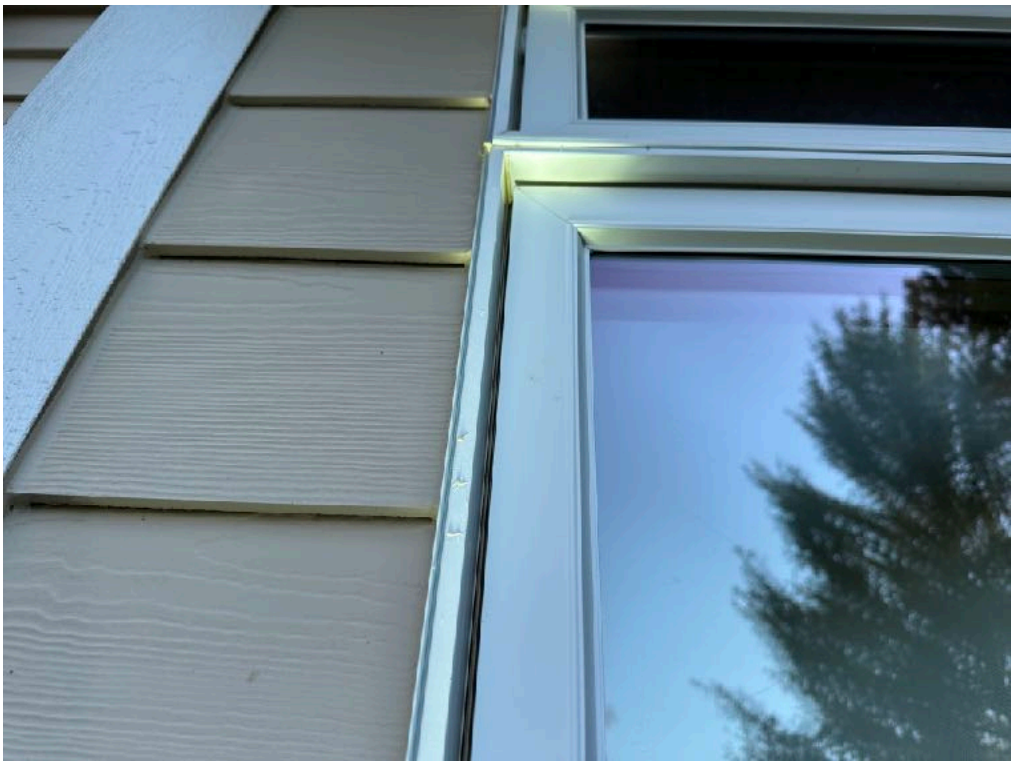
A-53: CHIP IN TRIM ALONG LEFT SIDE OF BUMP-OUT

A-54: VIEW OF FLASHING ALONG BOTTOM OF BUMP-OUT

A-55: LEFT SIDE OF WINDOW GROUP AT MAIN LEVEL IN BUMP-OUT

A-56: VIEW ALONG BOTTOM OF WINDOW FRAME
