FARMERS INSURANCE

RE:	Insured:	Yibiao Lu
	Claim Number:	7007986837-1-1
	Policy Number:	0980554965
	Loss Date:	07/13/2024
	Location of Loss:	17756 George Moran Dr, Eden Prairie, MN
	Subject:	Appraisal

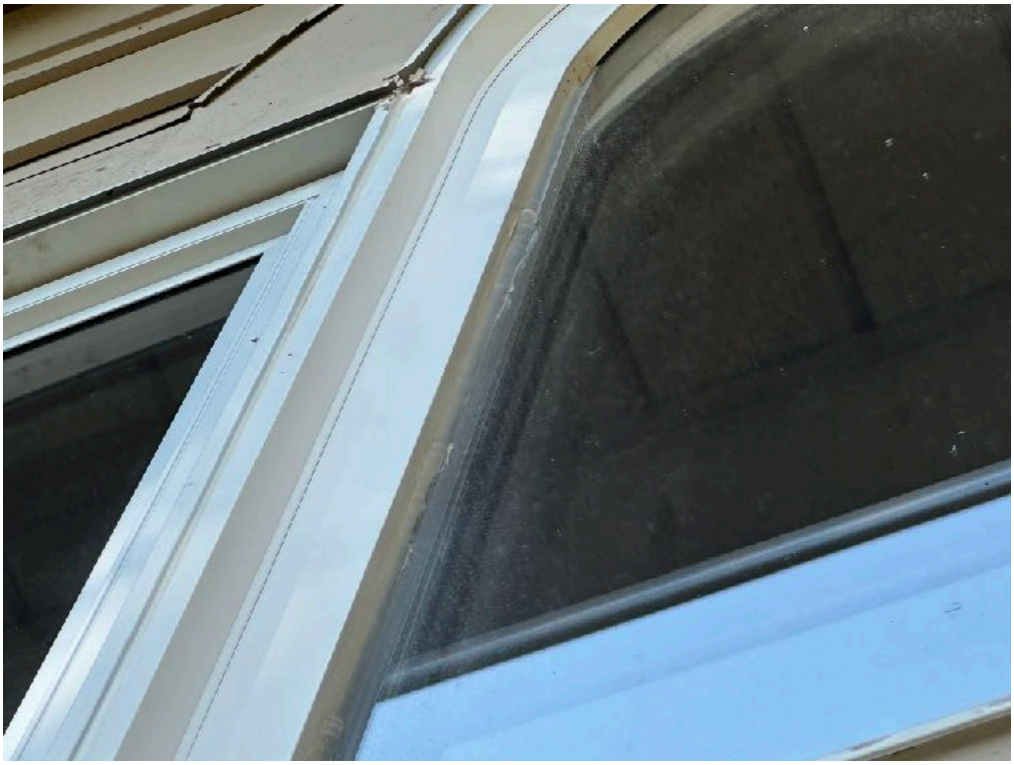
A-84: LEFT MULLION AT STAIRWAY WINDOW GROUP

A-85: UPPER WEST WINDOW AT STAIRWAY

A-86: LEFT SIDE OF UPPER CENTER WINDOW

A-87: RIGHT MULLION AT UPPER WINDOWS, CAULK PRESENT

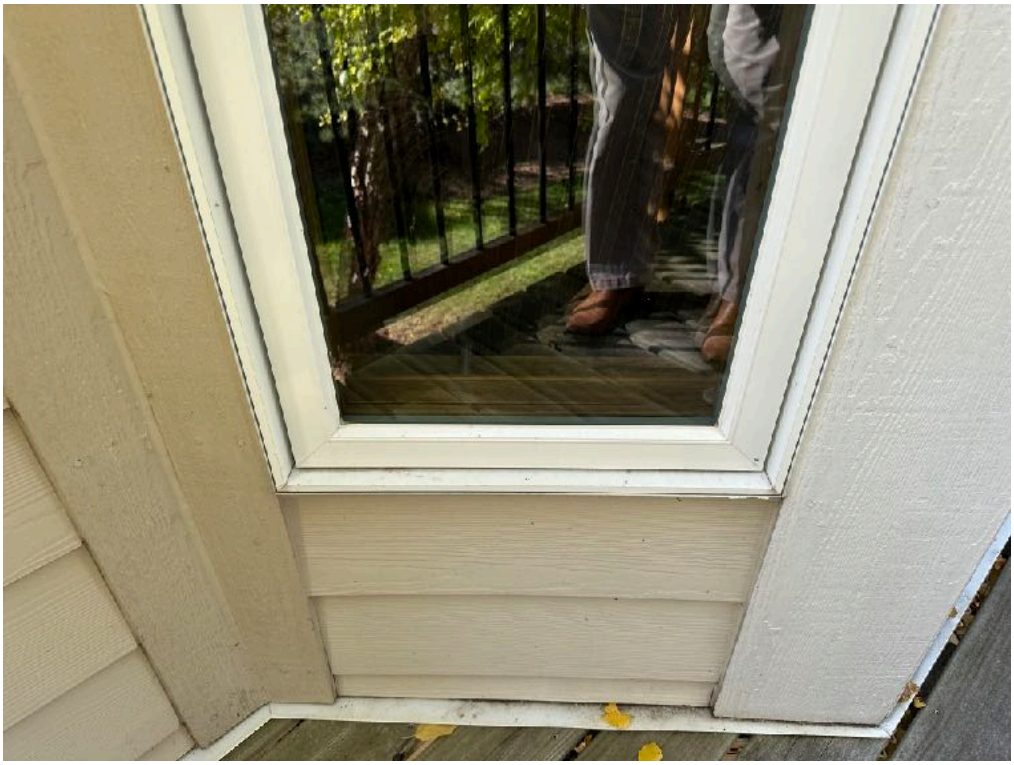
A-103: VIEW OF DENTS IN FLASHING AT BASE OF WALL ALONG DECK

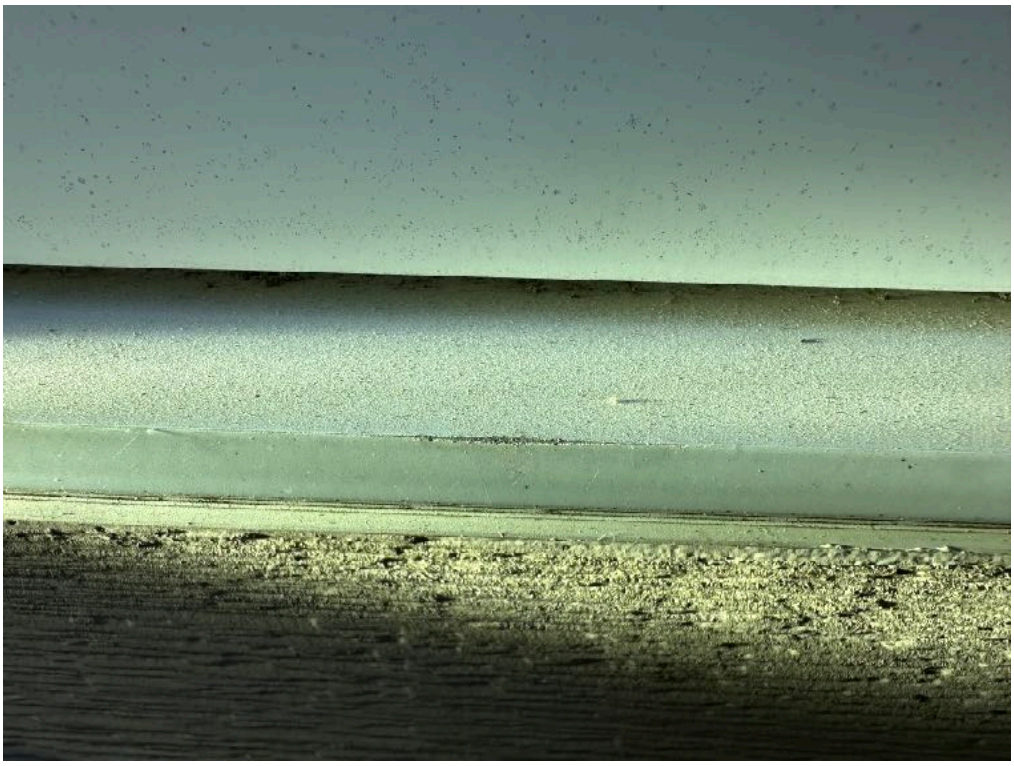
A-155: SCRAPING ALONG EDGE OF BOTTOM WINDOW FRAME

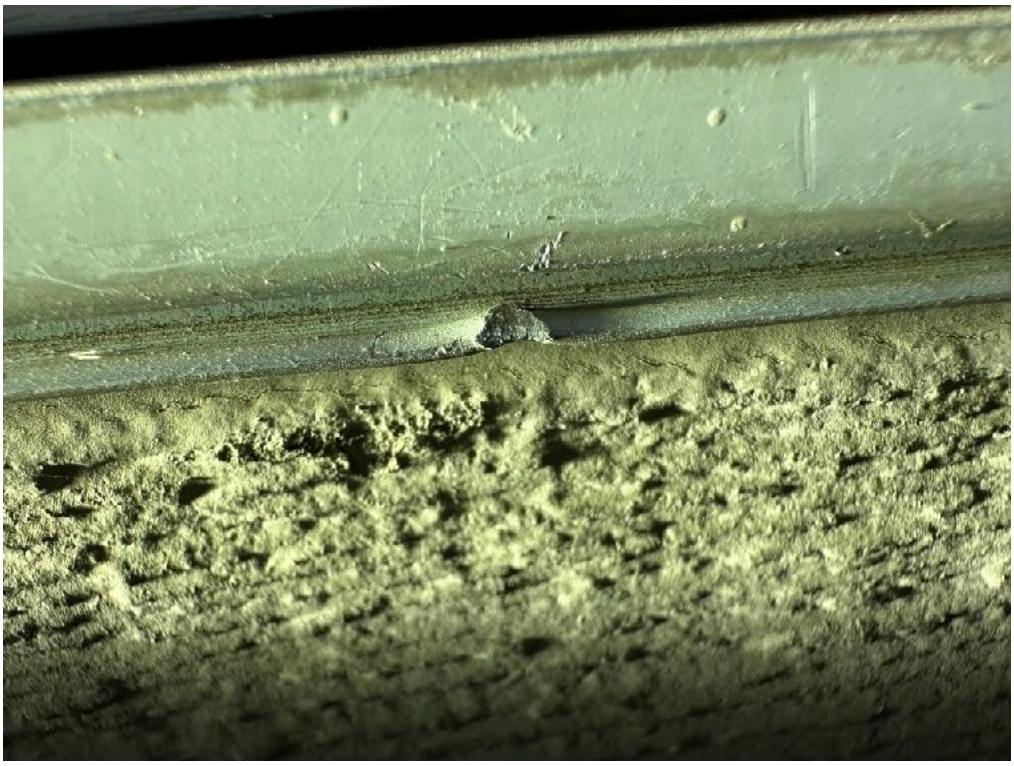
A-165: DENT WITH MISSING FINISHES ALONG BOTTOM OF WINDOW

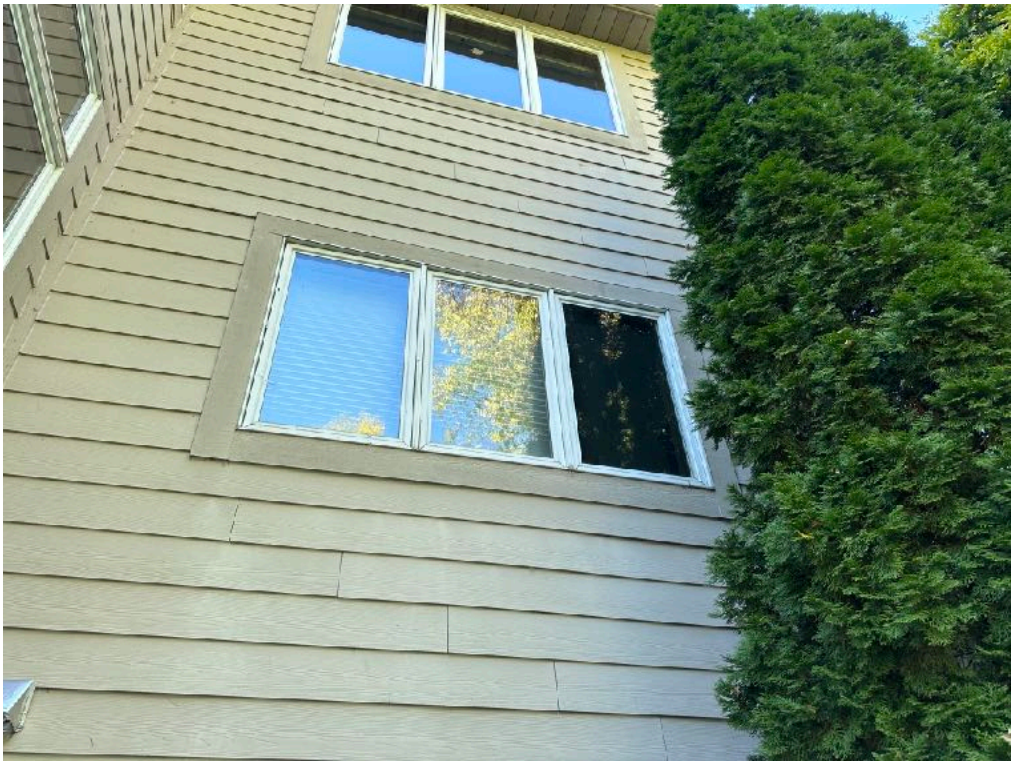
A-194: VIEW BETWEEN UPPER AND LOWER WINDOW AT NORTH KITCHEN WALL

A-195: LEFT SIDE BETWEEN UPPER AND LOWER NORTH KITCHEN WINDOWS

A-196: MAIN LEVEL WINDOW, EAST SIDE AT NORTH QUADRANT

A-197: VIEW ALONG TOP OF WINDOW
