# Inspection photos

Claim Number: 3013539499-1

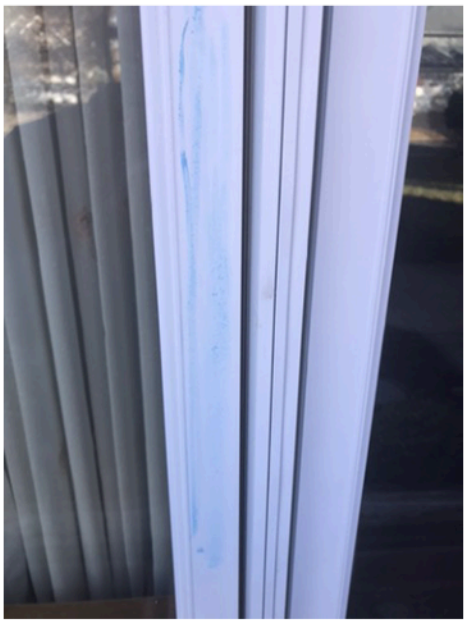
Front. Red= damaged sash

Hail Dent in 1 sash

No hail damage to frames or other sashes

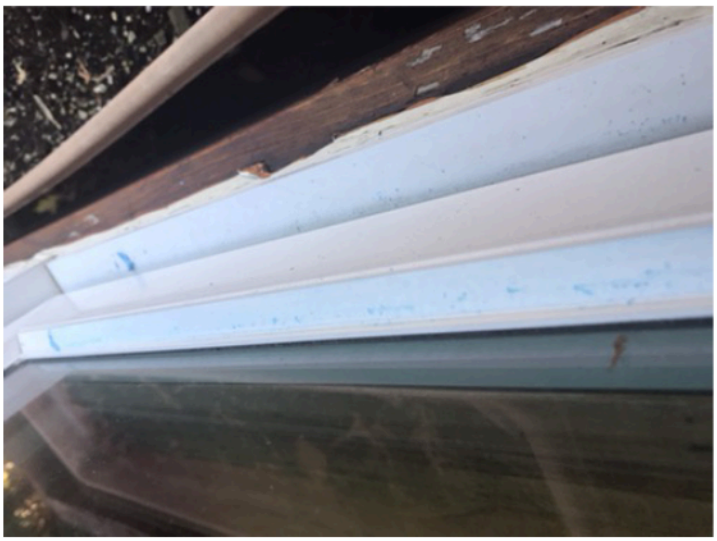
Dent with scratch. Not hail

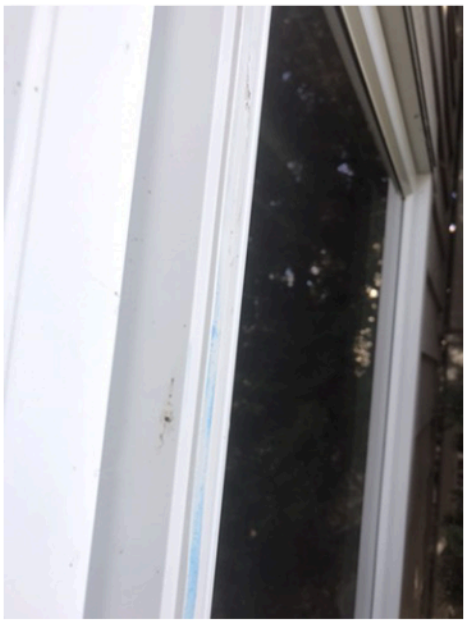
No storm damage

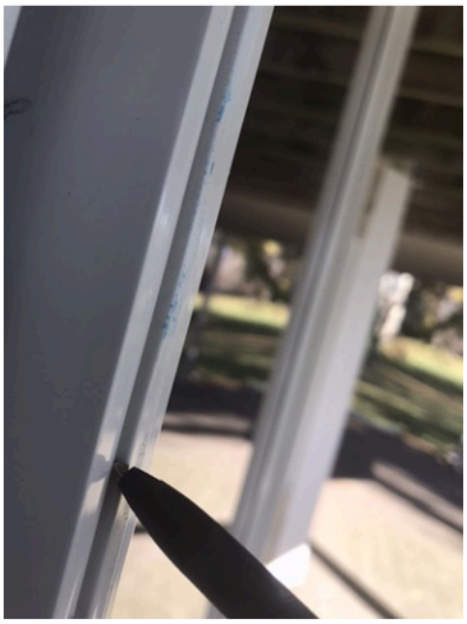
Back

No storm damage

Million is wavy from manufacturer. No storm damage found

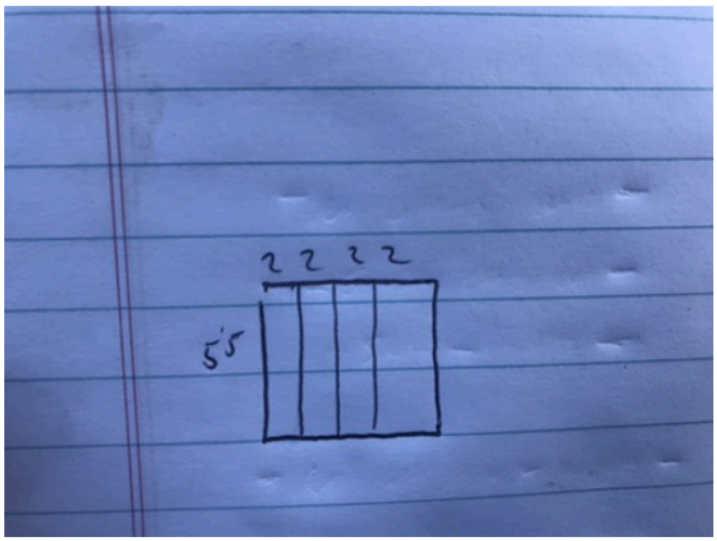
Front window

Dent in 1 sash
