Photo Sheet

Concise Resolution Services, LLC

Insured: Yibiao Lu

Claim #: 7007986837-1-1

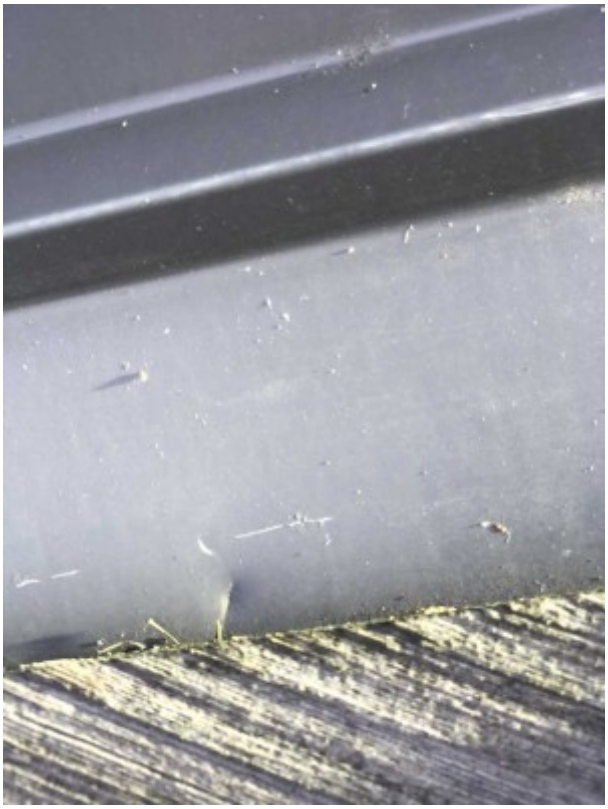
Dwelling - 3-Velley metal

Small spatter observed

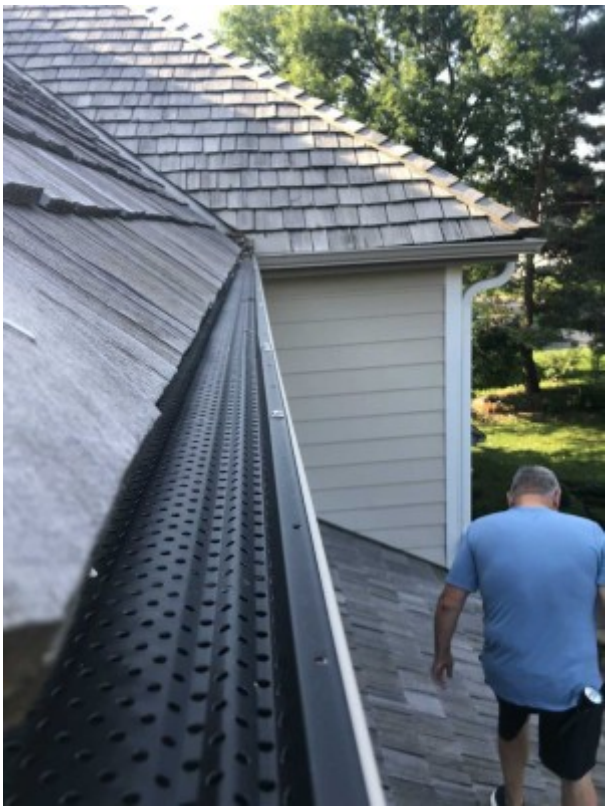
Dwelling/Front Elevation - 7-Gutter Guard

No hail damage to upper gutter guard

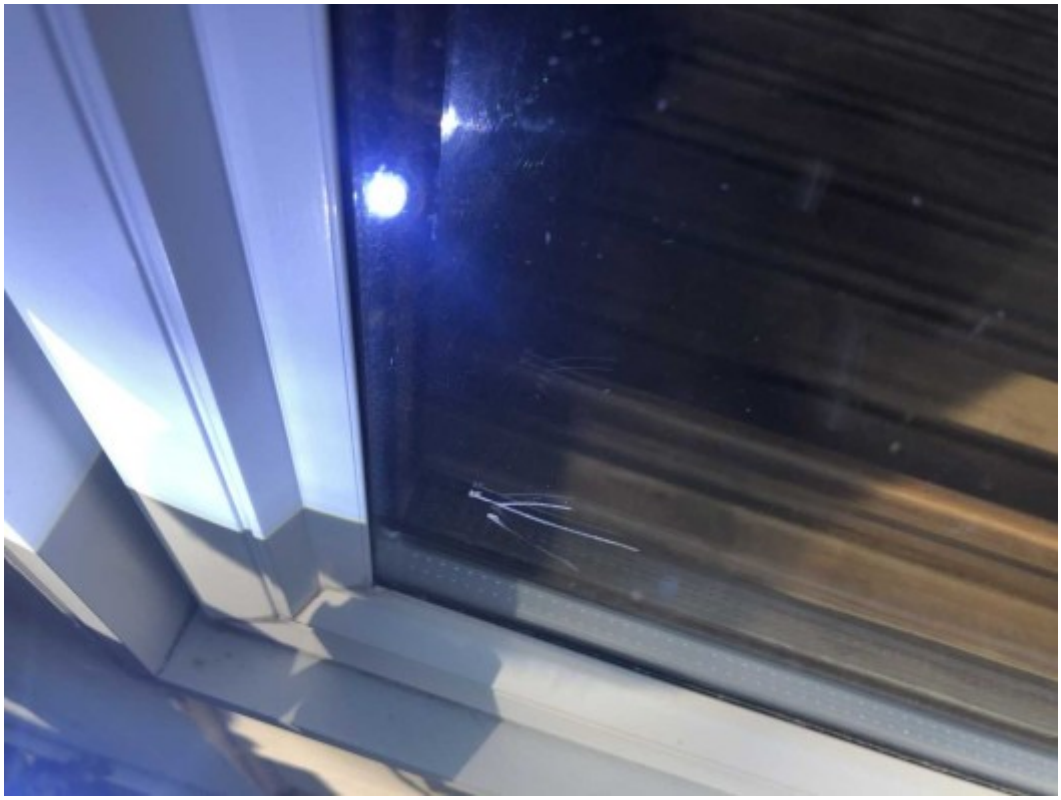
Dwelling/Rear Elevation - 29-Family Room

Damage observed to right sash
