FARMERS INSURANCE

RE:		
	Insured:	Yibiao Lu
	Claim Number:	7007986837-1-1
	Policy Number:	0980554965
	Loss Date:	07/13/2024
	Location of Loss:	17756 George Moran Dr, Eden Prairie, MN
	Subject:	Appraisal

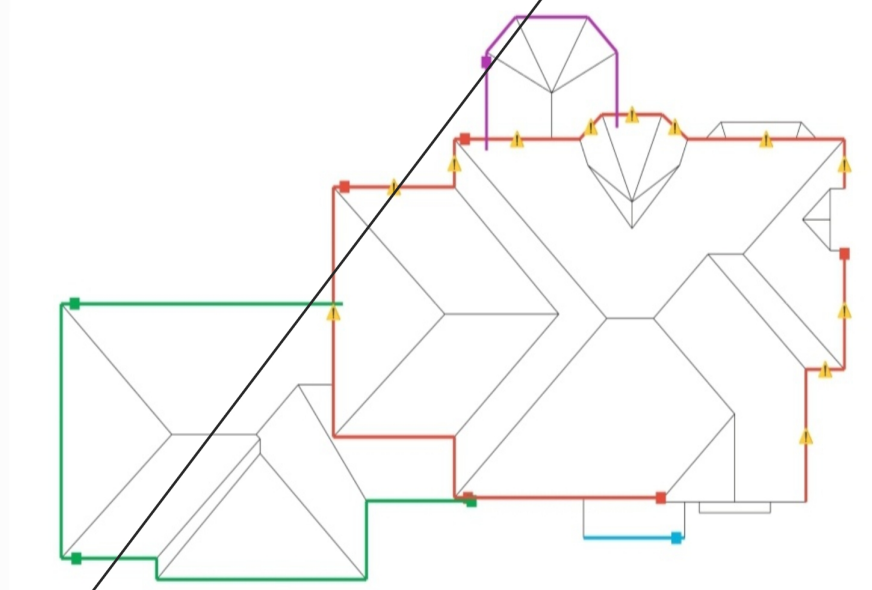
INSURED STATED ROOF DOES NOT NEED INSPECTION DUE TO CEDAR SHAKE ONKY BEING 2 YEARS OLD.
