BUILDING AND PEST INSPECTION
MELBOURNE.COM.AU

Property and Timber Pest

Inspection Date: 9 Jun 2026

Property Address: 9 Furness Close Wyndham Vale 3024

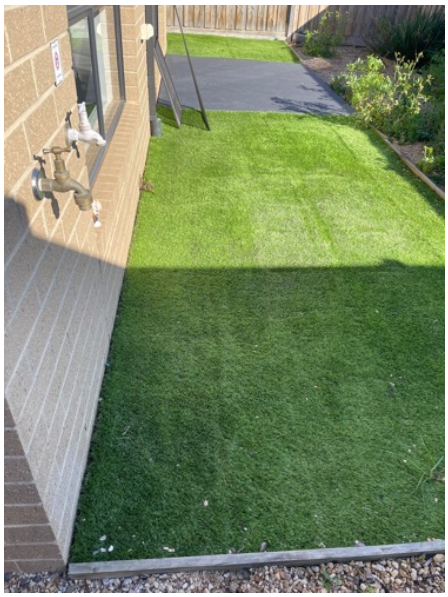
Major Defect 1.03

Finding: Slope away water from foundations & Concrete paths recommended along perimeter

In the All External Areas, the gravel levels are improperly graded, resulting in water pooling against the house. This condition poses a risk of water ingress and associated damage to the foundation and lower structural elements. It is recommended that the gravel be re-graded to ensure proper drainage, directing water to flow away from the property. Remedial action should include adjusting the surface gradient and potentially installing drainage solutions to prevent ongoing water accumulation adjacent to the residential structure.

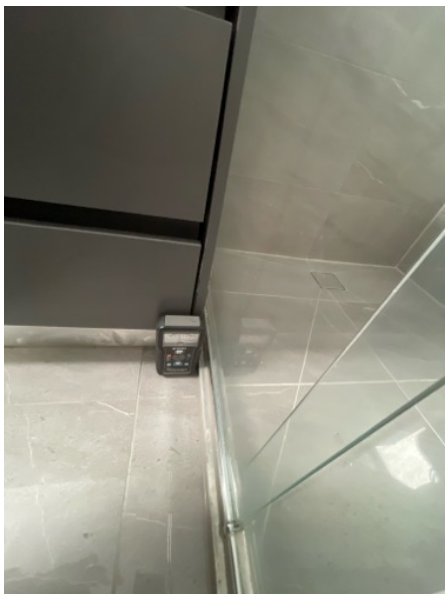
Major Defect 1.04

Location: Bathroom

Finding: Bathroom waterproofing/leaks

The inspection of the bathroom revealed evidence of moisture intrusion at the base of the shower screen. The moisture meter indicated elevated readings, suggesting that water is escaping and compromising the surrounding materials. This condition may lead to further deterioration, such as mold growth or structural damage, if not addressed promptly. It is recommended to reseal the affected area and ensure proper waterproofing. Engaging a professional contractor to evaluate and rectify the waterproofing system is advised to prevent future occurrences.

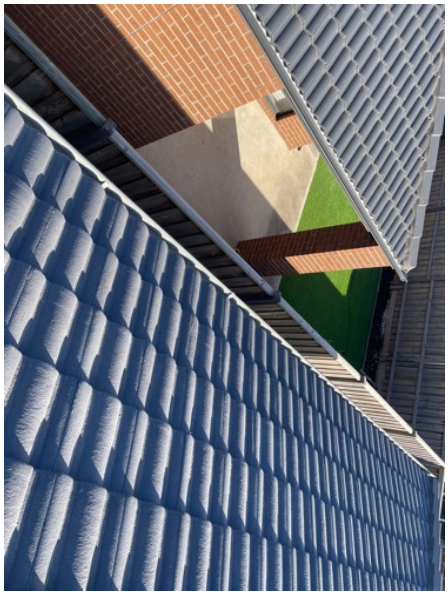
Minor Defect 2.04

Finding: Loose gutter clips

During the inspection of the roof exterior, it was observed that several gutter clips were loose, which may compromise the efficiency of the guttering system in managing rainwater drainage. This defect poses a risk of water overflow and potential damage to the property's structure. It is recommended that a licensed roof plumber be engaged to secure the gutter clips properly. Ensuring that the gutter system is firmly attached will help maintain its functionality and prevent any associated water damage to the property.

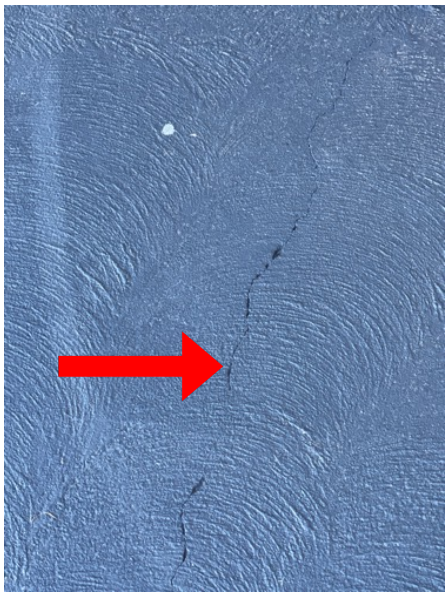
Minor Defect 2.05

Location: All External Areas

Finding: Cracked concrete

Some cracking / deterioration was observed to sections of concrete paving recommend to replace where necessary as some of it has limited service life remaining. (Some photo examples following] Cracking in concrete is common and is not always attributable to unsatisfactory workmanship. Common causes of cracking include shrinkage stress, stress due to trees, commercial or heavy vehicle traffic, soil movement due to changes in the moisture content as a result of garden watering or drainage problems. Tripping hazards should be filled or ground flat for the safety of the home's occupants. An investigation (by a competent person e.g. a licensed concreting contractor) is recommended to determine the method and extent of any remedial work required, and associated costs.

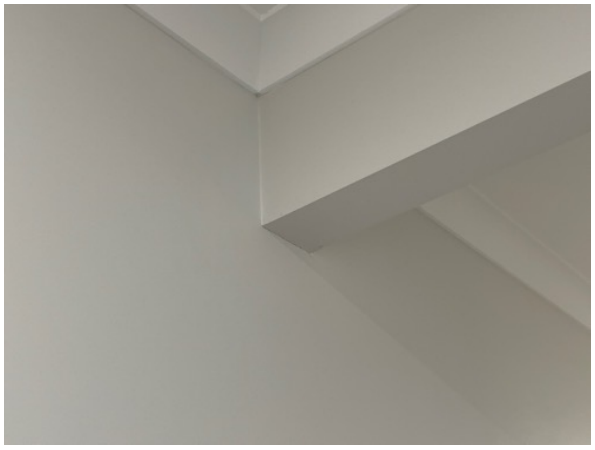
Minor Defect 2.08

Finding: Cornice

The internal areas exhibit noticeable cracking at the ceiling joints, indicative of minor structural movement or settlement. This condition, observed across multiple sections, may lead to further deterioration if not addressed. It is recommended to engage a qualified building professional to assess the extent of the issue. Remedial action should include sealing the cracks with appropriate filler material followed by repainting. Continuous monitoring is advised to ensure no progression occurs, as well as to maintain the aesthetic and structural integrity of the property.

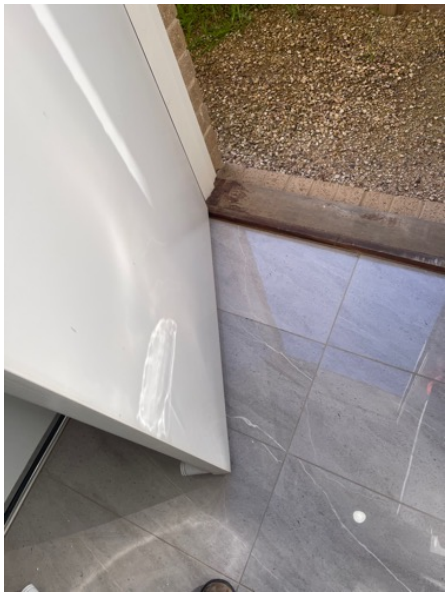
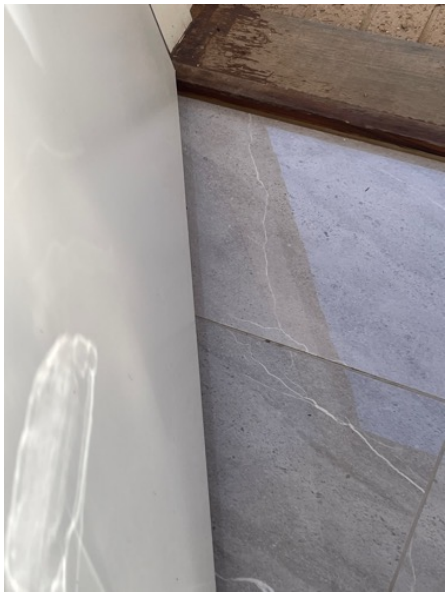
Minor Defect 2.09

Location: Laundry

Finding: Install raven seal

Recommended install raven seal

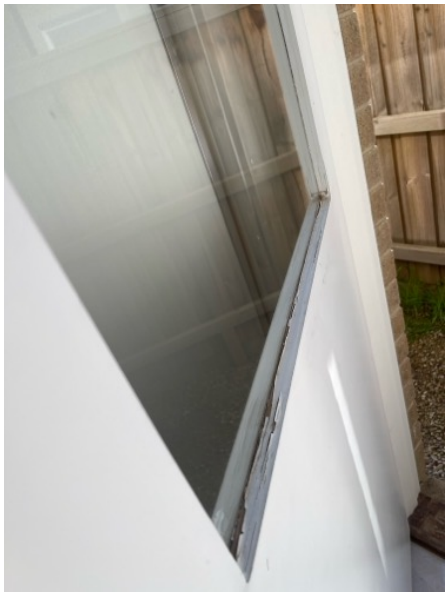
Minor Defect 2.10

Location: Laundry

Finding: Stuck and moisture damaged doors

The laundry door is observed to be stuck and exhibits visible damage, impairing its functionality and ease of use. This defect may lead to further wear if not addressed, potentially affecting the overall integrity and operation of the door. It is recommended that a qualified professional be engaged to assess the extent of the damage and perform necessary repairs or replacements to ensure the door functions properly and safely. Immediate attention to this issue will help maintain the utility and aesthetic appeal of the laundry area.

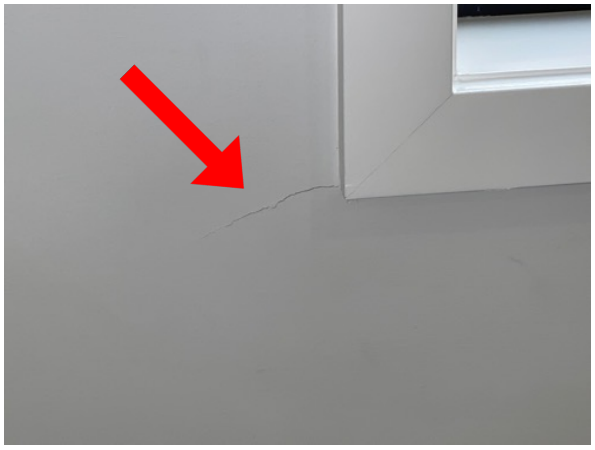
Minor Defect 2.11

Location: Bedroom 2

Finding: Plaster cracks

In Bedroom 2, minor cracking is evident on the wall adjacent to the window and on the ceiling near the ventilation unit. These cracks may be indicative of normal settlement or environmental factors affecting the property. It is recommended to monitor these cracks for any progression over time. As a remedial action, engaging a qualified builder to assess the structural integrity and, if necessary, performing minor cosmetic repairs such as filling and painting should be considered to prevent further issues.

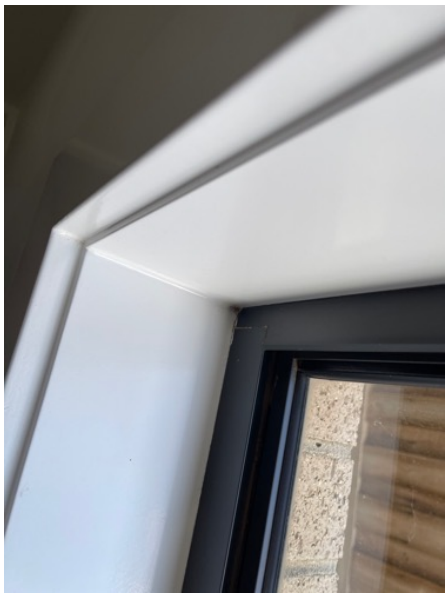
Minor Defect 2.12

Location: All Internal Areas

Finding: Damaged/leak windows

Recommended improve the seals of windows for water leaks as water ingress makes conditions favourable for termites and further damage the structure.

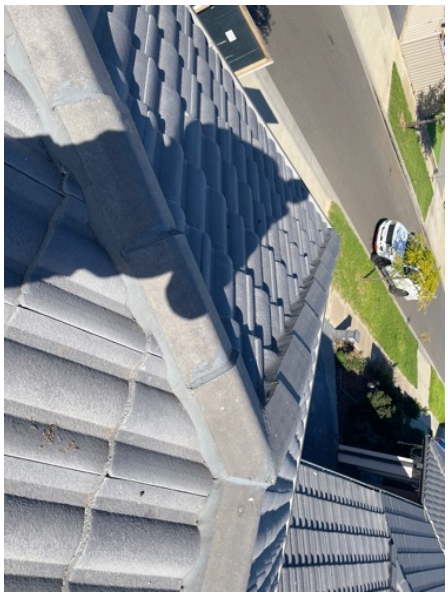
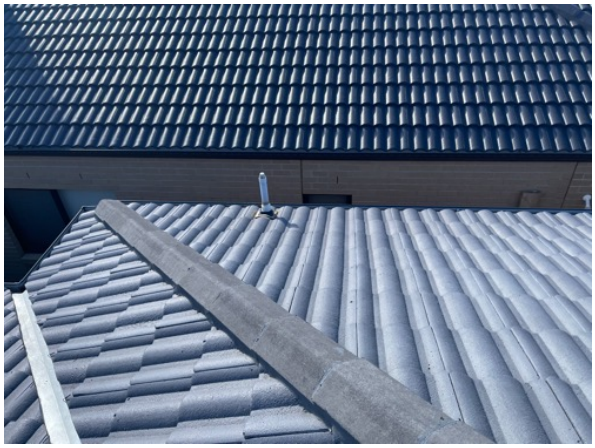
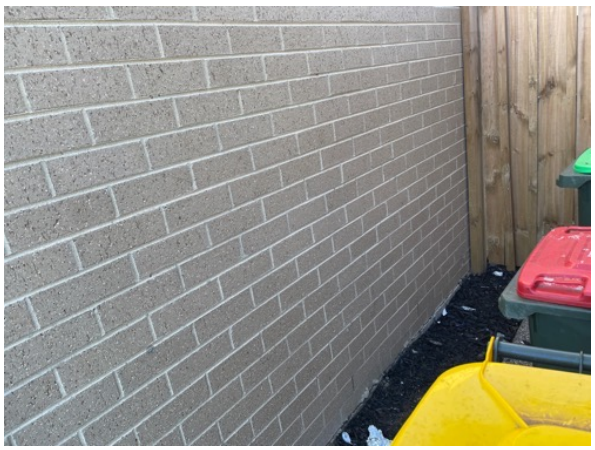
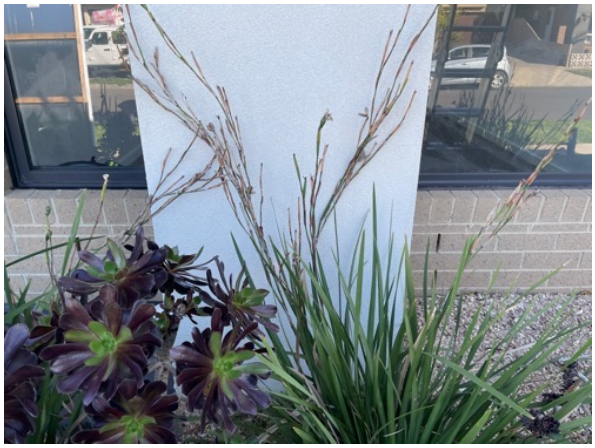
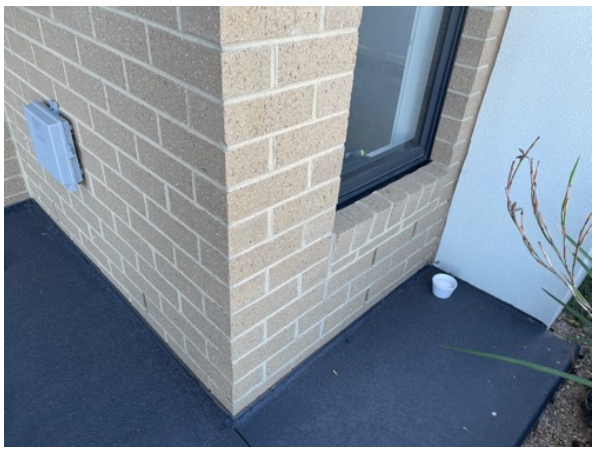
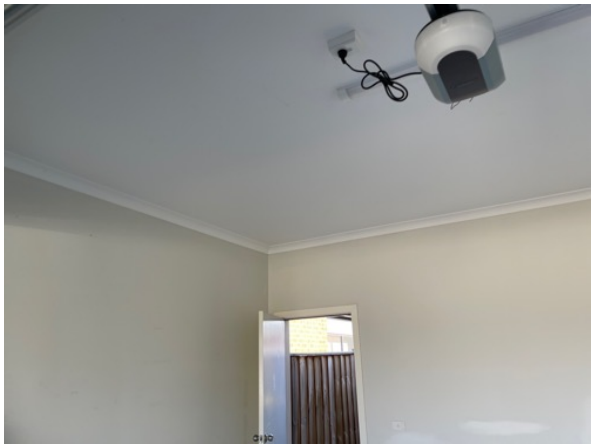
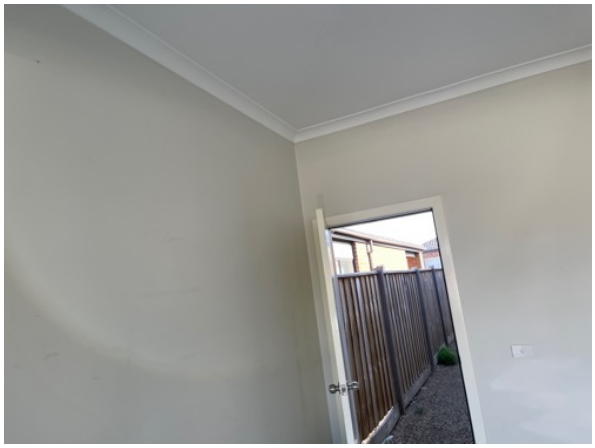
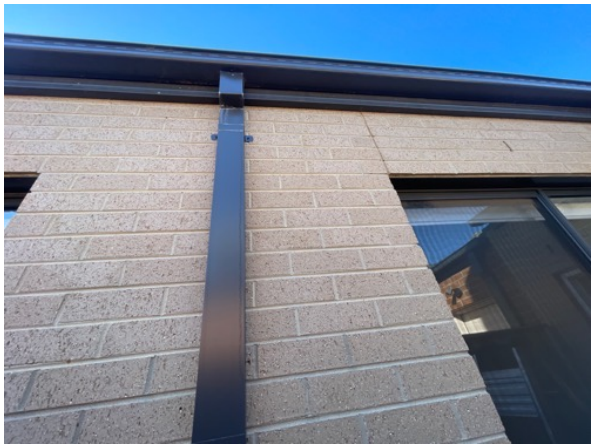
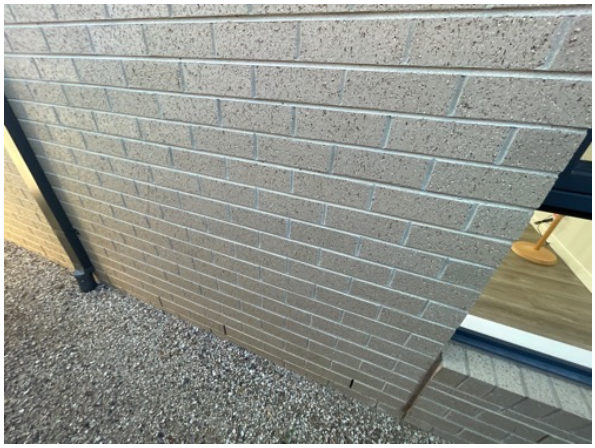
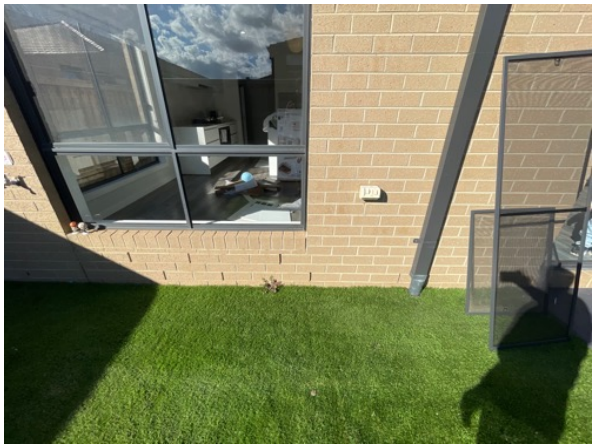
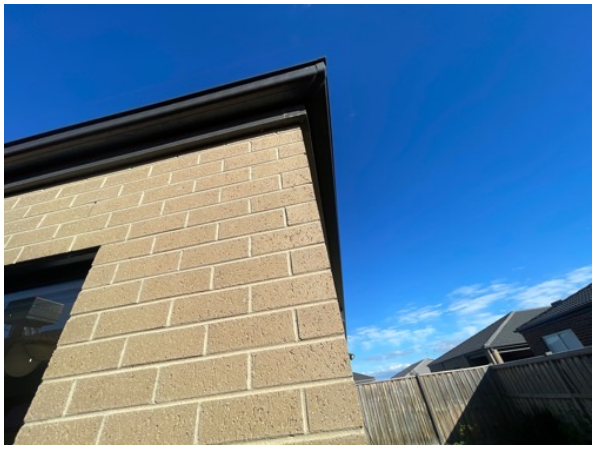
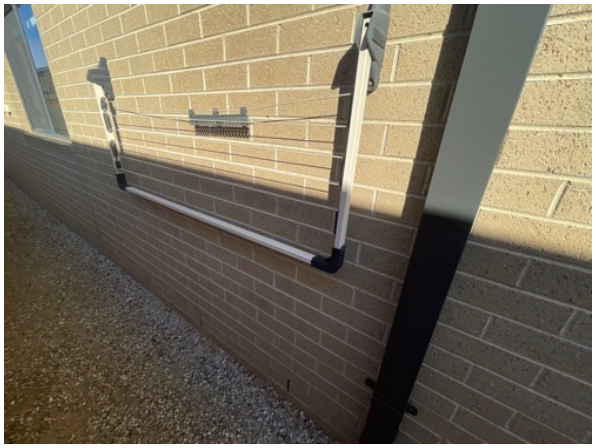
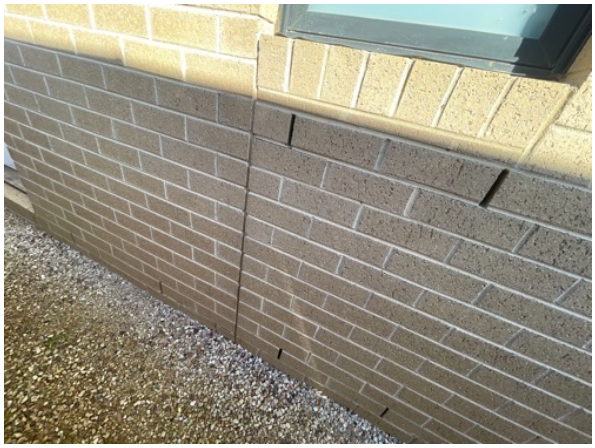
Finding: ADDITIONAL EXTERNAL PHOTOS

These photos are an indication of the obstructions & limitations which impeded full inspection of the property at the time of inspection. The obstructions can hide an array of defects and should be removed to allow for a full inspection to be carried out. The inspection only covers readily accessible areas of the building and site. The inspection did not include inaccessible, not readily accessible and unsafe or obstructed areas. Obstructions are defined as any condition or physical limitation which inhabits or prevents inspection and may include but not limited to: bricks, hebel, render, claddings, paths, roofing, fixed ceilings, wall linings, floor coverings, fixtures, fittings, furniture, clothes, stored articles/ materials, thermal insulation, sarking, pipes, ducts, builders debris, vegetation, pavement, or earth.

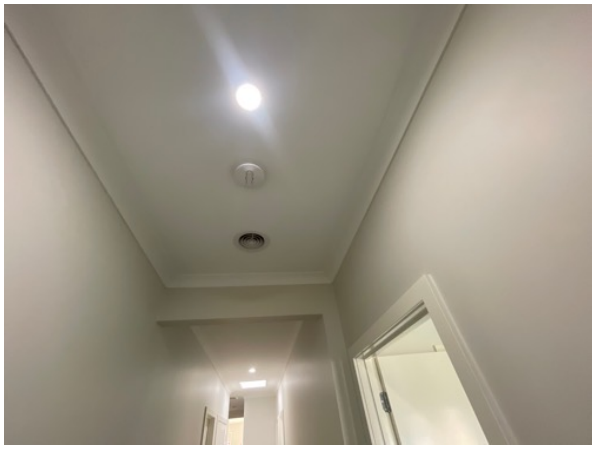
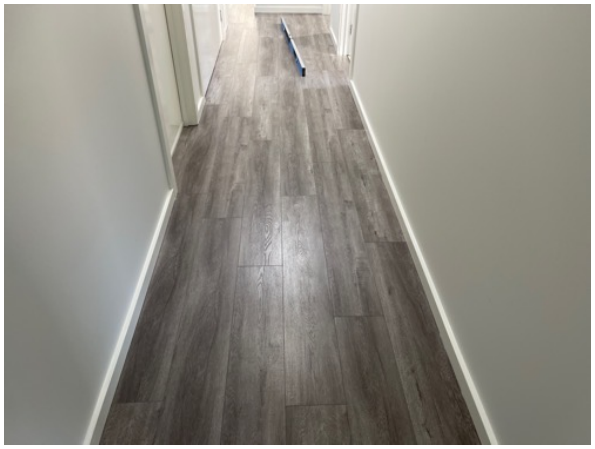
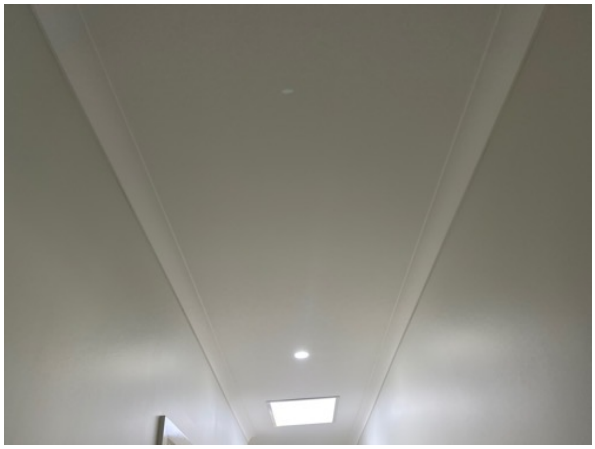
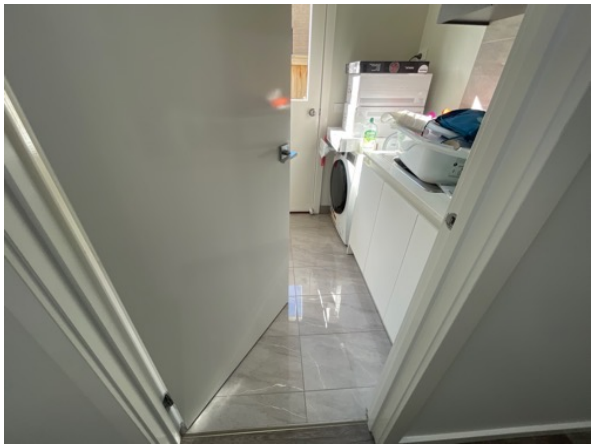
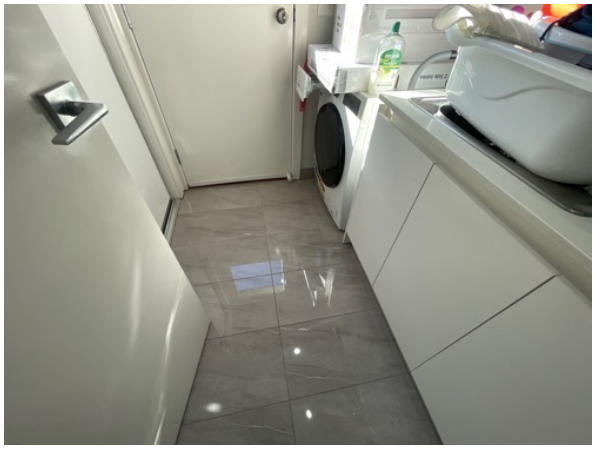
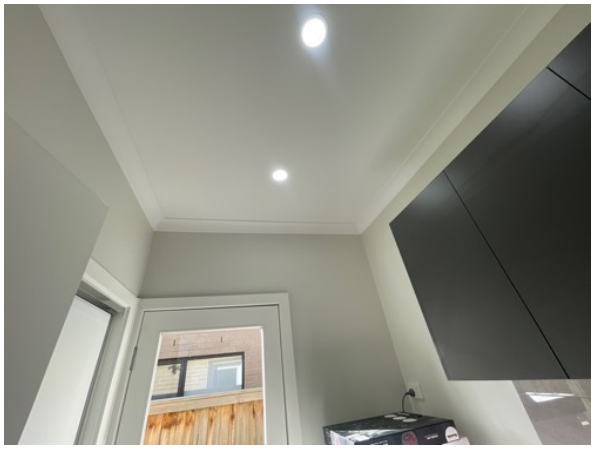
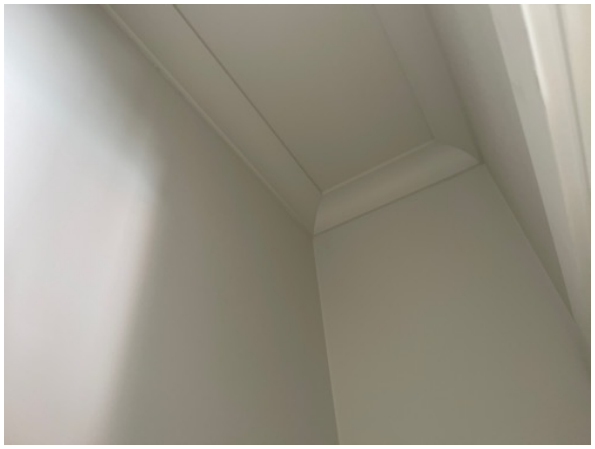
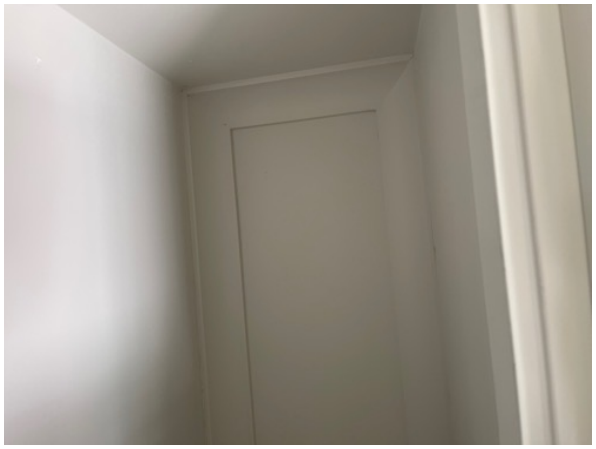
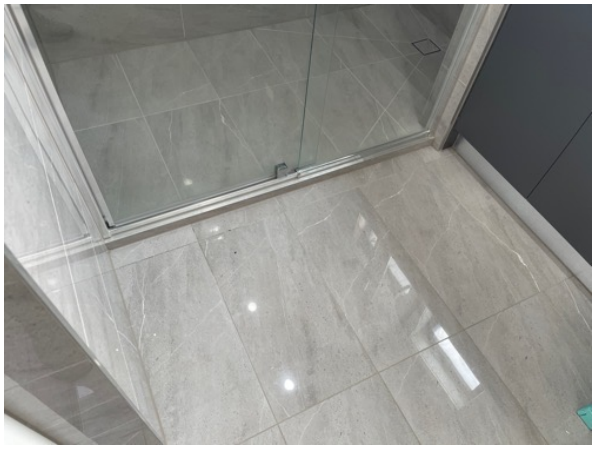
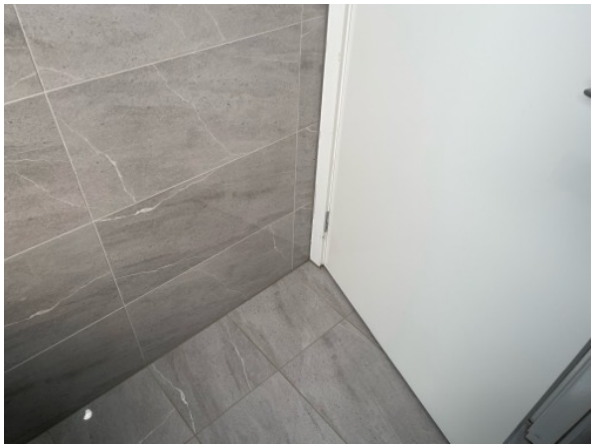
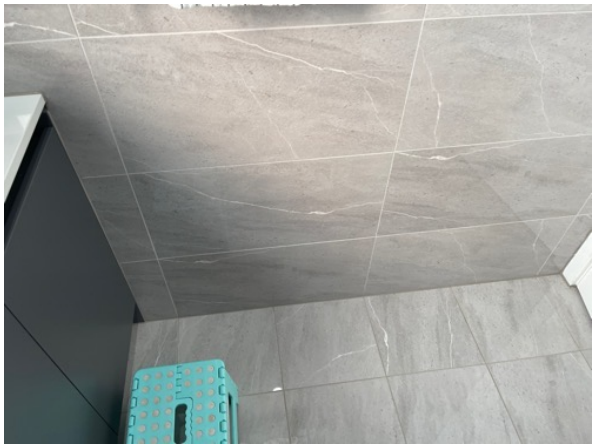
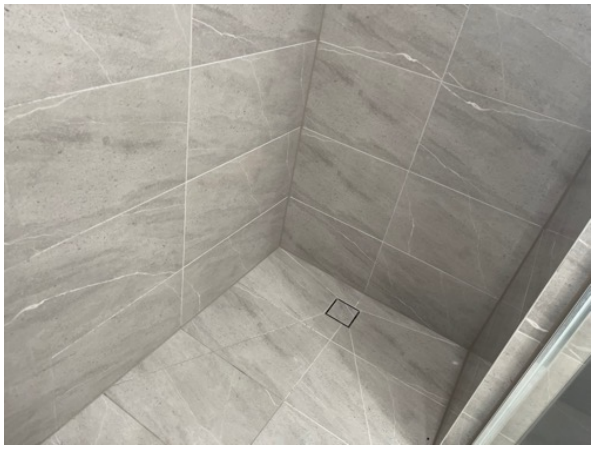
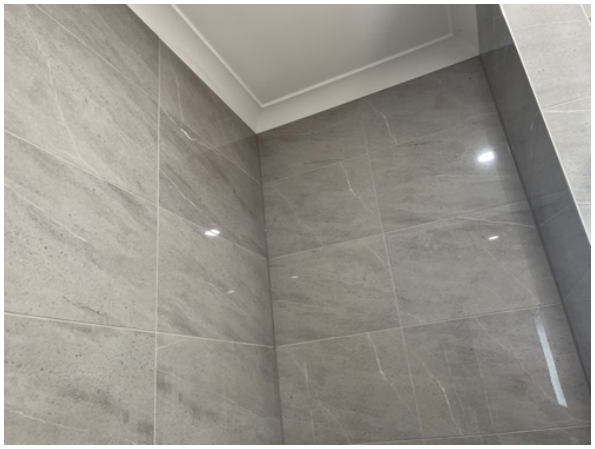
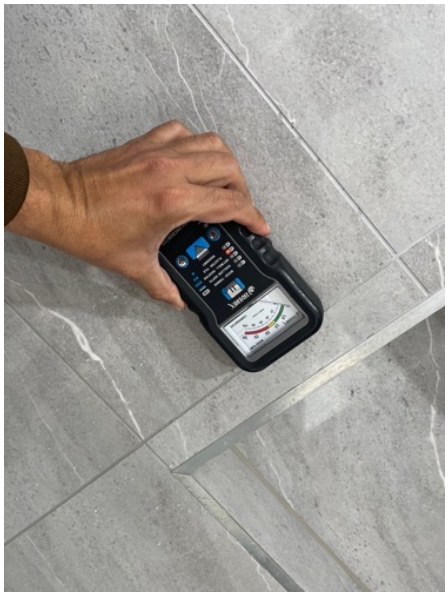
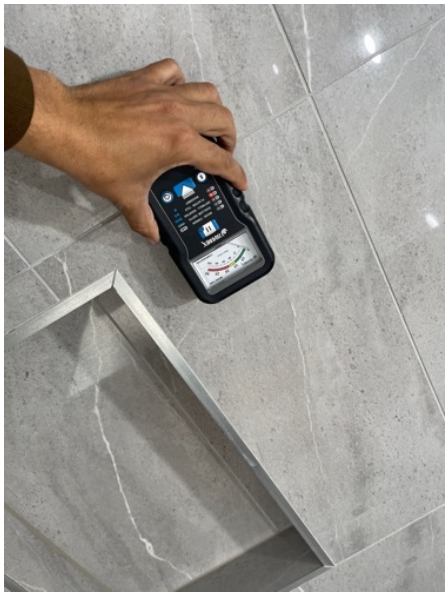
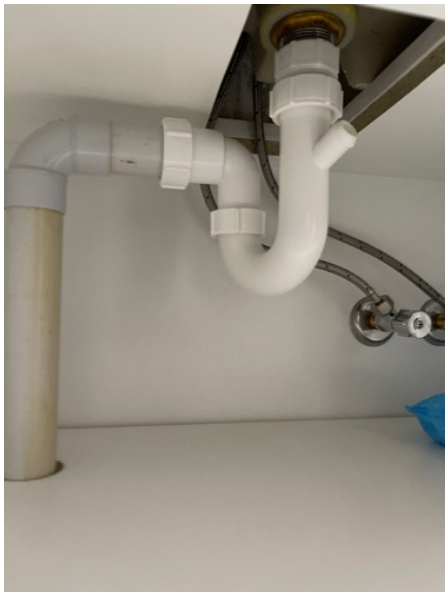
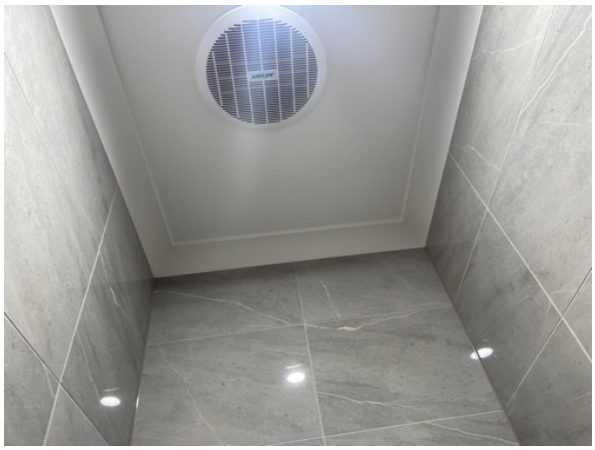
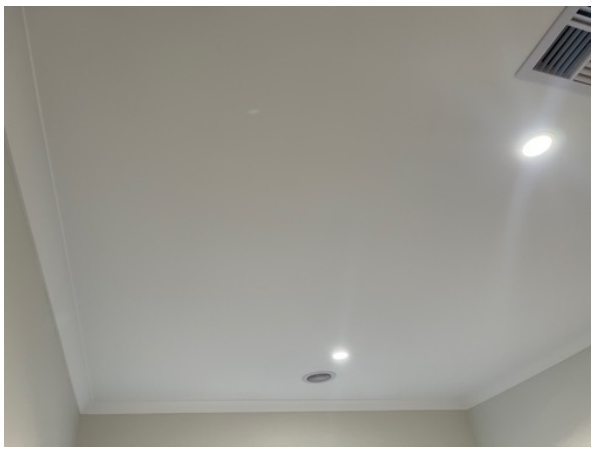
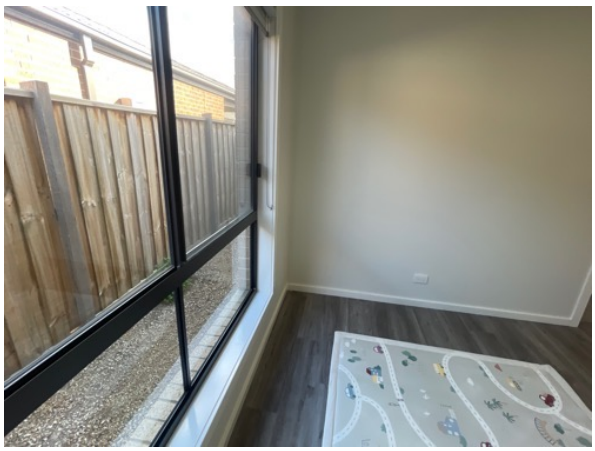
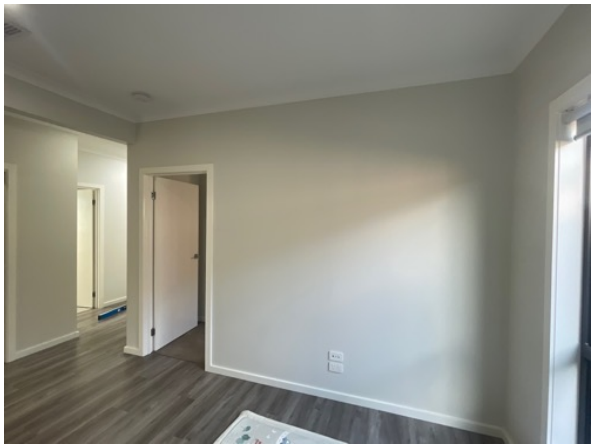
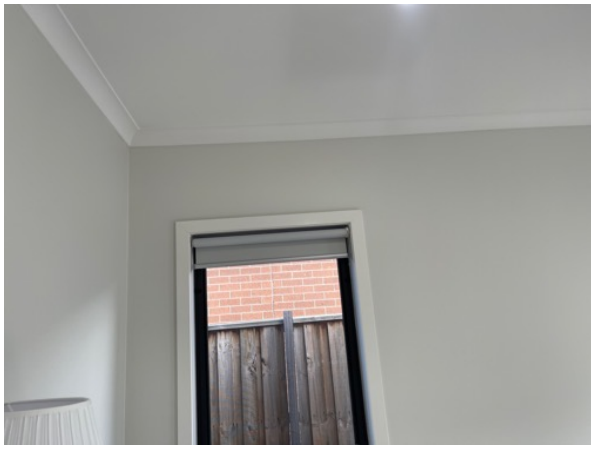
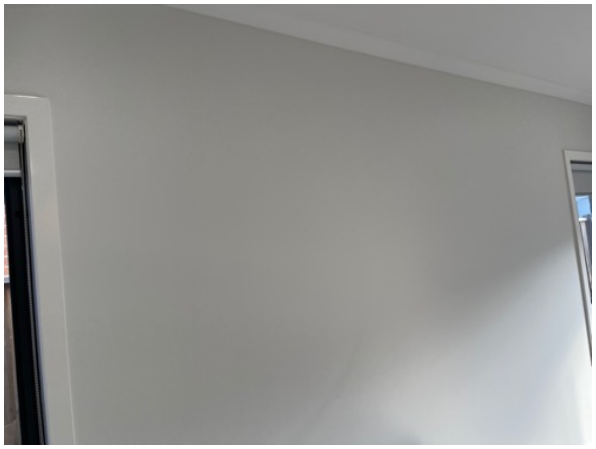
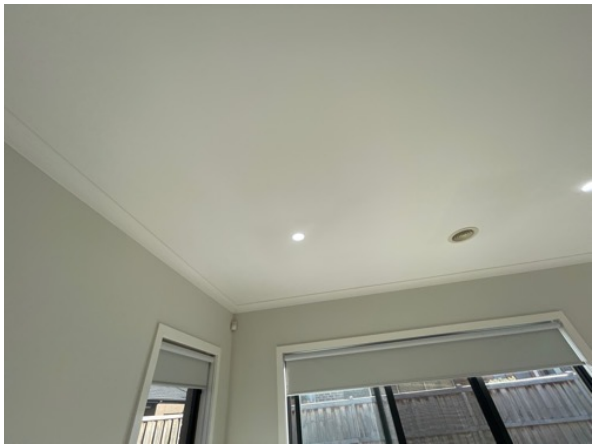
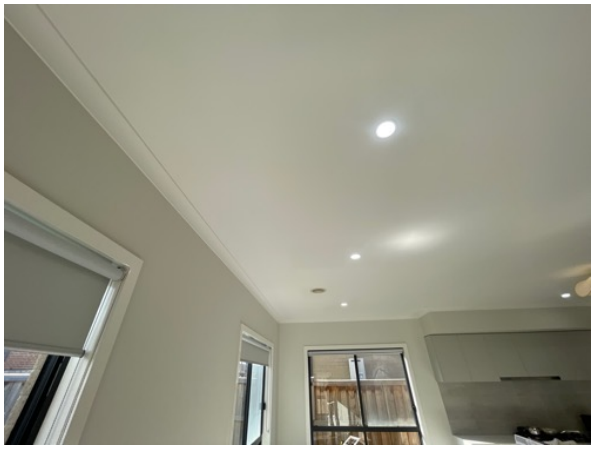
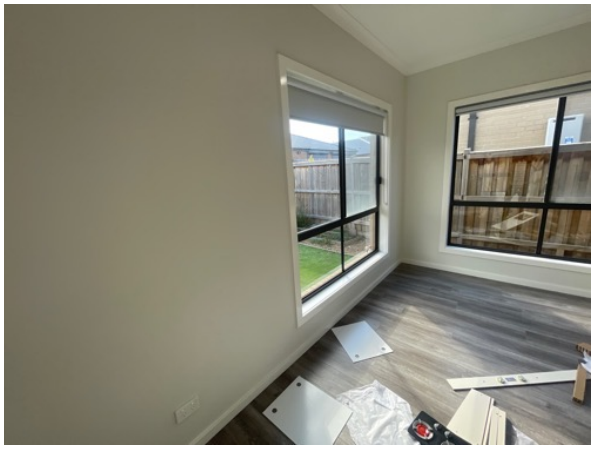
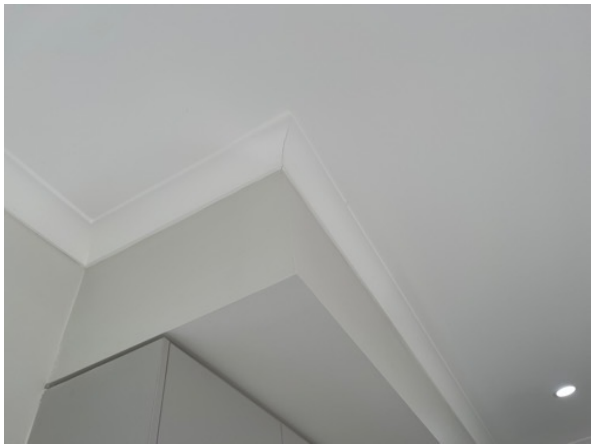
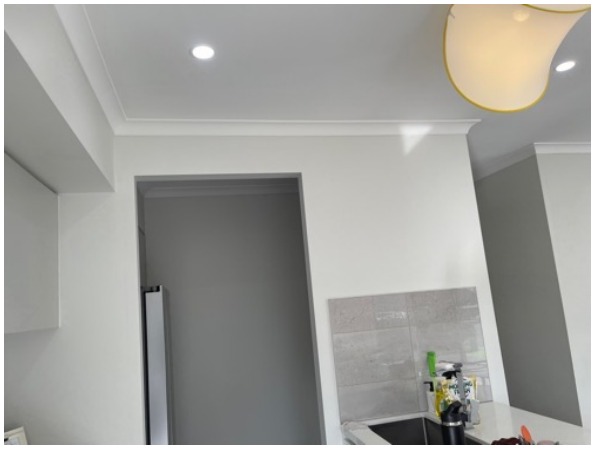
For your information 3.02

Location: All Internal Areas

Finding: ADDITIONAL INTERNAL PHOTOS

These photos are an indication of the obstructions & limitations which impeded full inspection of the property at the time of inspection. The obstructions can hide an array of defects and should be removed to allow for a full inspection to be carried out. The inspection only covers readily accessible areas of the building and site. The inspection did not include inaccessible, not readily accessible and unsafe or obstructed areas. Obstructions are defined as any condition or physical limitation which inhabits or prevents inspection and may include but not limited to: bricks, hebel, render, claddings, paths, roofing, fixed ceilings, wall linings, floor coverings, fixtures, fittings, furniture, clothes, stored articles/ materials, thermal insulation, sarking, pipes, ducts, builders debris, vegetation, pavement, or earth.

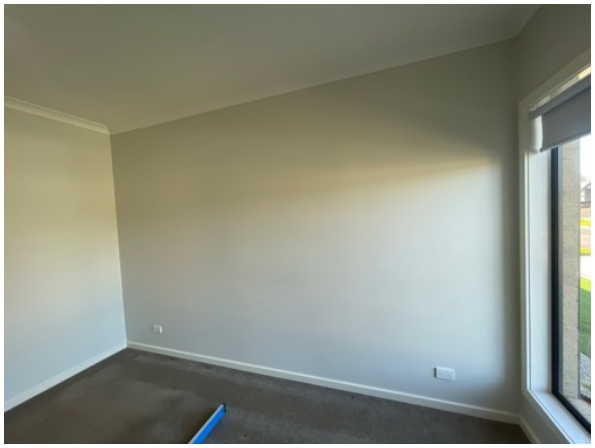
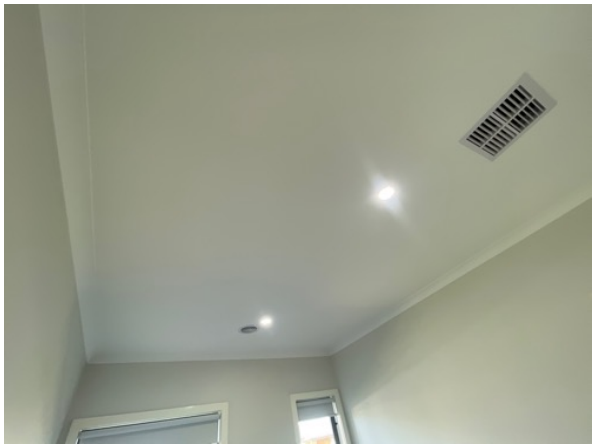
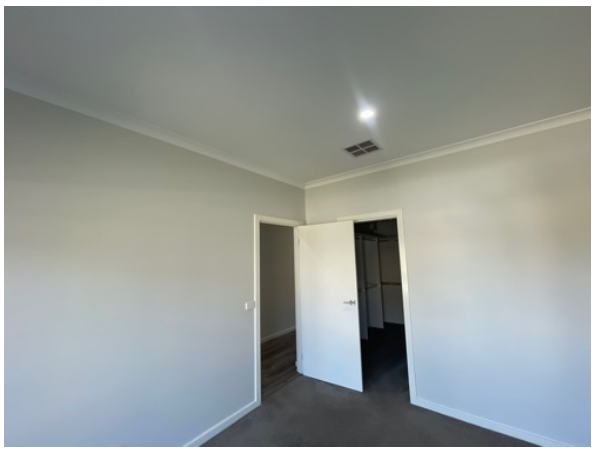
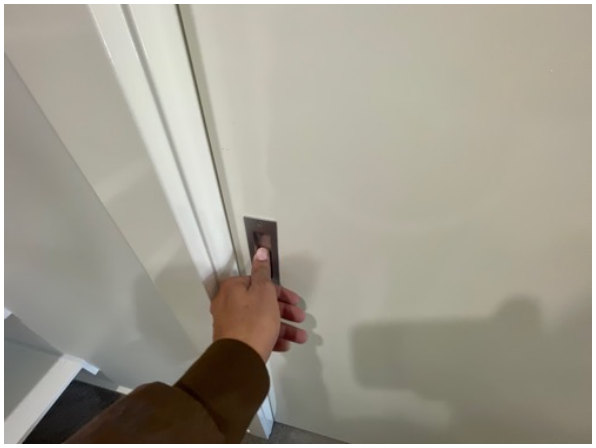
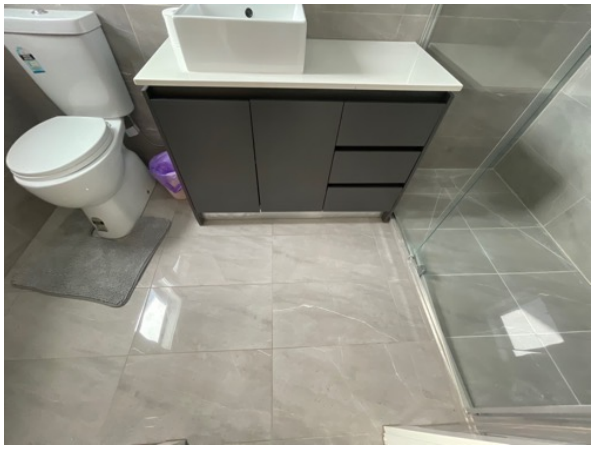
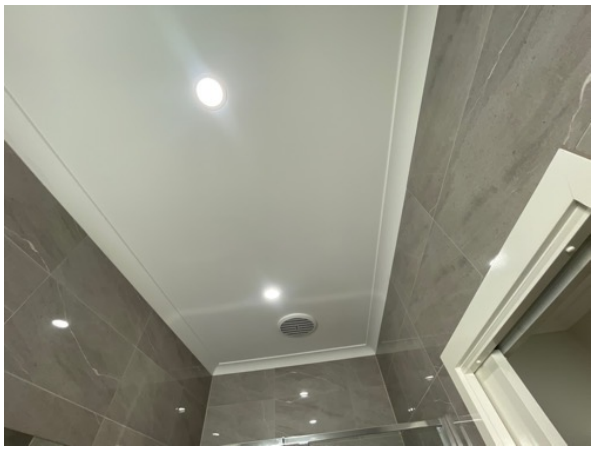
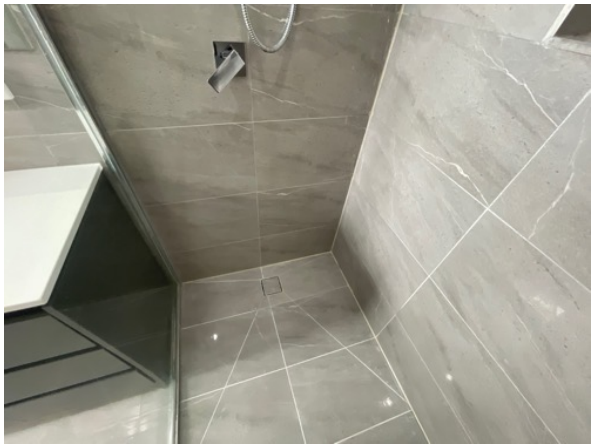
For your information 3.03

Location: Bedroom 1

Finding: ADDITIONAL BEDROOM 1 PHOTOS

These photos are an indication of the obstructions & limitations which impeded full inspection of the property at the time of inspection. The obstructions can hide an array of defects and should be removed to allow for a full inspection to be carried out. The inspection only covers readily accessible areas of the building and site. The inspection did not include inaccessible, not readily accessible and unsafe or obstructed areas. Obstructions are defined as any condition or physical limitation which inhabits or prevents inspection and may include but not limited to: bricks, hebel, render, claddings, paths, roofing, fixed ceilings, wall linings, floor coverings, fixtures, fittings, furniture, clothes, stored articles/ materials, thermal insulation, sarking, pipes, ducts, builders debris, vegetation, pavement, or earth.

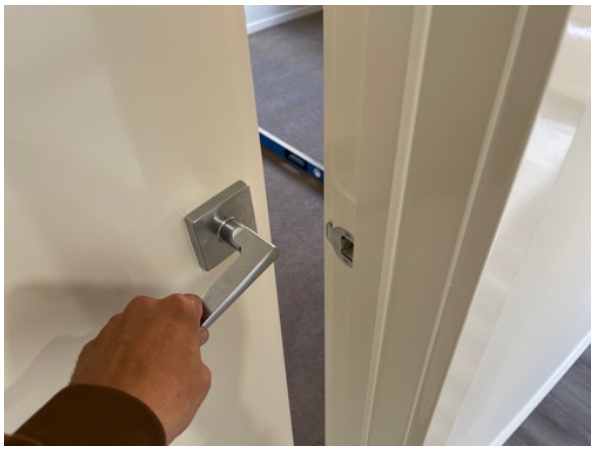
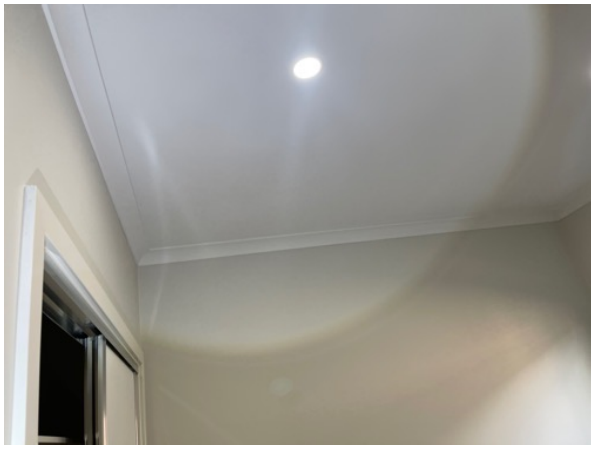
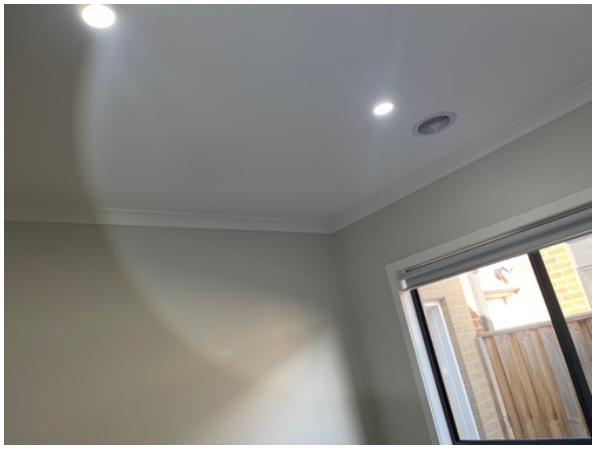
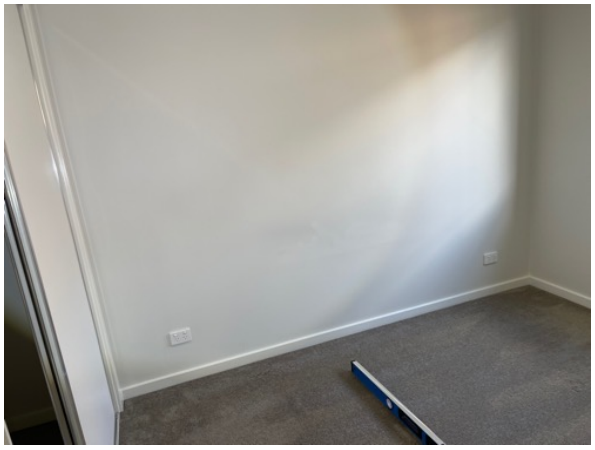
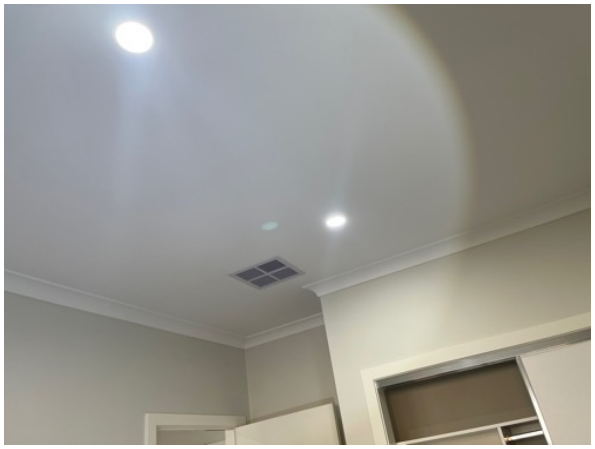
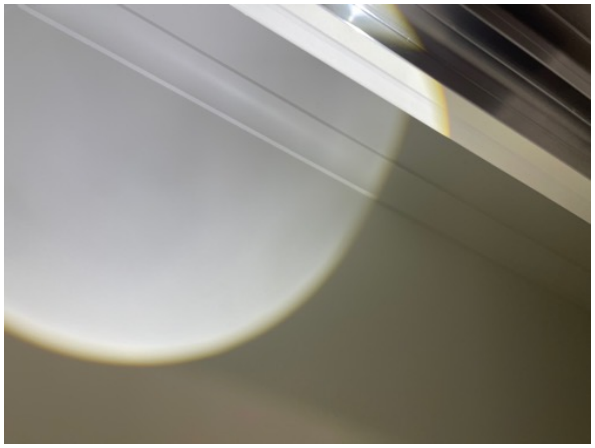
For your information 3.04

Location: Bedroom 2

These photos are an indication of the obstructions & limitations which impeded full inspection of the property at the time of inspection. The obstructions can hide an array of defects and should be removed to allow for a full inspection to be carried out. The inspection only covers readily accessible areas of the building and site. The inspection did not include inaccessible, not readily accessible and unsafe or obstructed areas. Obstructions are defined as any condition or physical limitation which inhabits or prevents inspection and may include but not

limited to: bricks, hebel, render, claddings, paths, roofing, fixed ceilings, wall linings, floor coverings, fixtures, fittings, furniture, clothes, stored articles/ materials, thermal insulation, sarking, pipes, ducts, builders debris, vegetation, pavement, or earth.

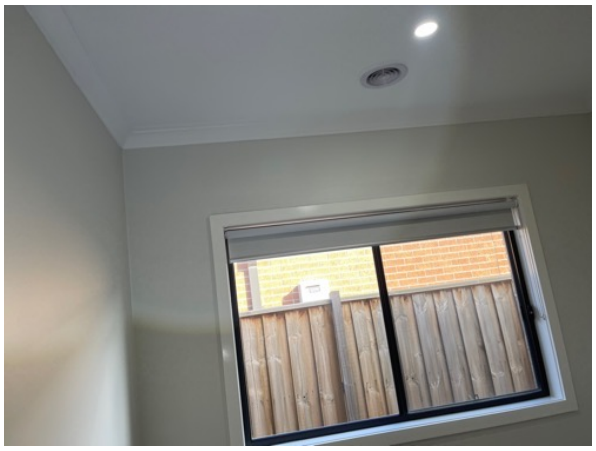
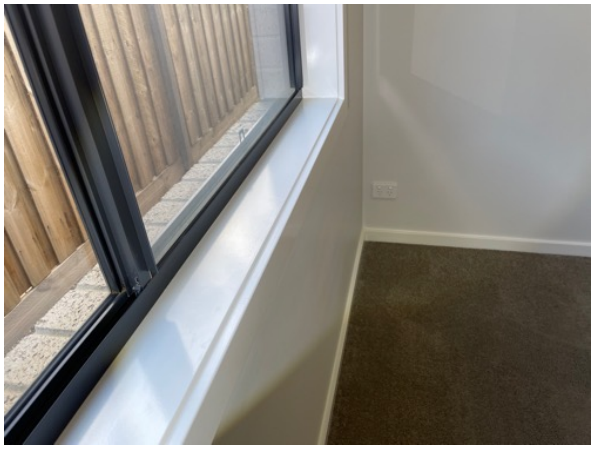
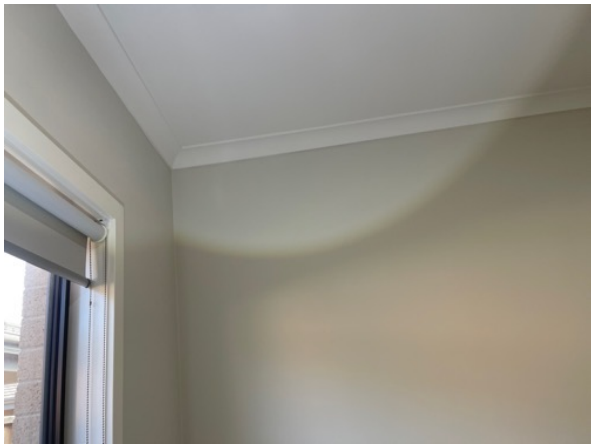
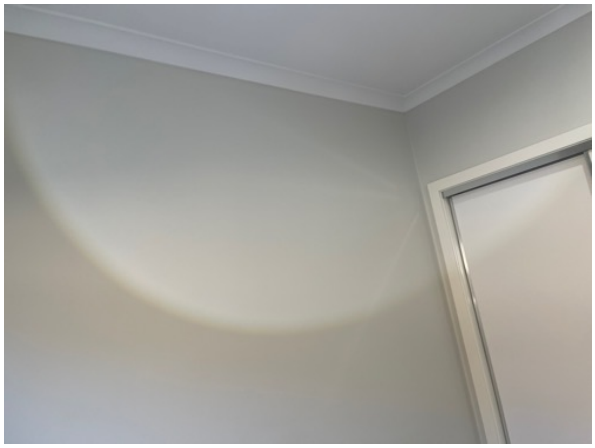
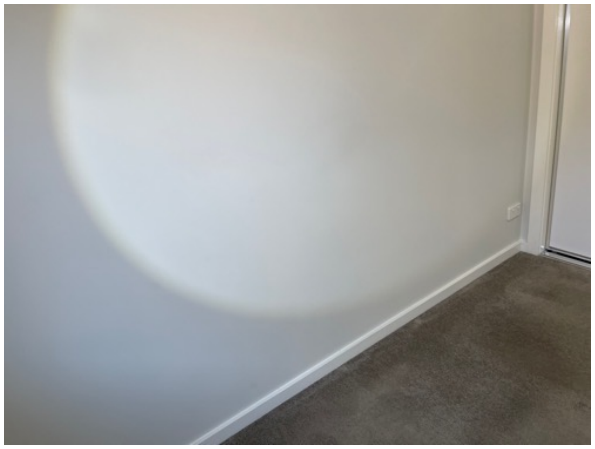
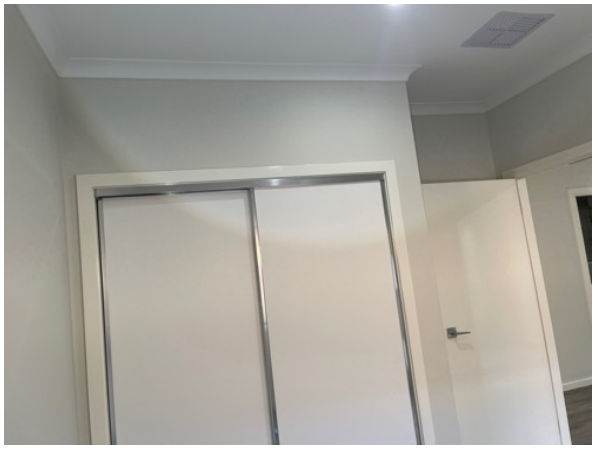
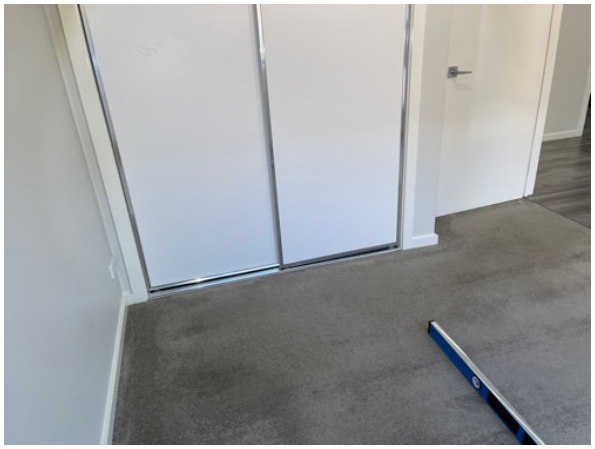
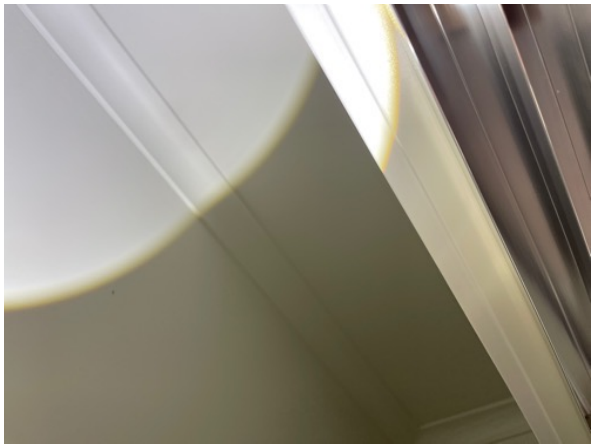
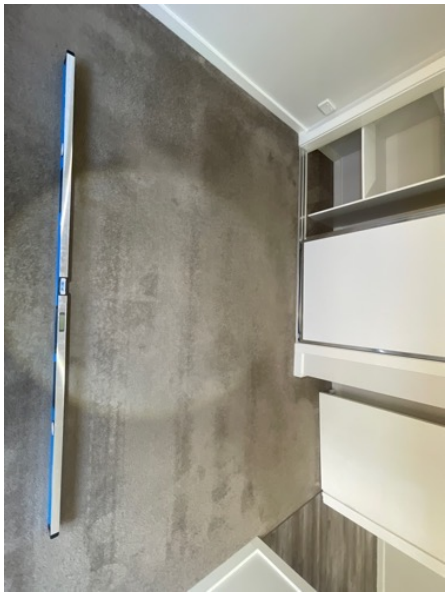
For your information 3.05

Location: Bedroom 3

Finding: ADDITIONAL BEDROOM 3 PHOTOS

These photos are an indication of the obstructions & limitations which impeded full inspection of the property at the time of inspection. The obstructions can hide an array of defects and should be removed to allow for a full inspection to be carried out. The inspection only covers readily accessible areas of the building and site. The inspection did not include inaccessible, not readily accessible and unsafe or obstructed areas. Obstructions are defined as any condition or physical limitation which inhabits or prevents inspection and may include but not limited to: bricks, hebel, render, claddings, paths, roofing, fixed ceilings, wall linings, floor coverings, fixtures, fittings, furniture, clothes, stored articles/ materials, thermal insulation, sarking, pipes, ducts, builders debris, vegetation, pavement, or earth.
