BUILDING AND PEST INSPECTION
MELBOURNE.COM.AU

Property and Timber Pest

Inspection Date: 9 Jun 2026

Property Address: 9 Furness Close Wyndham Vale 3024

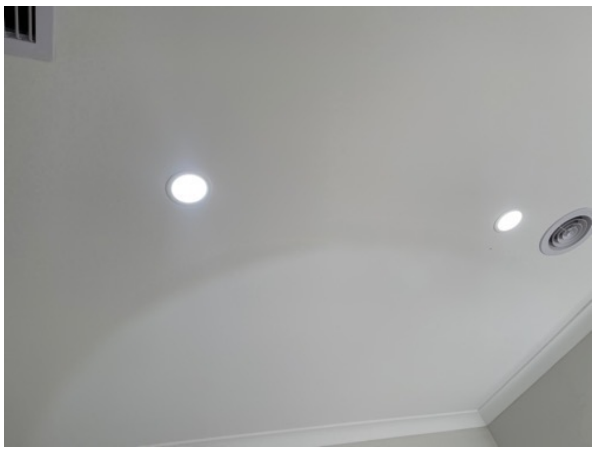
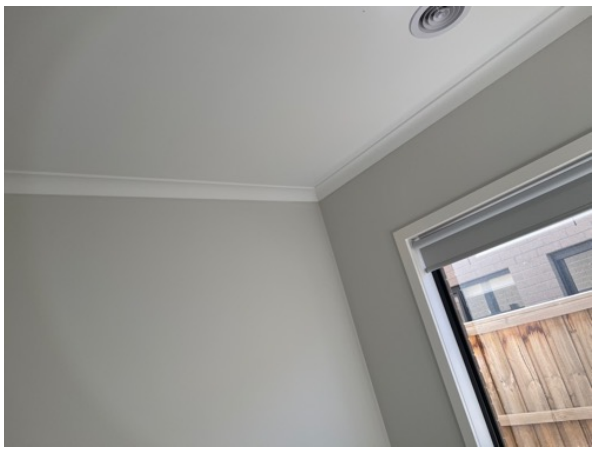
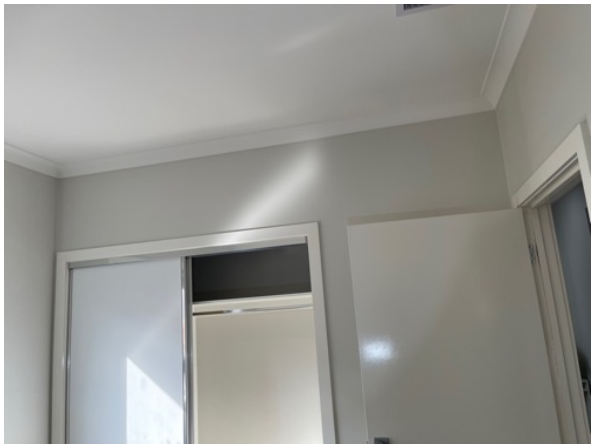
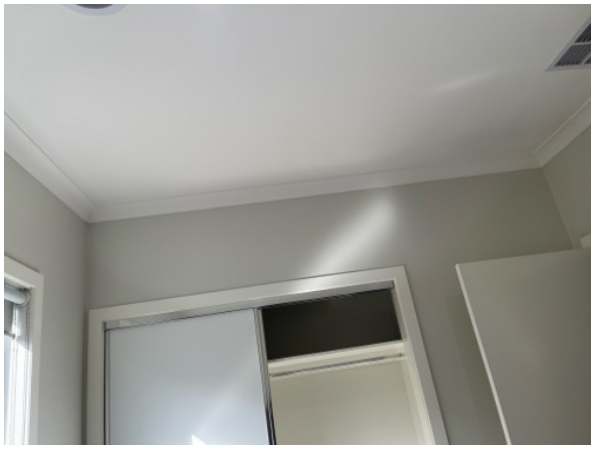
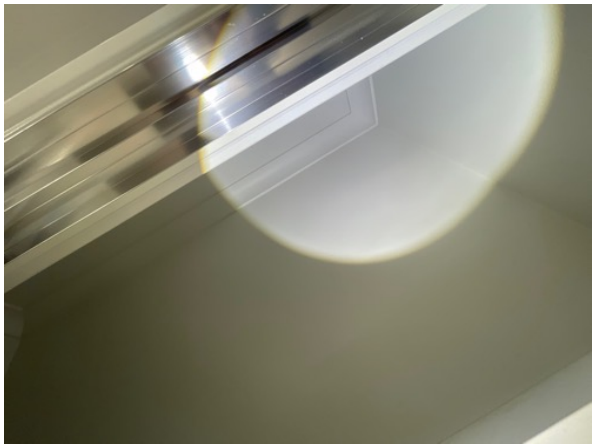
For your information 3.06

Location: Bedroom 4

Finding: ADDITIONAL BEDROOM 4 PHOTOS

These photos are an indication of the obstructions & limitations which impeded full inspection of the property at the time of inspection. The obstructions can hide an array of defects and should be removed to allow for a full inspection to be carried out. The inspection only covers readily accessible areas of the building and site. The inspection did not include inaccessible, not readily accessible and unsafe or obstructed areas. Obstructions are defined as any condition or physical limitation which inhabits or prevents inspection and may include but not limited to: bricks, hebel, render, claddings, paths, roofing, fixed ceilings, wall linings, floor coverings, fixtures, fittings, furniture, clothes, stored articles/ materials, thermal insulation, sarking, pipes, ducts, builders debris, vegetation, pavement, or earth.

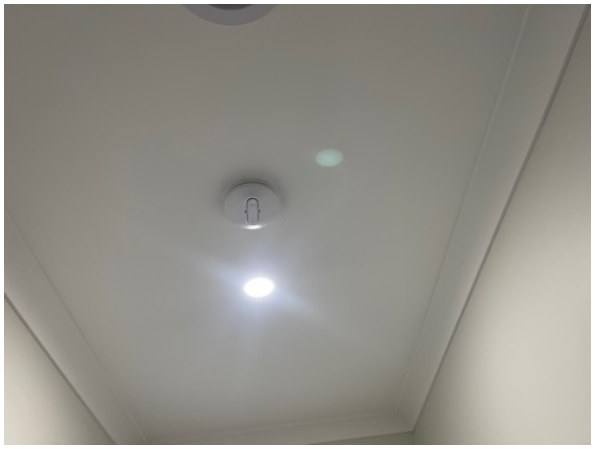
For your information 3.07

Location: All Internal Areas

Finding: Smoke Detectors and Alarms

Reporting on Smoke Detectors or Alarms, including hard wired smoke detection systems and their legislative requirements, is outside the Scope of this Report. Please note that this defect is highlighted as a caution only. We suspect, based on our experience in the building industry, that the absence of smoke detectors, or their poor condition, should be addressed as a matter of urgency to improve occupant safety. Additionally, it is advised that all smoke detectors be tested by the homeowner on a monthly basis. Please refer to AS3786 and state based legislation, which may also apply.

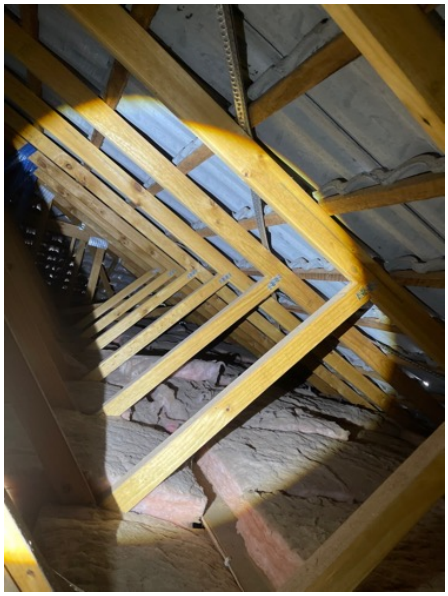
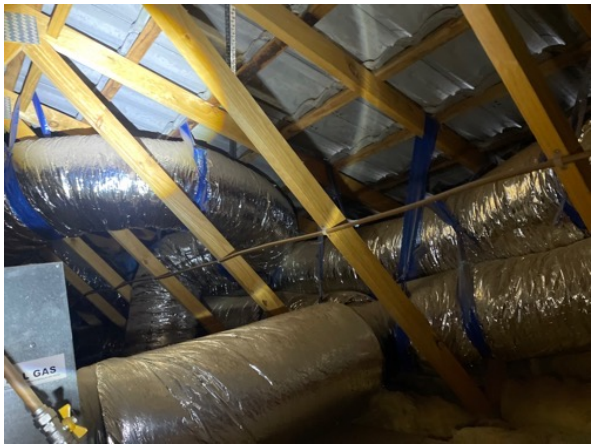
For your information 3.08

Location: Roofspace

Finding: ADDITIONAL ROOFSPACE PHOTOS

These photos are an indication of the obstructions & limitations which impeded full inspection of the property at the time of inspection. The obstructions can hide an array of defects and should be removed to allow for a full inspection to be carried out. The inspection only covers readily accessible areas of the building and site. The inspection did not include inaccessible, not readily accessible and unsafe or obstructed areas. Obstructions are defined as any condition or physical limitation which inhabits or prevents inspection and may include but not limited to: bricks, hebel, render, claddings, paths, roofing, fixed ceilings, wall linings, floor coverings, fixtures, fittings, furniture, clothes, stored articles/ materials, thermal insulation, sarking, pipes, ducts, builders debris, vegetation, pavement, or earth.

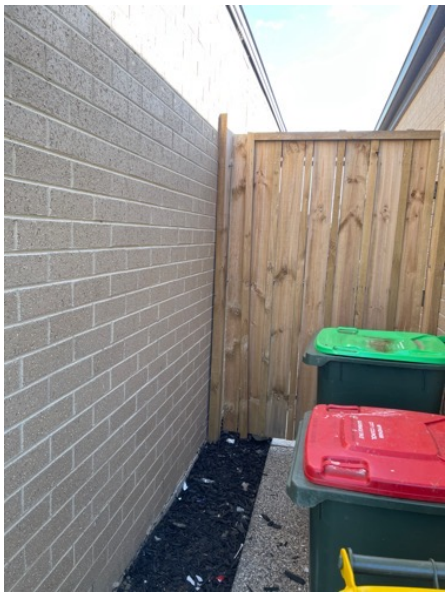
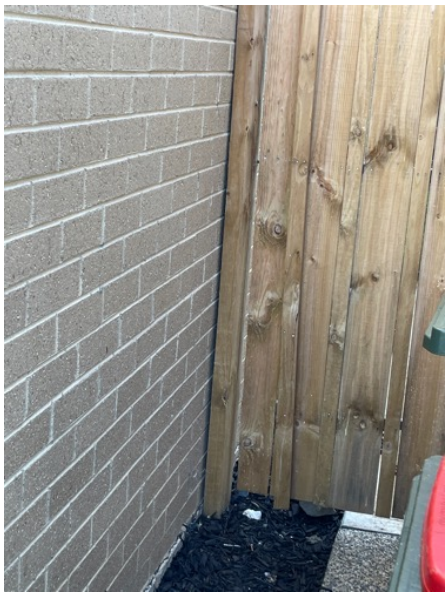
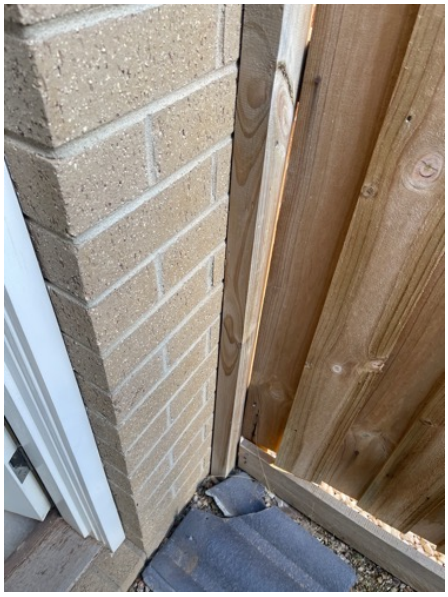
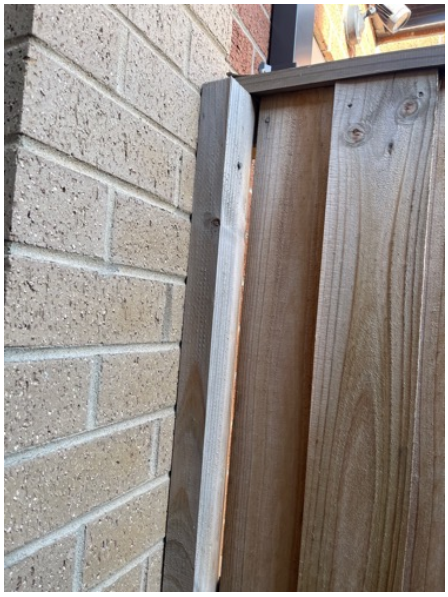
Conditions conducive to timber pest attack 4.01

Finding: Timber fence bridging

In the course of inspecting all external areas, it was observed that the timber fence exhibits bridging, which may facilitate termite access and compromise structural integrity. Such bridging results from timber in direct contact with soil or other conducive conditions that promote pest infiltration. To mitigate the risk of termite infestation and ensure the longevity of the fence structure, it is recommended to create a physical barrier by elevating the timber components off the ground and maintaining a clear separation. Additionally, regular inspection and maintenance should be undertaken to monitor and address any future vulnerabilities.

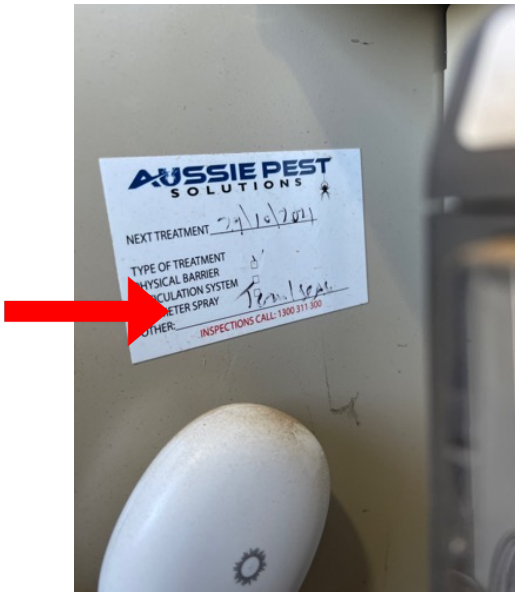
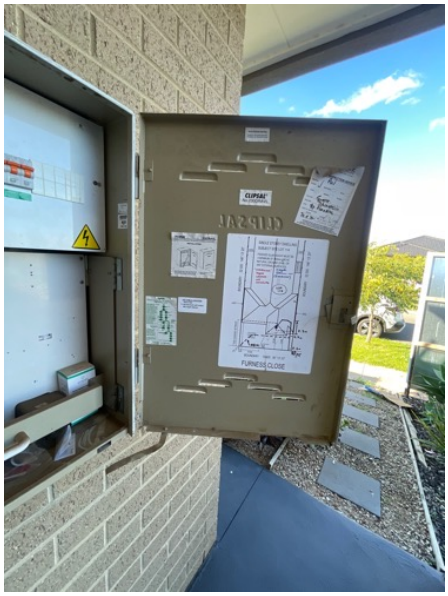
Conditions conducive to timber pest attack 4.02

Location: All External Areas

Finding: DURABLE NOTICE FOUND IN ELECTRIC METER BOX

Yes, a durable notice was found in the electrical meter box during the inspection. there was visible evidence or a previous termite treatment was located at the property.
During inspection of the property, it was noted that termite protection work had previously been completed but looks out of warranty or check the warranty with builder.
Most chemical / termite management systems expire and require replenishment.
It is recommended to Always ask the Vendor and preferably get an answer in writing (because we on the day of the inspection don't know the property history), any information relating to past termite activity to the property prior to purchase. Has the property been subject to termite attack, is there any termite damage, has there been any termite treatment. Often termite damage is removed or concealed by renovations (if done skilfully even the best inspector cannot tell). If the owner gives you false and misleading answers, then in the event of discovery of defects you may have action for misrepresentation

CHECK ALL WARRANTIES WITH OWNER OR CALL THE COMPANY GIVEN ON STICKER.
IMPORTANT DO TERMITE TREATMENTS WITHIN 28 DAYS OF THE INSPECTION IF WARRANTY EXPIRED.

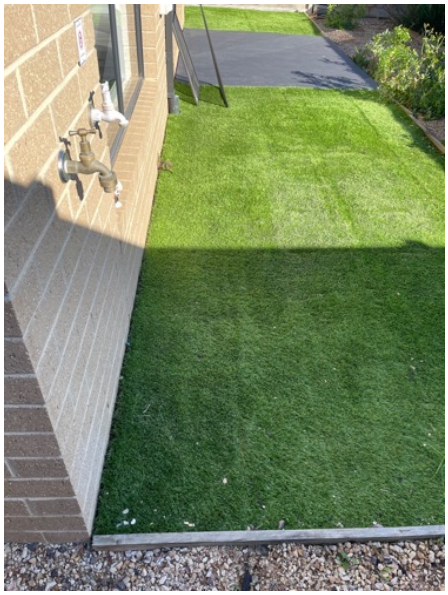
Conditions conducive to timber pest attack 4.03

Location: All External Areas

Finding: Conducive synthetic against the house

In the external areas of the property, the installation of synthetic grass is found to be conducive to termite activity due to its tendency to retain moisture. This environment creates conditions favorable for termites, increasing the risk of infestation. It is recommended that the synthetic grass be cut back by 500 mm from the building perimeter to mitigate this risk. Implementing this remedial action will help to reduce moisture levels near the structure, thereby decreasing the likelihood of termite colonization and safeguarding the structural integrity of the property.

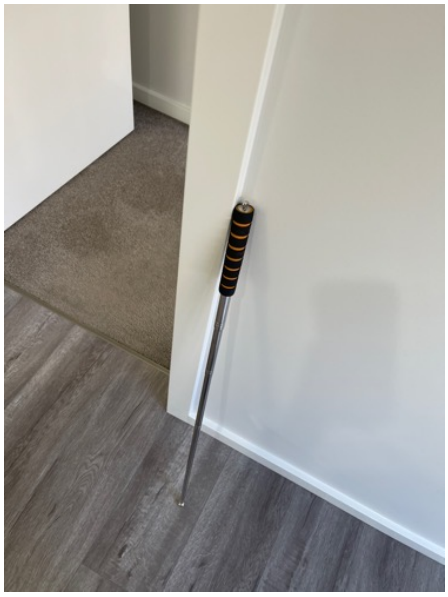
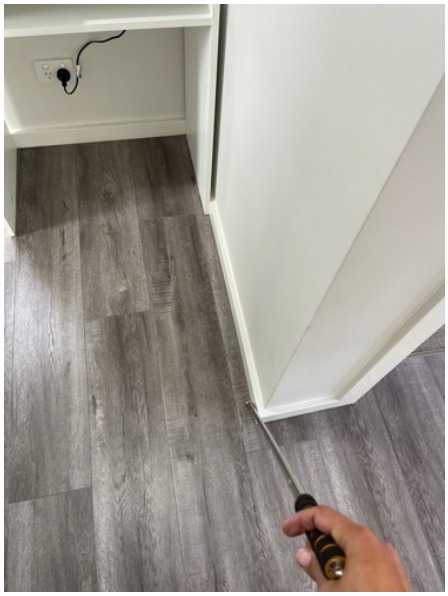
Conditions conducive to timber pest attack 4.04

Finding: Termite tapper used

During the course of the inspection, a termite tapper was used. The testing involved tapping accessible timber components to detect any hollowness that might indicate the presence of timber pests, such as termites. There were no signs of hollowness observed in any of the accessible areas, suggesting that there is no immediate evidence of termite activity within the internal environs of the premises.
While the current findings are correct at the time of inspection, it is recommended that as a precautionary measure,
regular inspections should be carried out at least annually, or more frequently in areas with a high risk of termite infestation. This will help in early detection and prevention of potential termite activity, which could lead to significant structural damage if left unchecked.
Furthermore, maintaining an environment that is not conducive to termite attraction, such as avoiding moisture accumulation near the foundation and ensuring that wood is not in direct contact with soil, will assist in reducing the risk of future termite problems. Additional measures might include professional application of termite prevention systems and treatments.
