■產品□設備技術通報				■異常處理手法 □技術傳承文件	
題目	Remain型態ESD處理方式	KM編號		作者	莊沅臻
Defect Code	REMAIN	Cause Code	ESD	■適用設備： □適用產品：	CFDV& CV傳送

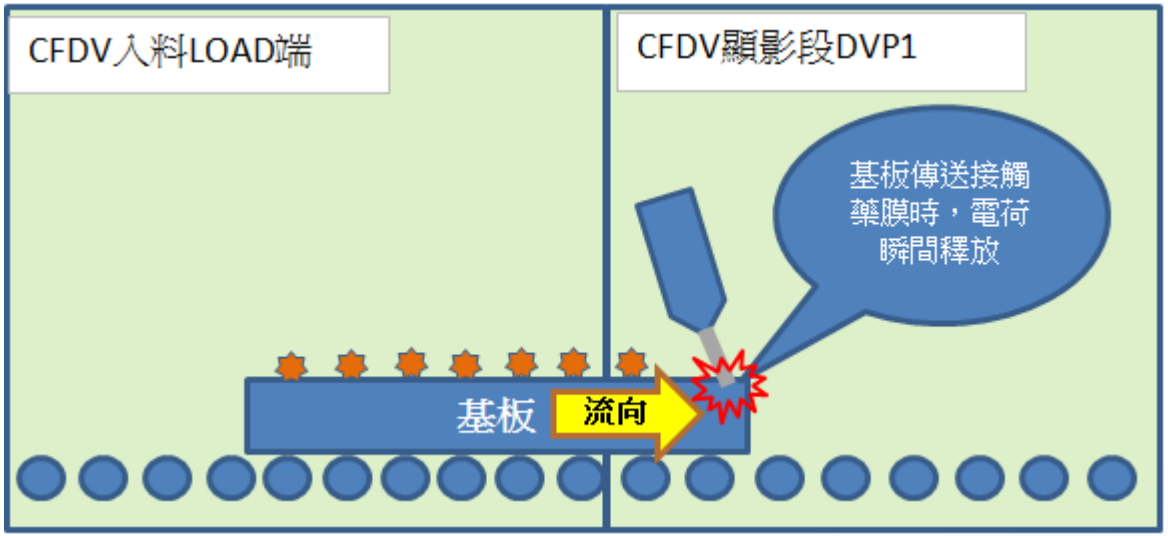
起因：生產玻璃基板於CV2傳送時，長期磨擦後造成與ROLLER接觸面積增加，而發生CV-ROLLER靜電累積增加(材質為非導體設計)而生產基板流經後吸附過多電荷。

結果：生產基板帶電後經過藥刀噴灑，接觸藥膜而瞬間釋放電荷，

從而導致靜電擊傷

CV2-ROLLER型態：
直接量測ROLLER表面最高可到3~4K V

基板流向與接觸藥膜放電

1.於CFDV LOAD段前方裝設靜電消除器中和基板上多餘電荷，以解決瞬間放電ISSUE。

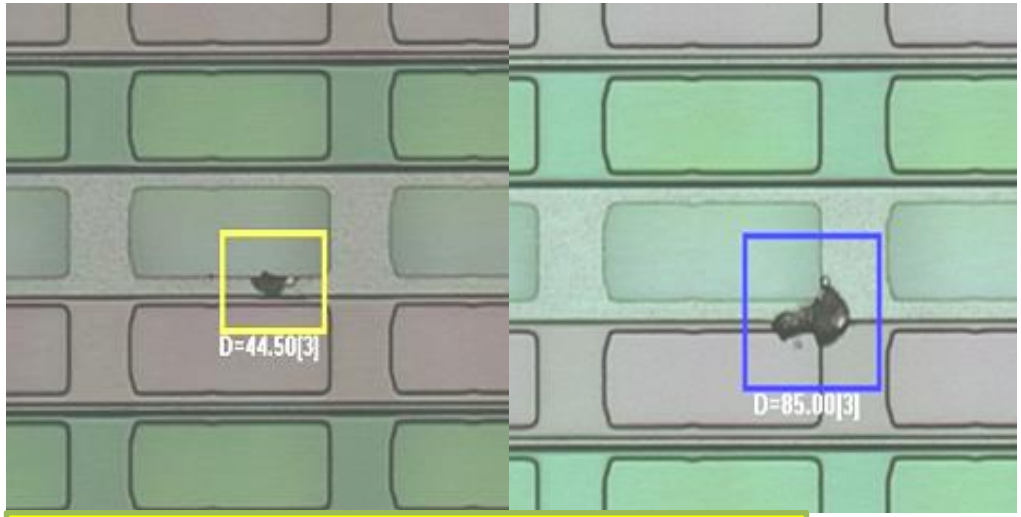
DF MAP：DF位置集中於每膜傳送進板端
