DEANE AUTO REPAIRS

Vehicle Condition Report

2008 Volkswagen Golf - using the vehicle data and findings
from the supplied inspection report.

PPI-2021-18670545

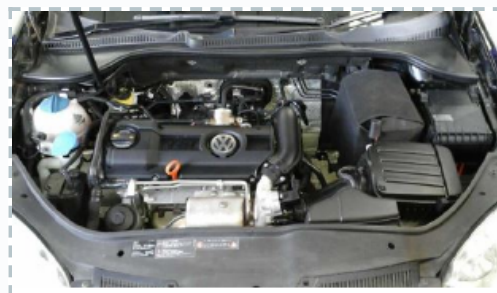
Photo record

Photo notes: Current vehicle views retained from the source inspection. Add close-ups of the oil leak and battery/starter test results when available.
