OSHA Report **Nationwide Nissan/Kia**

Complete On: 7/16/2024

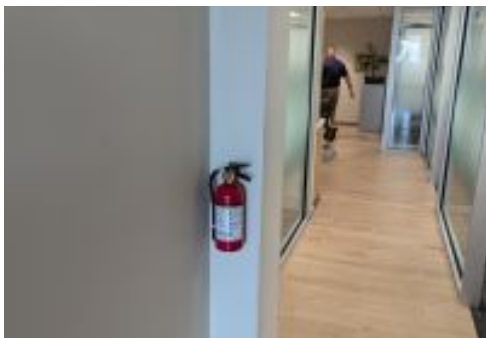
The fire extinguisher signs above the unit are not posted properly.

High Risk

Almost every fire extinguisher does not have signage above.
