Quansheng UV-K5 - Manufacturing Defects

Adding a capacitor to address external PTT busy lockout issue

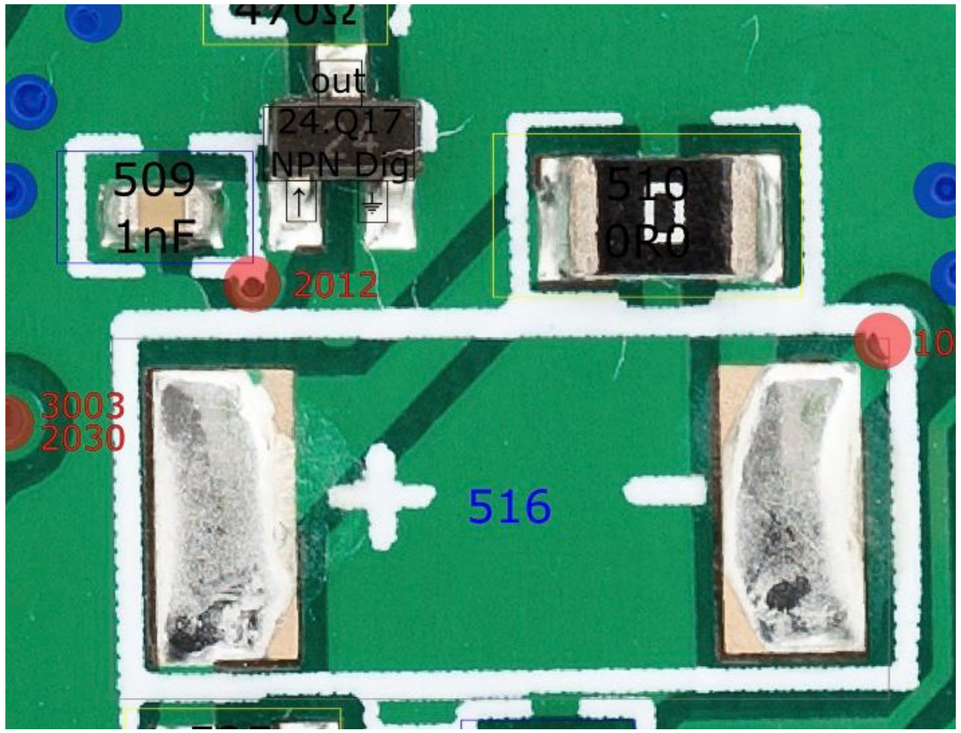
Adding a capacitor to address external PTT busy lockout issue

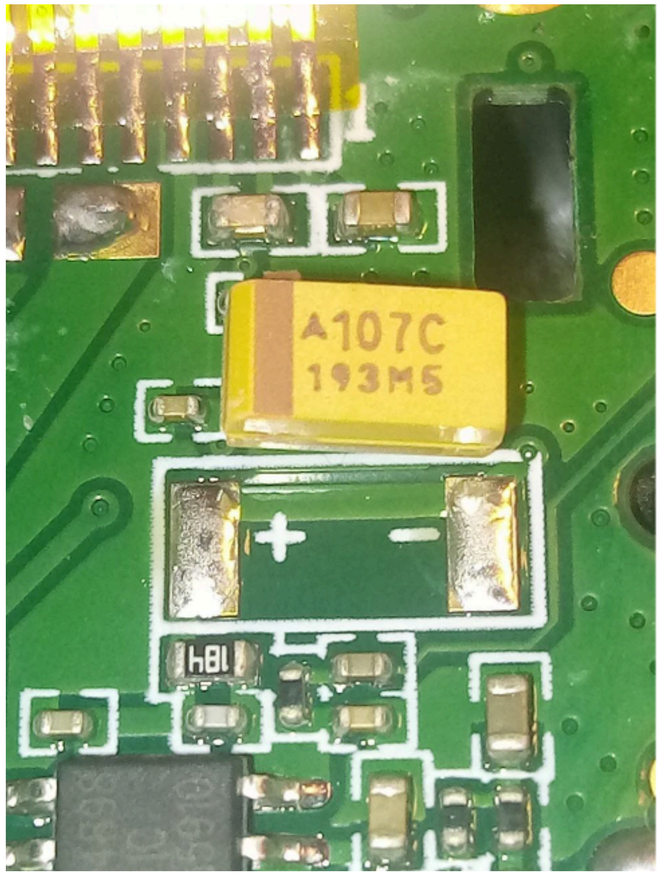
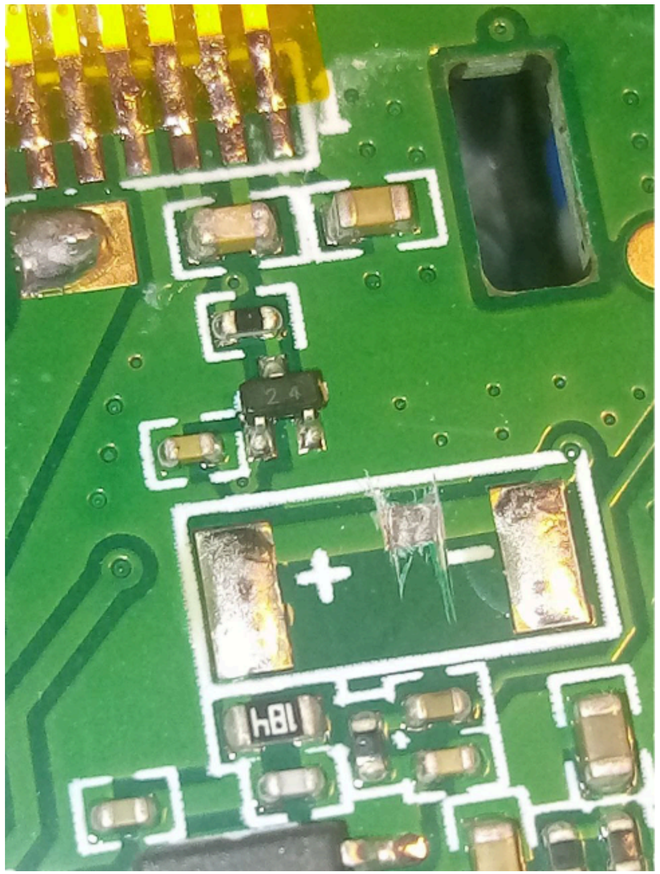
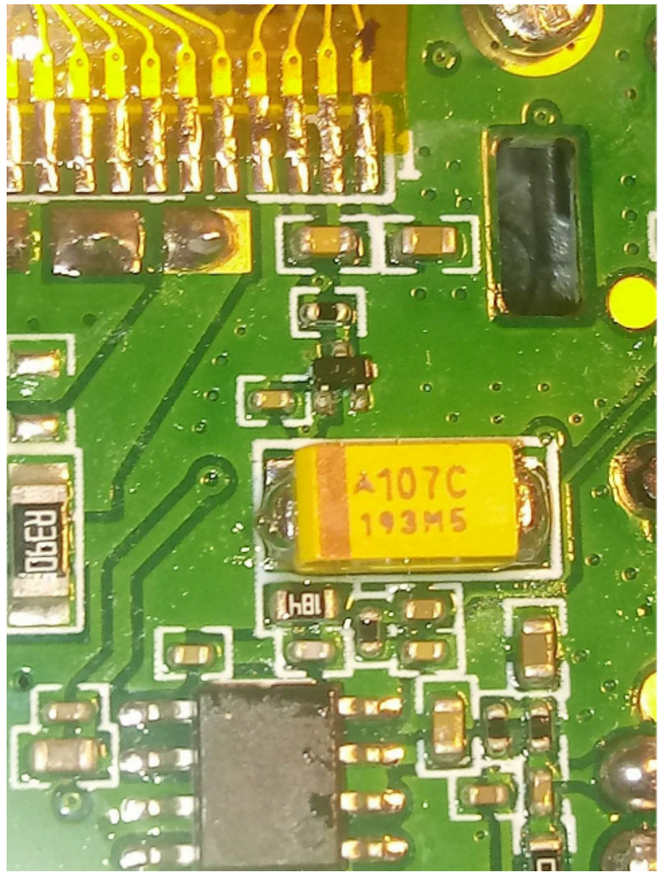
Adding a capacitor to address external PTT busy lockout issue
