Field impact sound insulation of floors

Client:	Example client	Description:	Timber-joist floor with a floating chipboard deck
Test room:	Dwelling A bedroom below dwelling B bedroom	Date of test:	2026-07-20
Receiving room volume [m³]:	30.4	Temperature [°C]:	20.1
Relative humidity [%]:	54

Report no.: EXAMPLE-16283-2

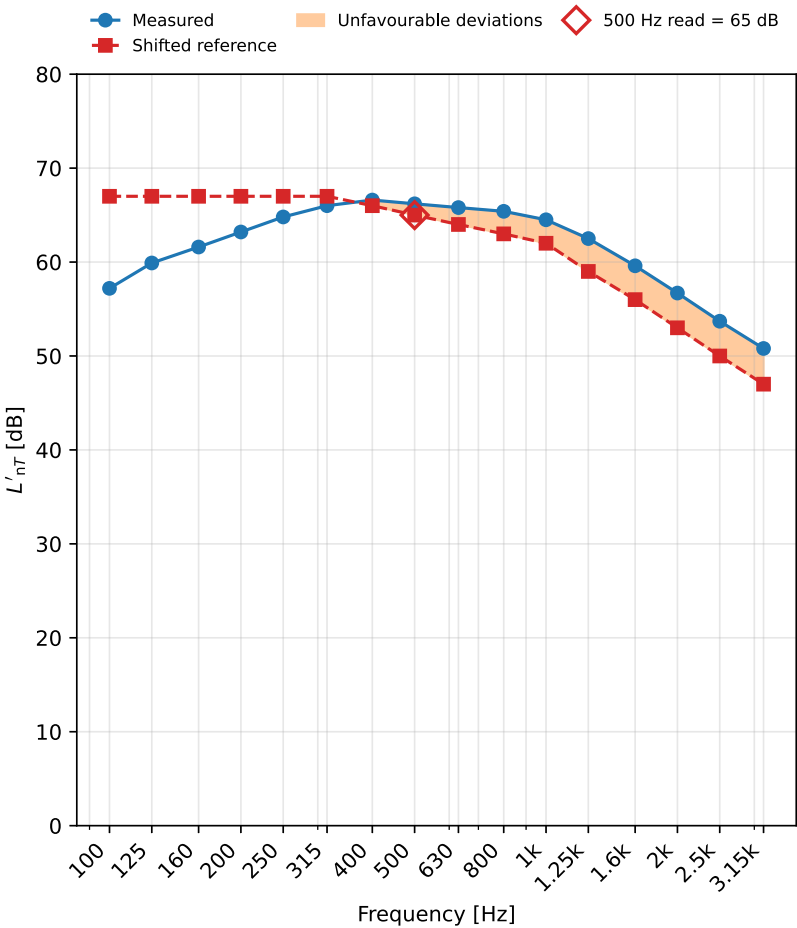
One-third-octave L'_{nT} [dB]

$$L'_{nT,w} (C_I) = 65 (-5) \text{ dB}$$

Result vs requirement: $L'_{nT,w} = 65 \text{ dB}$, required $\leq 58 \text{ dB}$ → **FAIL**
