REPORT NUMBER: NCAP-MGA-19-060

NEW CAR ASSESSMENT PROGRAM (NCAP)
Frontal Barrier Impact Test

AUDI AG
2019 Audi A6 45 TFSI S tronic quattro 4-Door Sedan
NHTSA No.: O20195806

FINAL REPORT

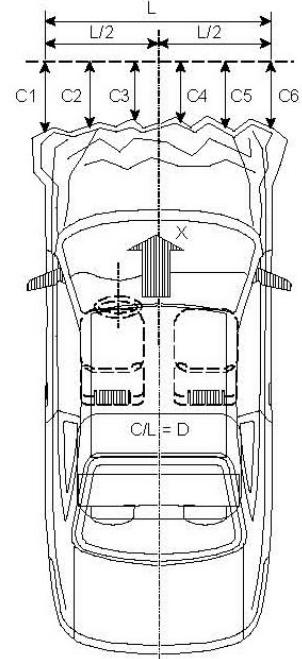
CRUSH PROFILE

Collision Deformation Classification:	<u>12FDEW2</u>
Midpoint of Damage:	<u>Centerline</u>
Damage Region Length (mm):	<u>1600</u>
Impact Mode:	<u>Frontal</u>

No.	Measurement Description	Units	Pre-Test	Post-Test	Difference
C1	Crush zone 1 at left side	mm	4729	4440	289
C2	Crush zone 2 at left side	mm	4842	4480	362
C3	Crush zone 3 at left side	mm	4909	4457	452
C4	Crush zone 4 at right side	mm	4909	4432	477
C5	Crush zone 5 at right side	mm	4842	4452	390
C6	Crush zone 6 at right side	mm	4729	4455	274
L	C1 TO C6	mm	1600	1588	12

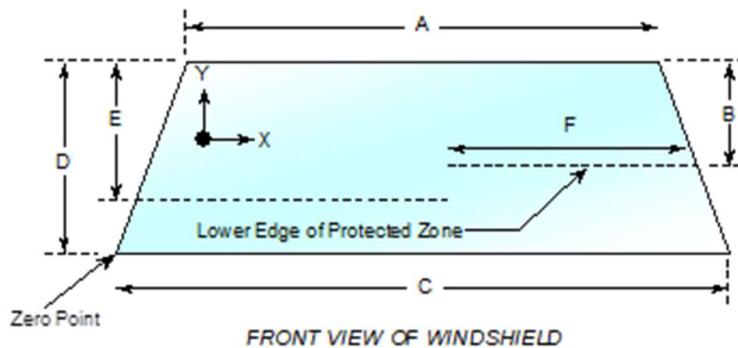
WINDSHIELD PERIPHERY MEASUREMENTS

Measurement	Pre-Test (mm)	Post-Test (mm)	% of Retention
Left Side	2062	2062	100
Right Side	2062	2062	100
Total	4124	4124	100
