Inspection report

AV-26-004181 | Site visit 2026-09-14 | Report revision 1

INSURED	Cedar Quay Warehousing LLC
SITE	Building 4, East Quay Industrial Park, Fairhaven
REPORTED EVENT	Wind damage and subsequent water entry at the east roof corner
INSPECTING ADJUSTER	Alex Rowan

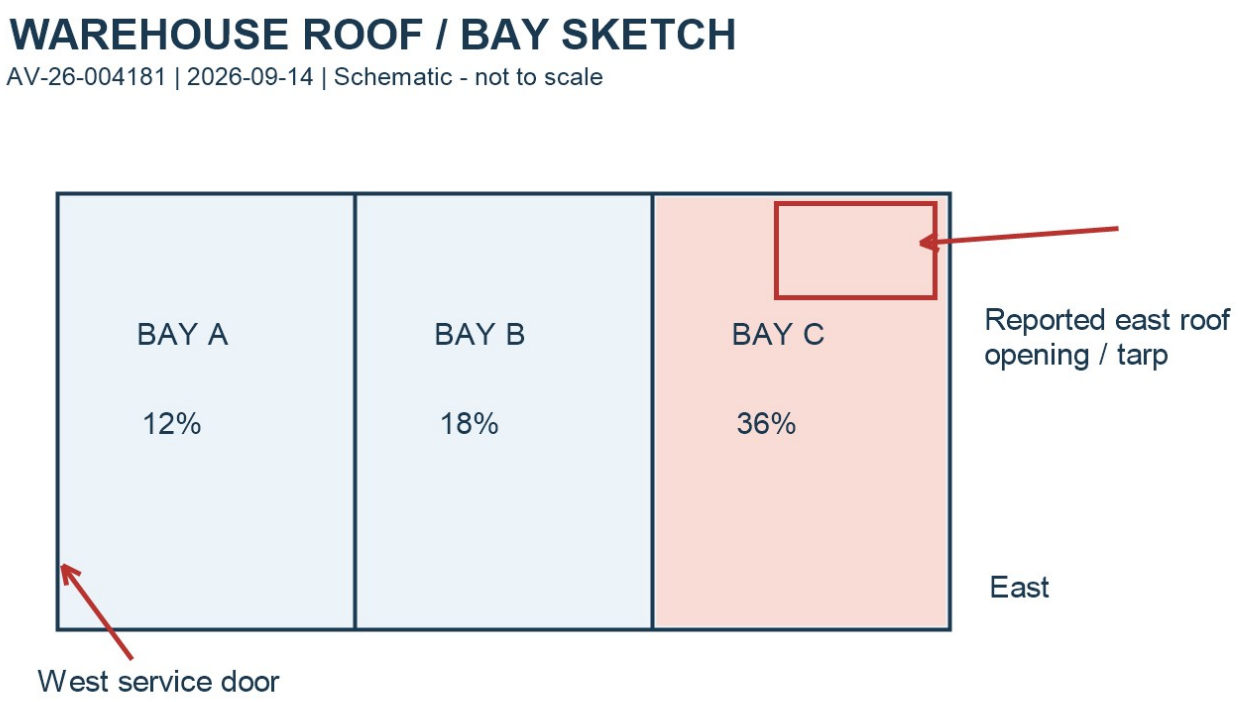
PHOTO EXHIBIT | AV-26-004181

The east roof corner has displaced metal sheets and temporary blue weather protection. Interior ceiling insulation is locally stained. Cartons beside the east wall show moisture exposure. These observations alone do not establish when the opening formed or whether all stock was damaged in this event.

A - Displaced roof sheets / temporary tarp

B - Local interior moisture staining
