Inspection report

AV-26-004267 | Site visit 2026-09-19 | Report revision 1

INSURED	Lantern Yard Bistro Ltd
SITE	Unit 7, Lantern Yard Retail Court, Westbridge
REPORTED EVENT	Reported contained cooking-area fire with smoke contamination
INSPECTING ADJUSTER	Priya Lane

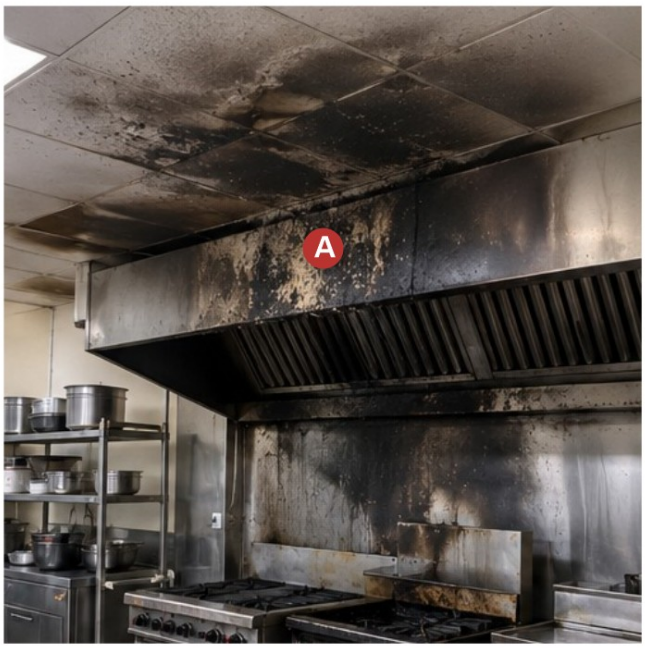
PHOTO EXHIBIT | AV-26-004267

Soot is visible on the extraction hood, filters and nearby ceiling. Local ceiling discoloration and deposits are shown in the photographic schedule. Photographs do not establish the ignition source, the condition of concealed ductwork or whether the extraction motor is repairable.

A - Visible hood / ceiling soot deposits

B - Filter staining; concealed duct not inspected

Obtain the extraction-system service log and specialist duct inspection. Do not equate cosmetic smoke deposits with confirmed equipment failure. Keep cleaning and replacement scopes separate until the specialist report is received.

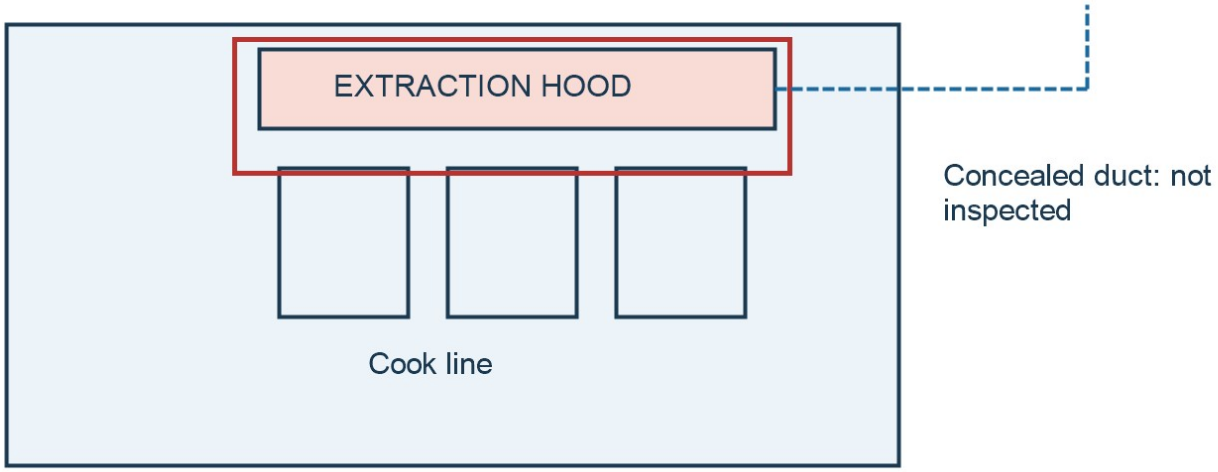
KITCHEN EXTRACTION / CEILING SKETCH

Visible soot area shown in red; ignition source remains unconfirmed.

The kitchen sketch distinguishes the visible hood and ceiling appearance from the uninspected concealed duct. The dashed route is not an established ignition or spread path.
