Inspection report

AV-26-004318 | Site visit 2026-09-24 | Report revision 1

INSURED	Harbor Route Delivery Services Inc
SITE	Depot B, Harbor Route Distribution Yard, Northport
REPORTED EVENT	Rear-left damage to a delivery van reported after a depot maneuver
INSPECTING ADJUSTER	Alex Rowan

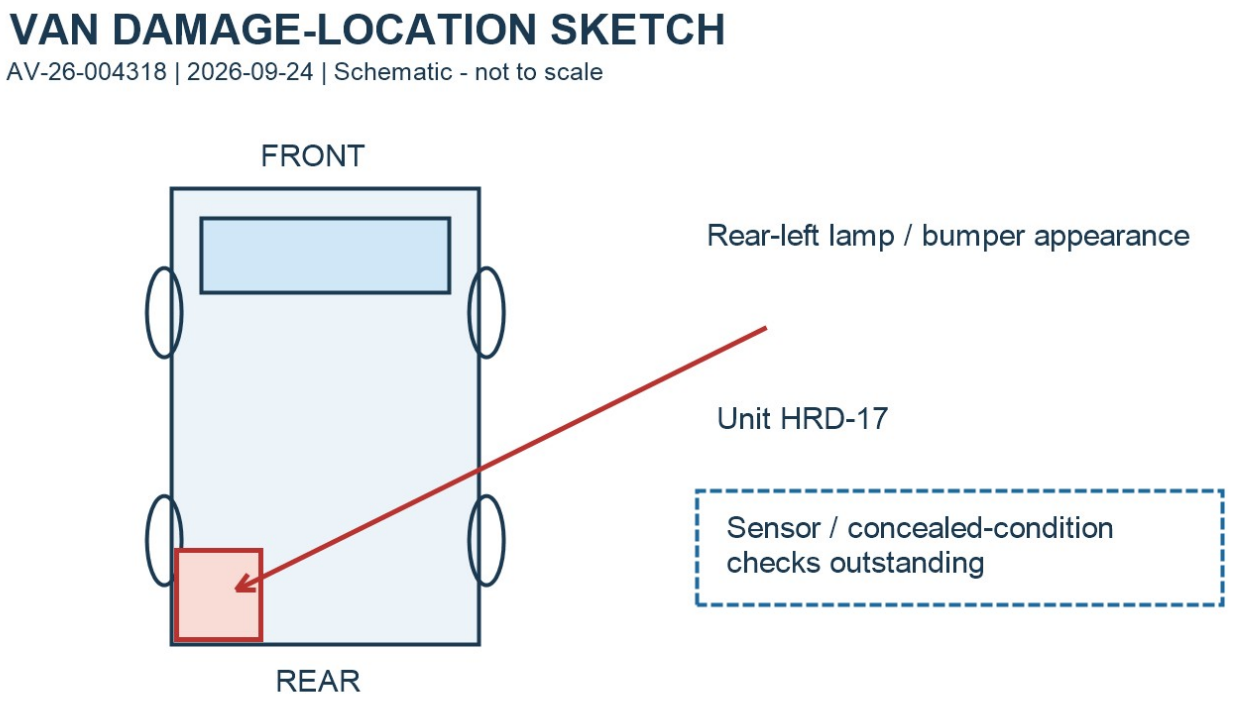
PHOTO EXHIBIT | AV-26-004318

The rear-left tail-light lens is cracked and the adjacent black bumper is scuffed and locally displaced. No underbody, sensor calibration or concealed structural condition can be established from the supplied exterior photographs.

A - Rear-left bumper appearance

B - Cracked lamp lens; concealed parts unverified

Obtain the depot incident log, the full repairer’s revised scope and any available original CCTV. The message forwarding the access instructions contains an attachment that is not stored separately in the claim folder.
