Inspection report

AV-26-004401 | Site visit 2026-10-05 | Report revision 1

INSURED	Meadow Lane Household Supply Ltd
SITE	Shop 12, Meadow Lane Arcade, Brookfield
REPORTED EVENT	Reported customer slip near a wet retail aisle
INSPECTING ADJUSTER	Elena Brooks

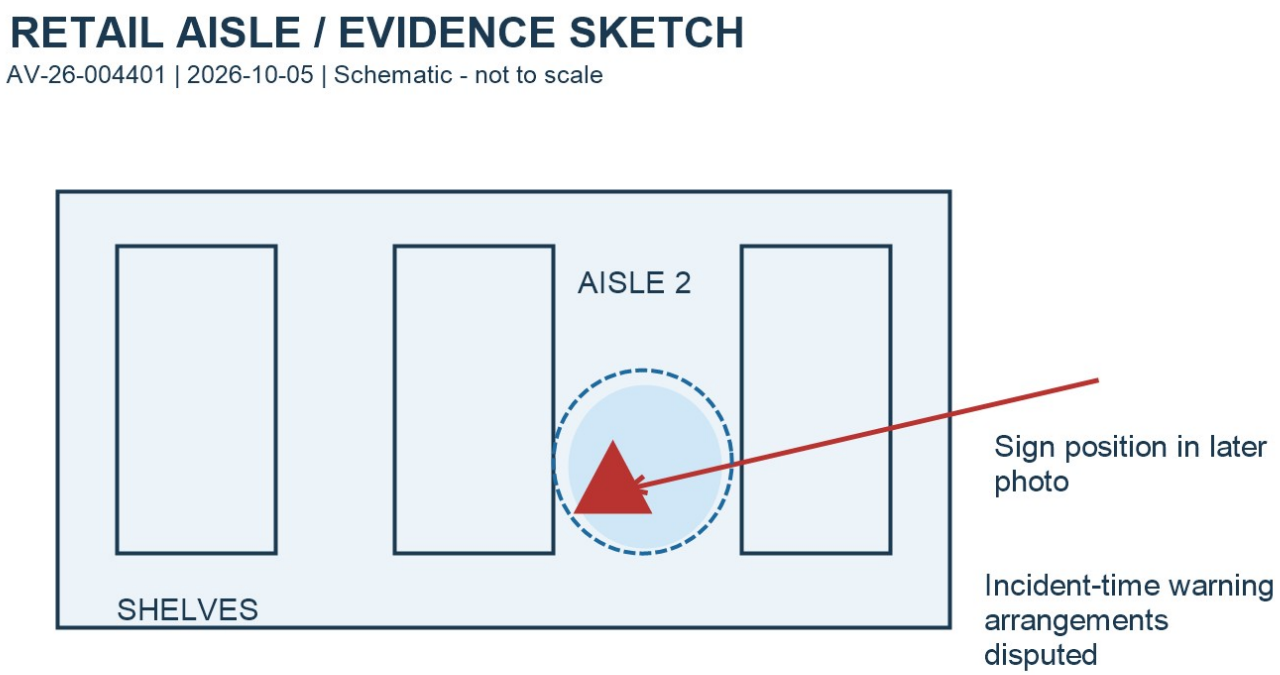
PHOTO EXHIBIT | AV-26-004401

The supplied later photographs show a shallow puddle, a gray bucket and a yellow folding sign in the retail aisle. They do not establish the warning arrangements at the incident time. The cleaning log has a gap between 10:30 and 11:30.

A - Sign shown in later photograph

B - Water visible; incident-time position disputed

Request the original cleaning log, dated witness accounts and consented supporting correspondence. Preserve the earlier and later statements separately. Do not treat the later photograph as proof of the earlier sign position.
