Inspection report

AV-26-004459 | Site visit 2026-10-10 | Report revision 1

INSURED	Bluegate Storage Operations LLC
SITE	Unit B-14, Bluegate Storage Court, Southhaven
REPORTED EVENT	Damaged storage-unit latch and reported missing property
INSPECTING ADJUSTER	Priya Lane

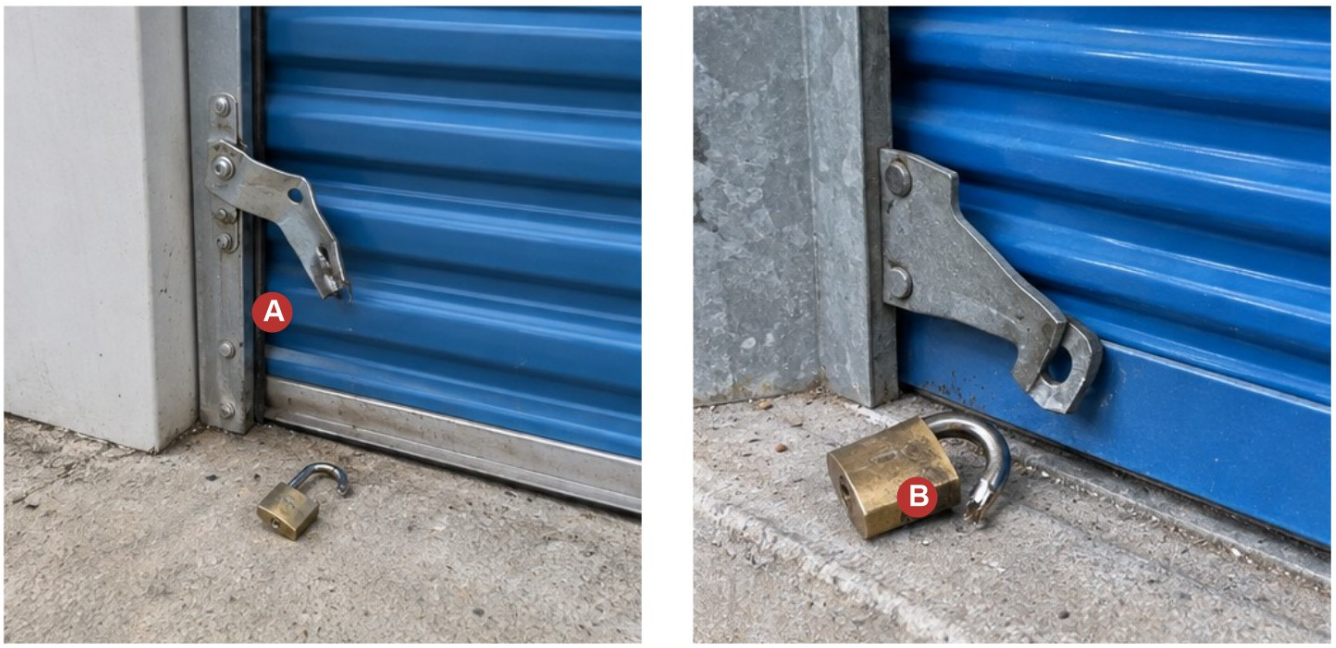
PHOTO EXHIBIT | AV-26-004459

The blue roll-up door has a deformed steel latch assembly and a detached padlock is visible near the threshold. Neither photograph identifies who caused the damage or establishes which items were inside. Keep access damage and reported missing property as separate facts.

A - Deformed latch appearance

B - Detached padlock; contents not visible

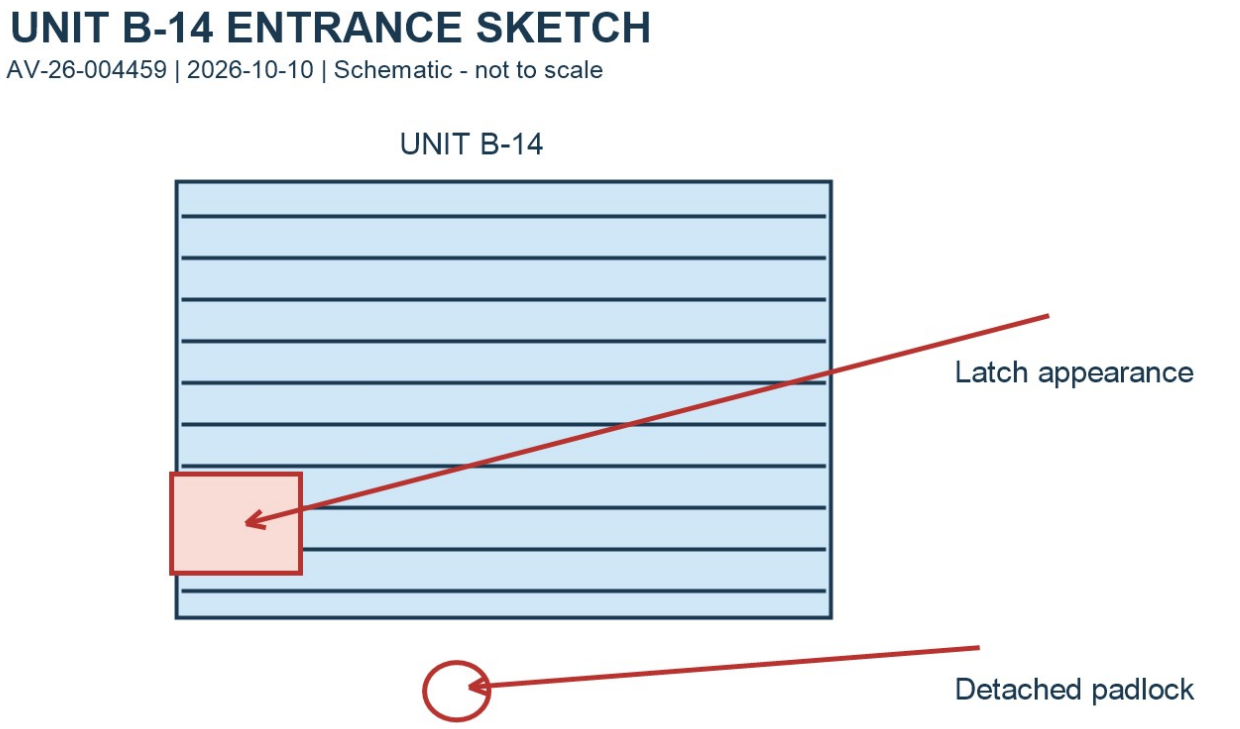
Location and evidence sketch

The entrance sketch identifies the latch and detached padlock. The interior and contents are not shown; the diagram cannot establish who entered or reconcile the reported missing-property count.
