Inspection report

AV-26-004507 | Site visit 2026-10-16 | Report revision 1

INSURED	Rivermark Fabrication Works Ltd
SITE	Workshop 3, Rivermark Industrial Estate, Eastfield
REPORTED EVENT	Reported workshop water ingress with affected stock and equipment
INSPECTING ADJUSTER	Elena Brooks

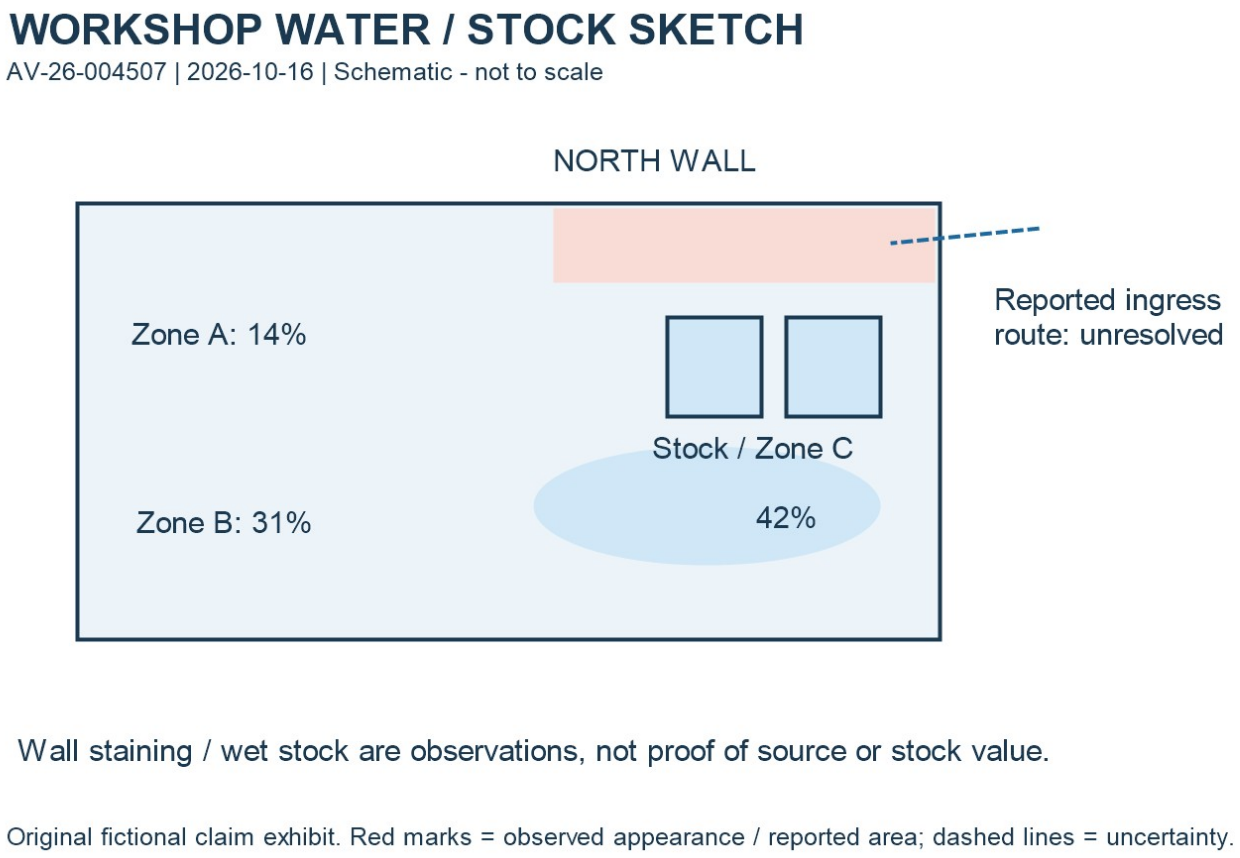
PHOTO EXHIBIT | AV-26-004507

A low brown water mark is visible on the workshop wall and nearby cardboard cartons show moisture damage. A small pump is present. The photographs alone do not prove ingress route, duration, machinery failure or ownership/value of the affected stock.

A - Wall staining and local wetting

B - Moisture-affected cartons; value unverified

Reconcile the contractor’s revised PDF proposal with the first inspection, identify recoverable stock and obtain the plumbing report. Retain the email that supplied the revised proposal and distinguish its attachment from the earlier loose inspection.
