Complete the following sheets by writing the hazards as you see them, but first please watch the youtube video.

Allow 40 minutes to complete

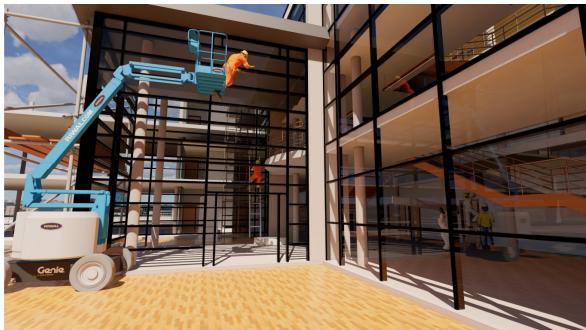
Figure 8

Obviously the man is leaning from the cherry picker without a harness and is in danger of falling. In addition people passing through the doorway beneath the cherry picker are at risk of falling objects.

In a better safety environment the man on the cherry picker should possibly have considered additional safety measures...such as doing a **Task Analysis** prior to commencing work.

Items which should be picked up by a task analysis might include:

1. Appropriate positioning of the Cherry Picker.
2. Preventing access through the doorway for the duration of the task.
3. Use of Barriers around task work area.
4. Have someone standing on the ground to act as a 'spotter'.
5. Coordinate with other trades, to minimise work-area conflicts.
