CABINET I/O

Sheet: /
File: extern.kicad_sch

Title: **EXTERMINATION**

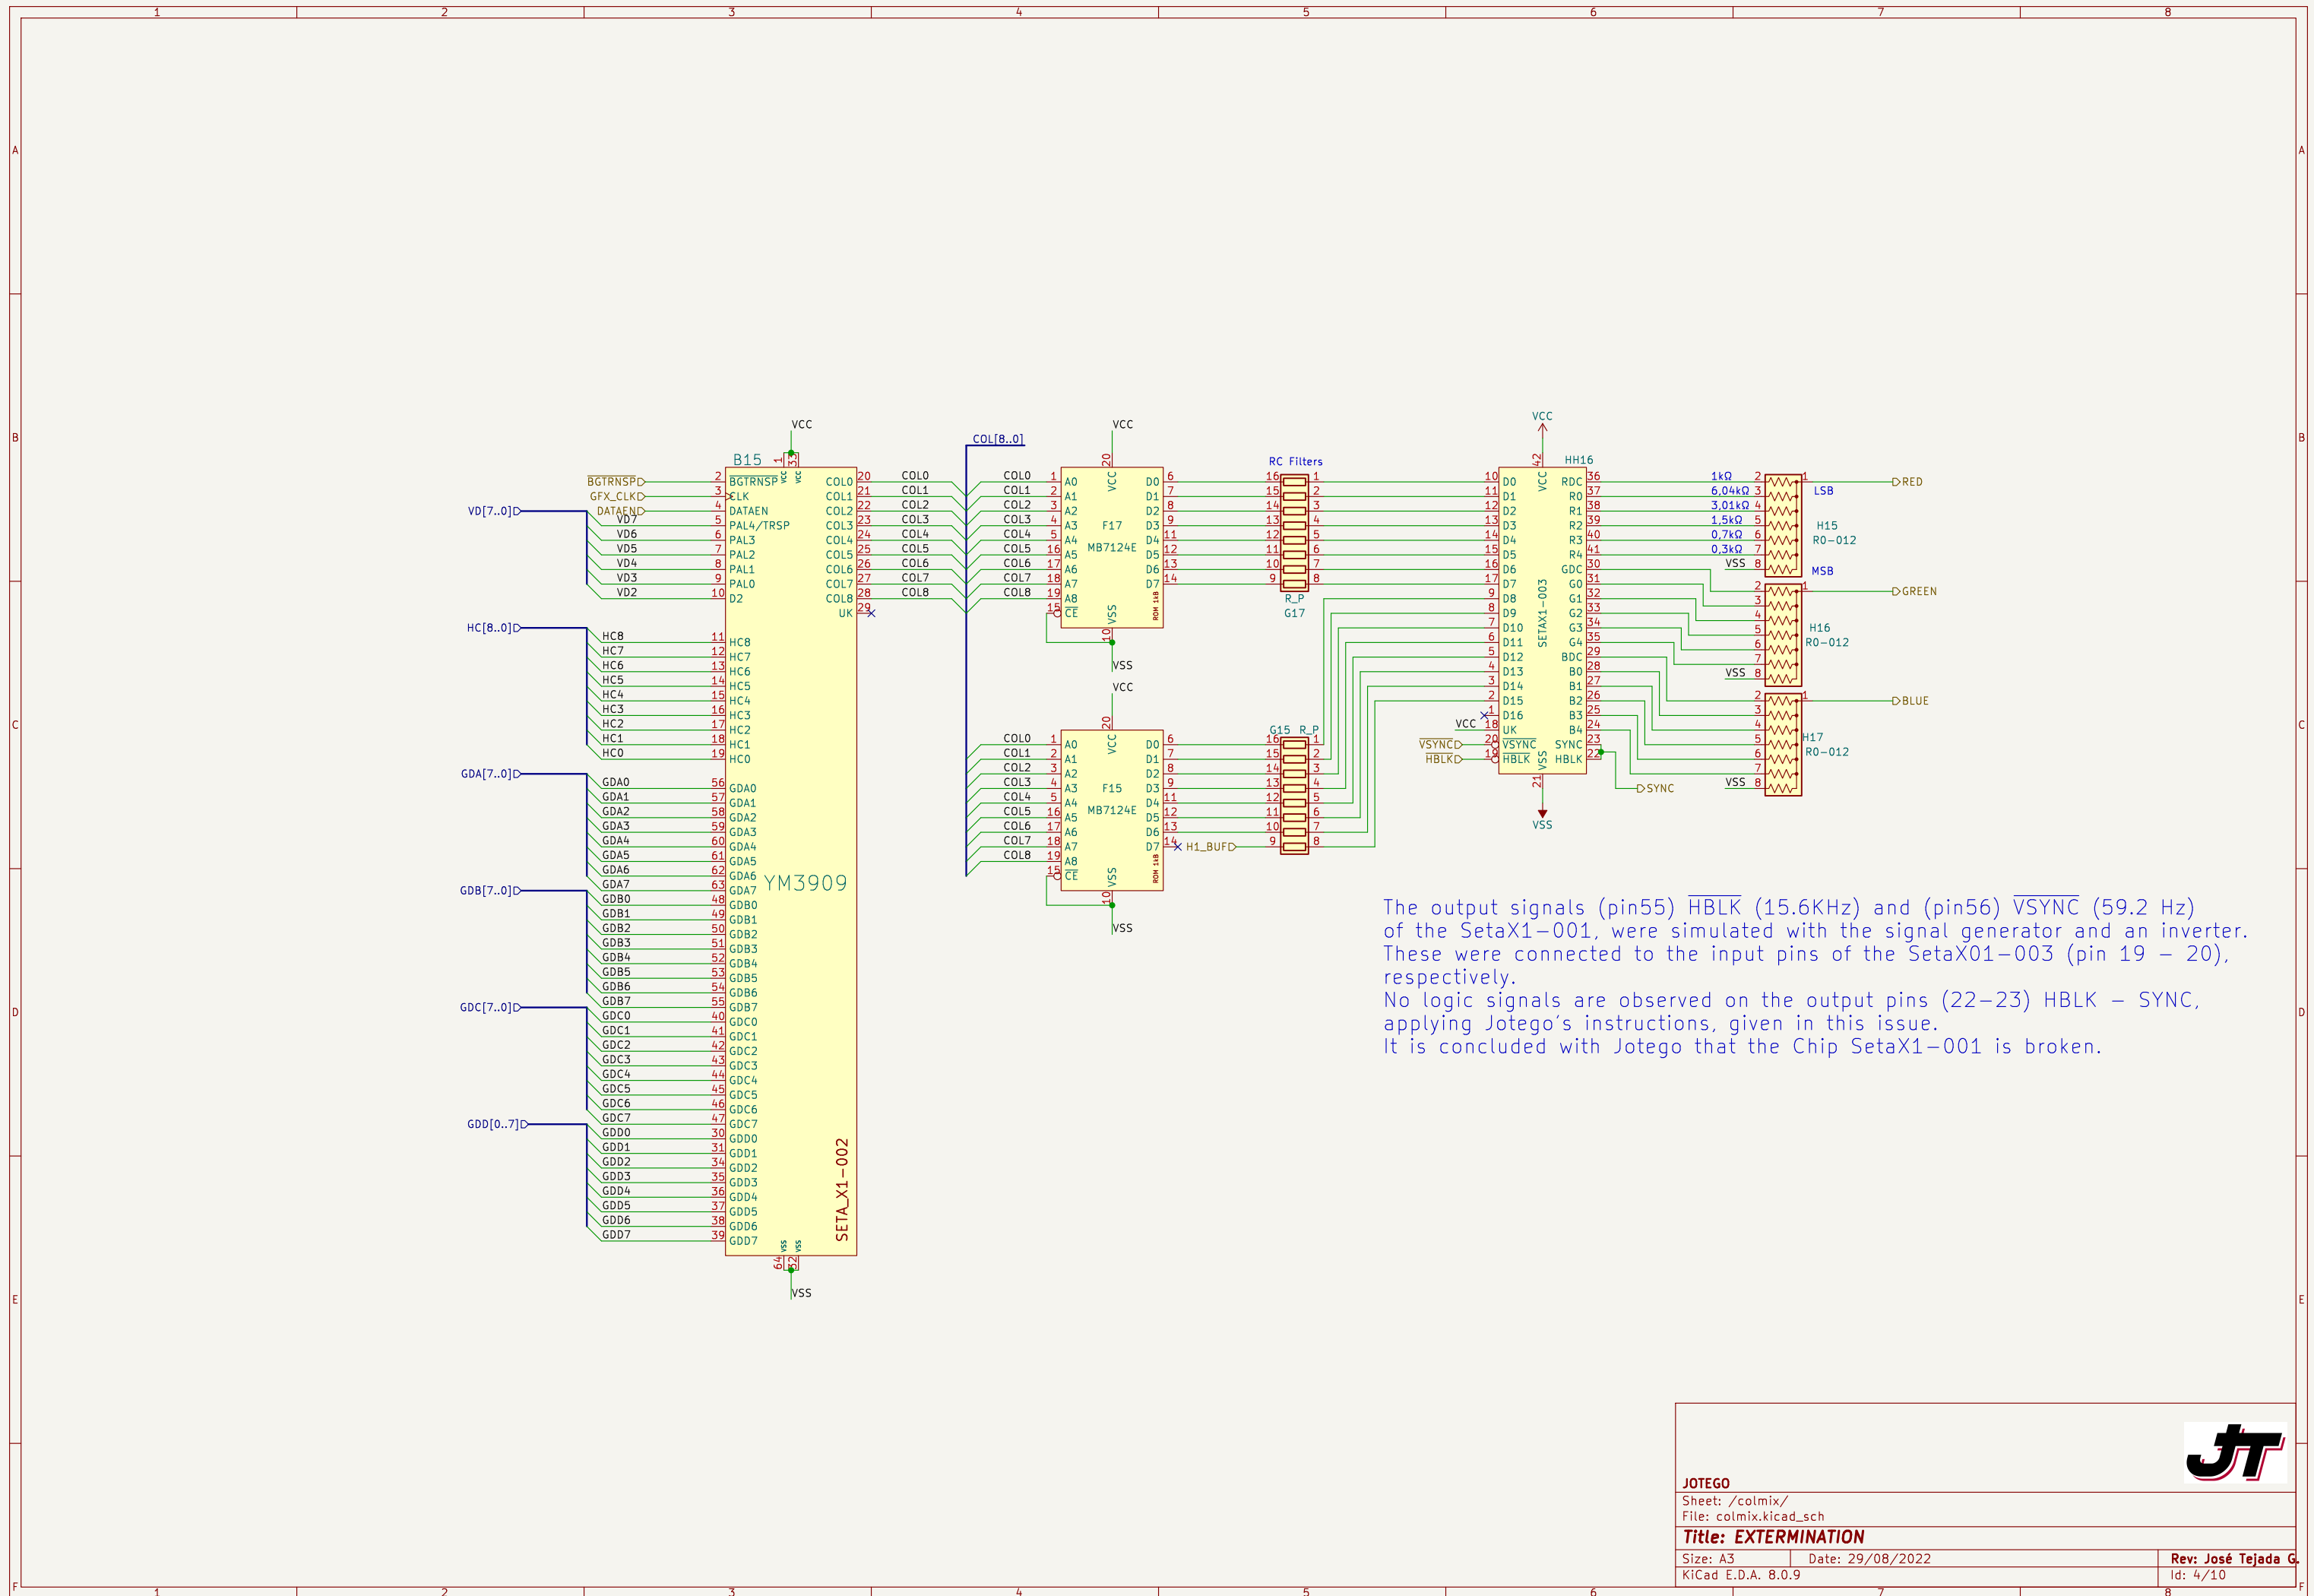
The output signals (pin55) $\overline{\text{HBLK}}$ (15.6KHz) and (pin56) $\overline{\text{VSYNC}}$ (59.2 Hz) of the SetaX1-001, were simulated with the signal generator and an inverter. These were connected to the input pins of the SetaX01-003 (pin 19 – 20), respectively.

No logic signals are observed on the output pins (22–23) $\text{HBLK} - \text{SYNC}$, applying Jotego's instructions, given in this issue.

It is concluded with Jotego that the Chip SetaX1-001 is broken.
