BUILDING SURVEY REPORT

45 - 51 Caledonian Crescent, James Square, Edinburgh
Project Number: 21049
Date: 30-Nov-21
Revision: Not applicable

45 - 51 CALEDONIAN CRESCENT, JAMES SQUARE, EDINBURGH

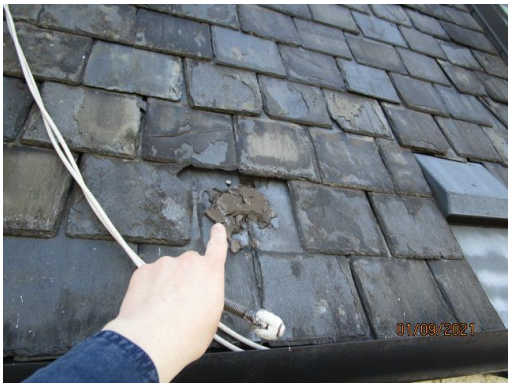
2.1.11. Mansard roof sections: The slatework is in fair condition, we have allowed for in the short term to replace any broken, slipped or missing slates.

Photo 09 – Slatework requiring repairs – slate missing to mansard.

3.2.7. Slatework: Include for replacement of damaged, slipped and missing slates.
