## BUILDING SURVEY REPORT

39 - 65 Caledonian Crescent, James Square, Edinburgh
Project Number: 21049
Date: 17-Nov-21
Revision: Not applicable

# 39 – 65 CALEDONIAN CRESCENT, JAMES SQUARE, EDINBURGH

# BUILDING SURVEY REPORT

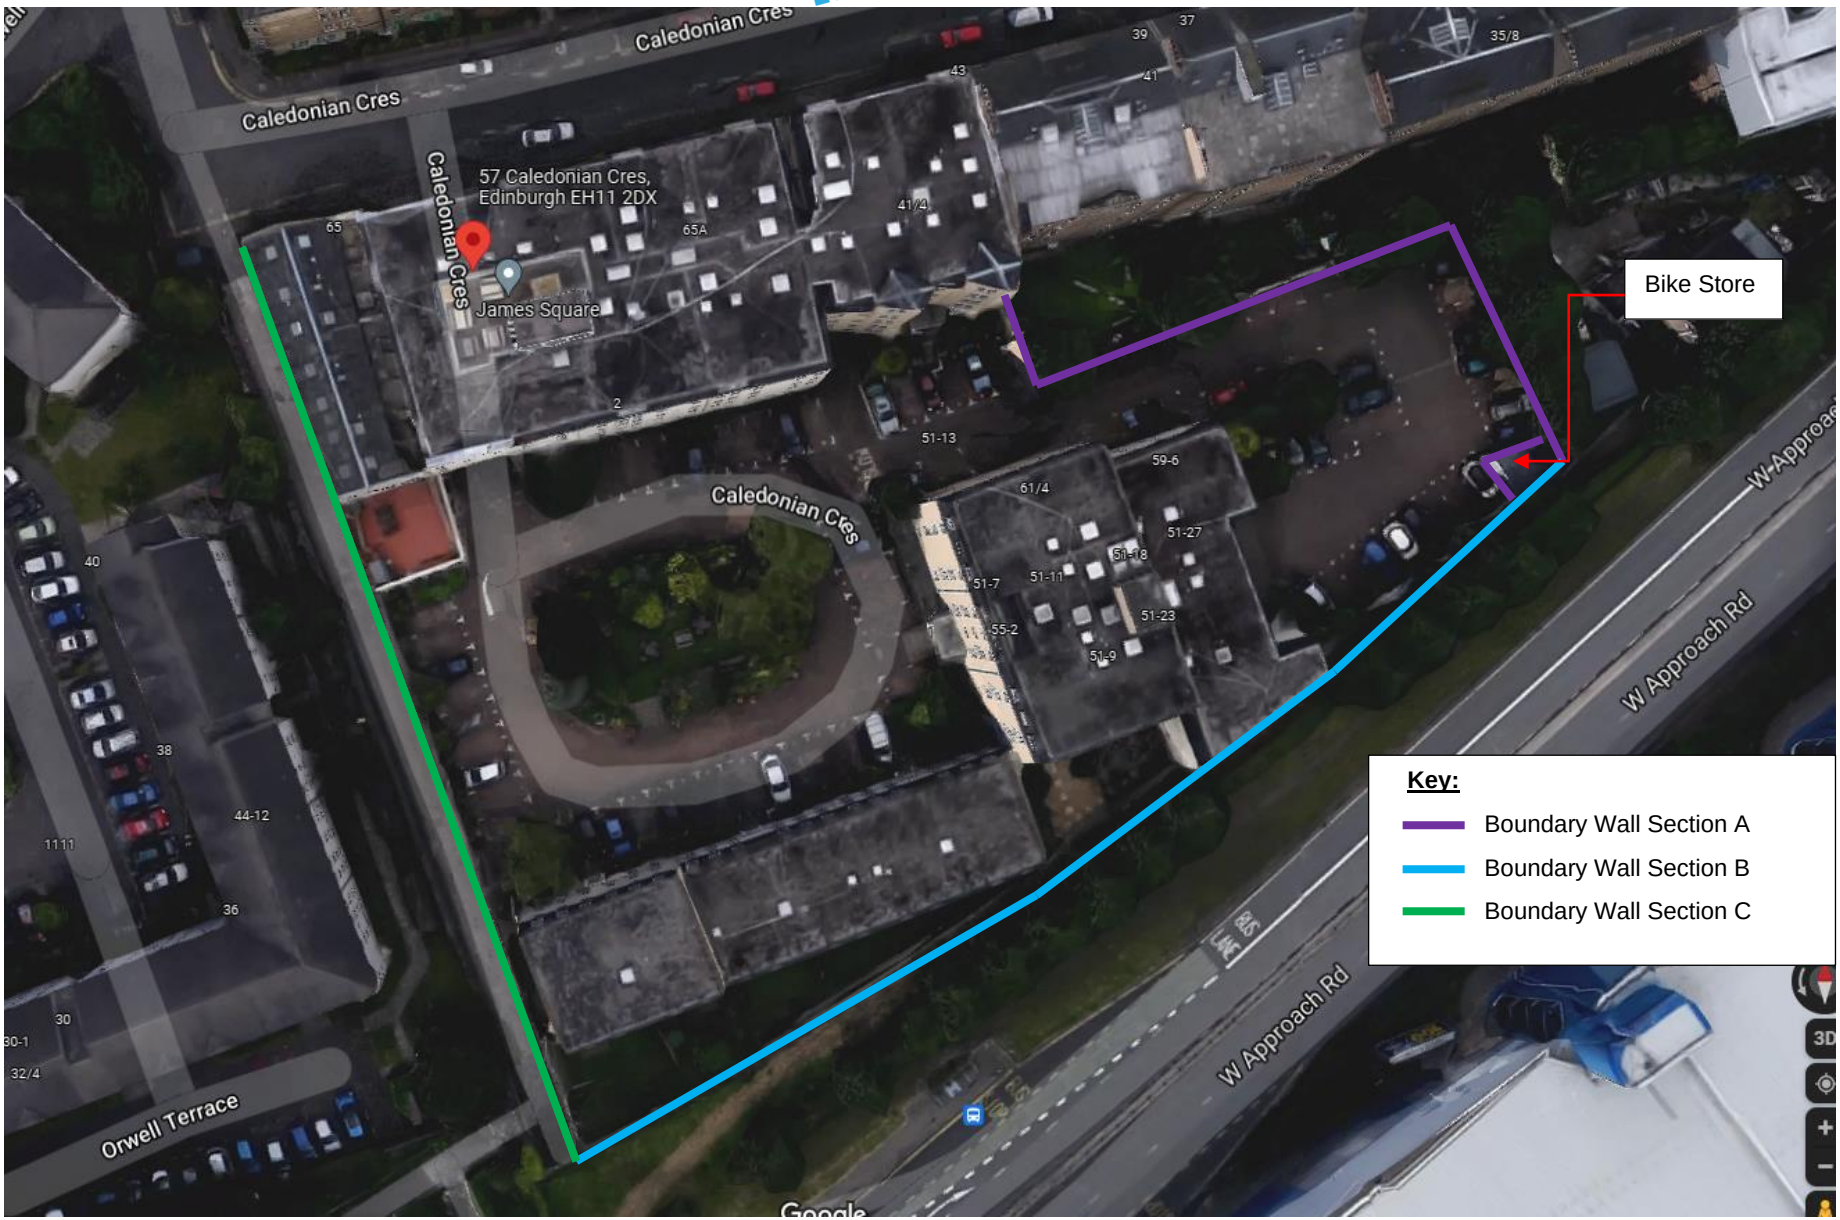
## APPENDIX 1 – BOUNDARY WALL PLAN

6.1.1. **Boundary wall section A:** Comprises the east most boundary walls along the south east corner of block 45 round to the south east most corner of to the bike store, which encompasses the car parking area as well as the bike store – Refer to Boundary Wall plan within appendix 01. The first section is mutual to the tenement at 41/43 Caledonian Crescent. There are repairs required to the James Square side of the wall, render is bossed in areas and cracked. To the section of the wall where the bins were in place at the time of survey and obscured the wall, to the areas visible the wall is in a fair condition. The internal face to the tenement at 41/43 requires some stone repairs and pointing works as well as render repairs. We have however not included for these within our costs, as we would assume these are the responsibility of the tenement owners.

6.1.7. **Boundary wall section B:** Comprises the east to west on the western approach road to blocks 39 – 61. To the James Square elevation, there is a dry dash render, generally this is in a fairly good condition and would appear to have been re-rendered fairly recently. There is a small section of bossed render at low level to the west most corner however this is minor.
