VIBE WITH JUDEO · CASE FILES

THE EDMUND FITZGERALD

LAKE SUPERIOR · 10 NOV 1975 → 2026

CAUSE: "MOST PROBABLE" · STILL DISPUTED

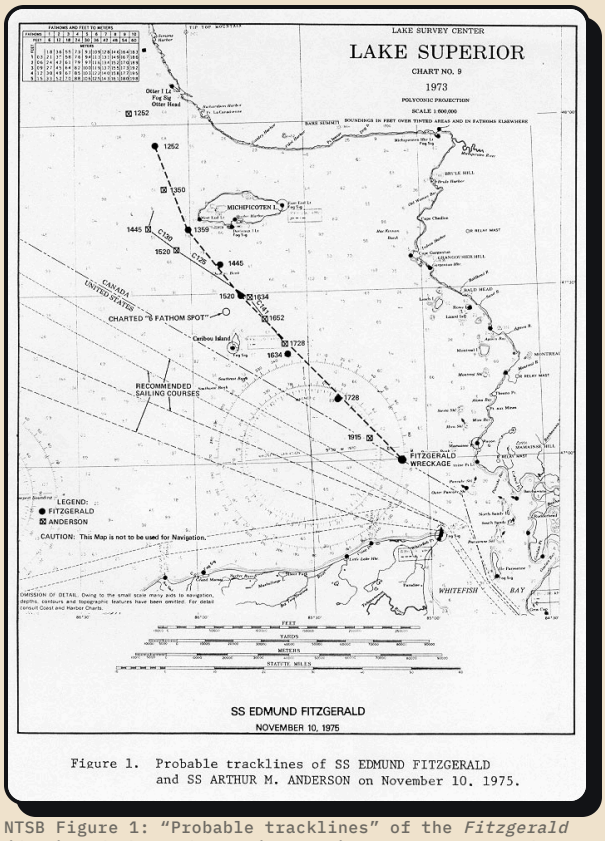
Figure 1. Probable tracklines of SS EDMUND FITZGERALD and SS ARTHUR M. ANDERSON on November 10. 1975.

NTSB Figure 1: "Probable tracklines" of the *Fitzgerald* (dots) and the *Anderson* (squares) on 10 Nov 1975, drawn on Lake Survey Chart No. 9. NTSB-MAR-78-3 (public domain).

Two pictures of the track. The NTSB drew the probable tracklines on the left. The Coast Guard board said the times and positions reported from the *Anderson* "were not sufficiently accurate" to reconstruct either ship's track. That gap matters on page 8. CONFLICT

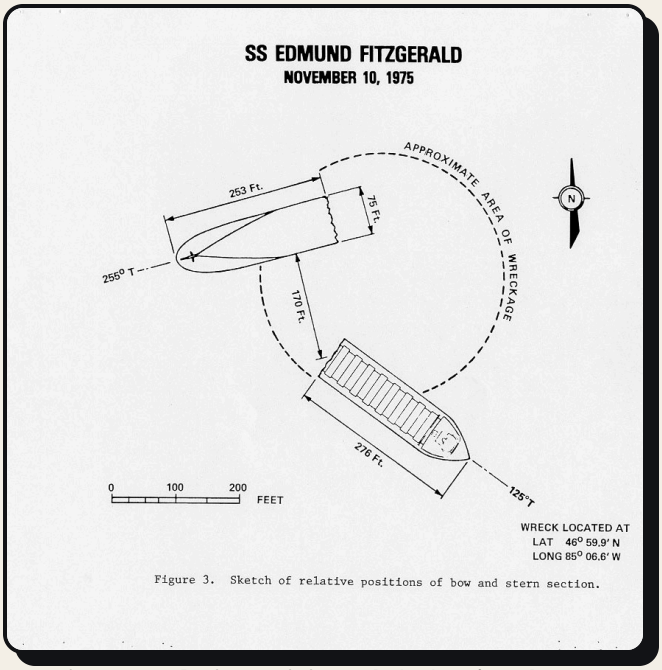
NTSB Figure 2: arrangement of the ship. Three holds separated by “screen” bulkheads; tank top; midship section. NTSB-MAR-78-3 (public domain).

NTSB Figure 3: relative positions of the bow (276 ft, upright) and the stern (253 ft, upside down) on the bottom. NTSB-MAR-78-3 (public domain).

The wreck, in the reports' words. About 200 ft of the middle of the ship is missing, “an area of distorted metal” between the two pieces; the fractures show “curving, twisted edges such as is associated with ductile failure.” A break-up on the surface was judged less likely because the two halves lie within a ship length of each other. VERIFIED **And a song.** In 2010 Gordon Lightfoot changed one line in his live performances so it no longer suggested the crew was at fault for a hatch failure; the recording was left as it was. VERIFIED

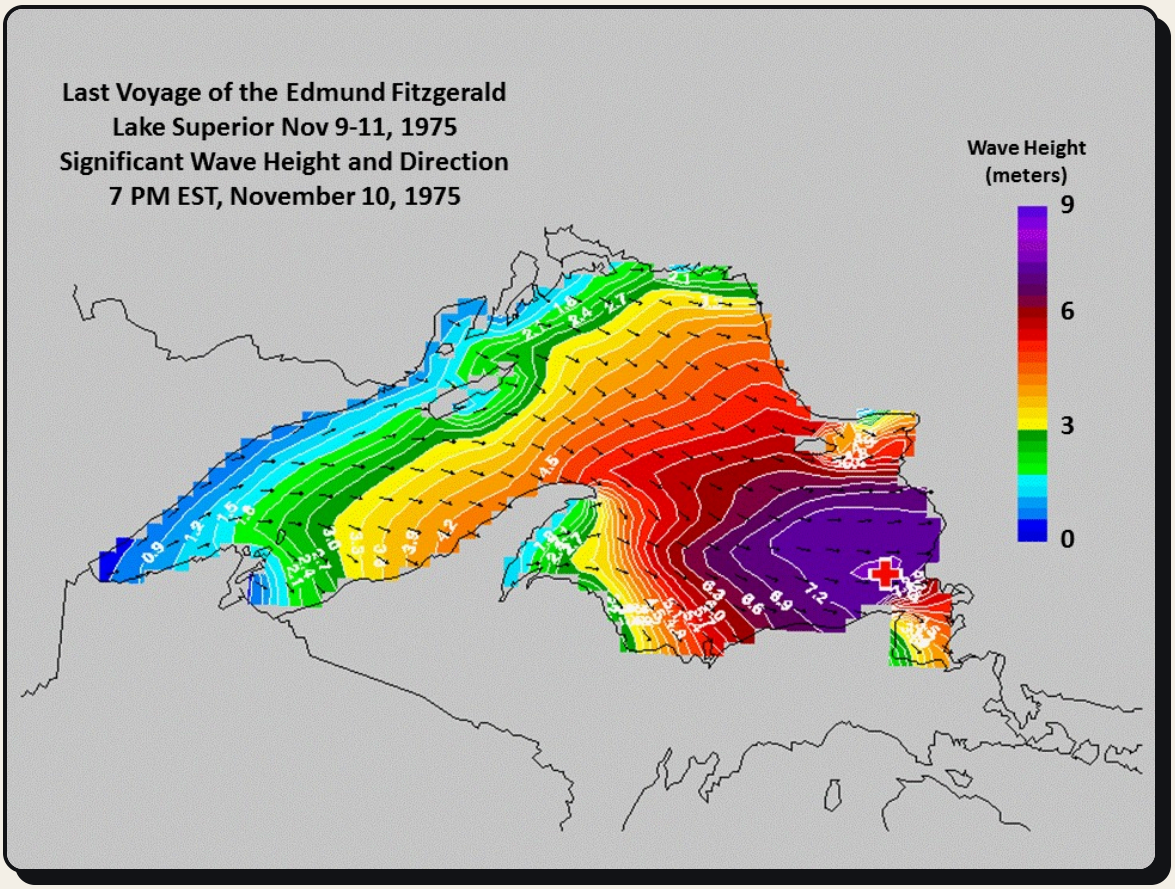
National Weather Service, Marquette, Michigan: modelled significant wave height and direction at 7 p.m. EST, 10 November 1975 (public domain). The *Fitzgerald* sank in the east of the lake, where the colours run highest.

The 2006 re-run. NOAA and NWS scientists (Hultquist, Dutter and Schwab) re-ran the storm with modern models: waves around 25 ft at her place and time. VERIFIED A 2005 student-newspaper account (*The Daily Cardinal*) adds that six hours earlier or later she might have missed the worst. ATTRIBUTED
