Service report

J-1001 · Completed heating inspection

Harbourview Dental
14 Harbour St, Balmain NSW 2041

Feb 28, 2030 · Technician: Priya

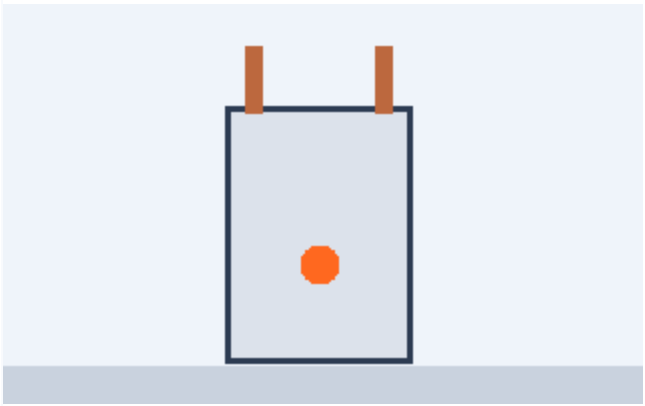
Pressure above the recorded range.

Supply pressure
95 psi
Out of range · expected 40–80 psi

Pressure regulator

Discuss regulator work with the office.
