Service report

J-1001 · Water heater service

Harbourview Dental
14 Harbour St, Balmain NSW 2041

Nov 3, 2026 · Technician: Priya

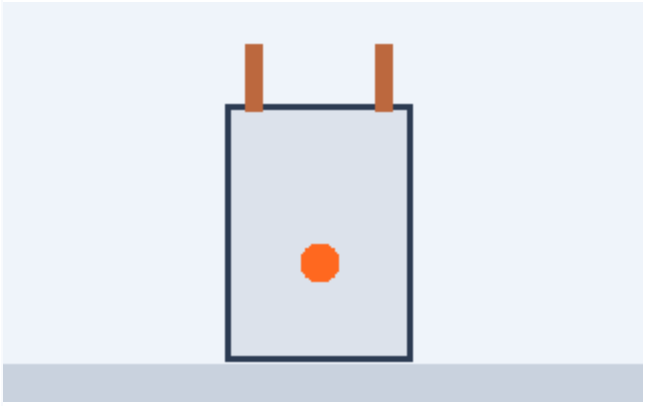
Water heater installation

High water pressure

Water pressure
95 psi
Out of range · expected 40–80 psi

Inspection notes
Expansion tank needs attention

Pressure regulator

Fit a regulator before the next service
