Location	
Parcel Number	
Zoning	NT-2
Lot Size	127' x 45' -- ~5667 sq.ft. = 0.13 acres
Living Area	1288 sq.ft., 1-story
Gross Area	1957 sq.ft.
Building Use	Single-Family Residential, Single Unit
Occ. Group	R-3
Const. Type	Type V
Project Scope	Repair of vehicle impact damage to exterior and interior wood-framed wall. Scope includes replacement of four damaged 2x4 studs, interior drywall, exterior sheathing and stucco cladding to match existing. A 3'x3' window will be inspected for structural integrity and replaced to match existing if required. No structural changes to layout, roof, or foundation. No plumbing, electrical, or mechanical modifications involved. Smoke and CO alarms to be verified per FBC requirements.
Evacuation Zone	'C'
Flood Zone?	No
Market Value (2025)	\$413,815

A0.1.....	Title, Index, Legend
A0.2.....	References, Resources, BOM
A1.1.....	Site Plan
A1.2.....	Floor Plan
A2.1.....	Damage Side Elevation
A3.1.....	Damage Wall Section
A5.1.....	Top Plate & Header
A5.2.....	Bottom Plate & Sub-Floor
A5.3.....	Window & External Repairs
A5.4.....	Storm Shutter Installation
A7.1.....	Miscellaneous

Structural Framing Repair

WALL REPAIR SECTION

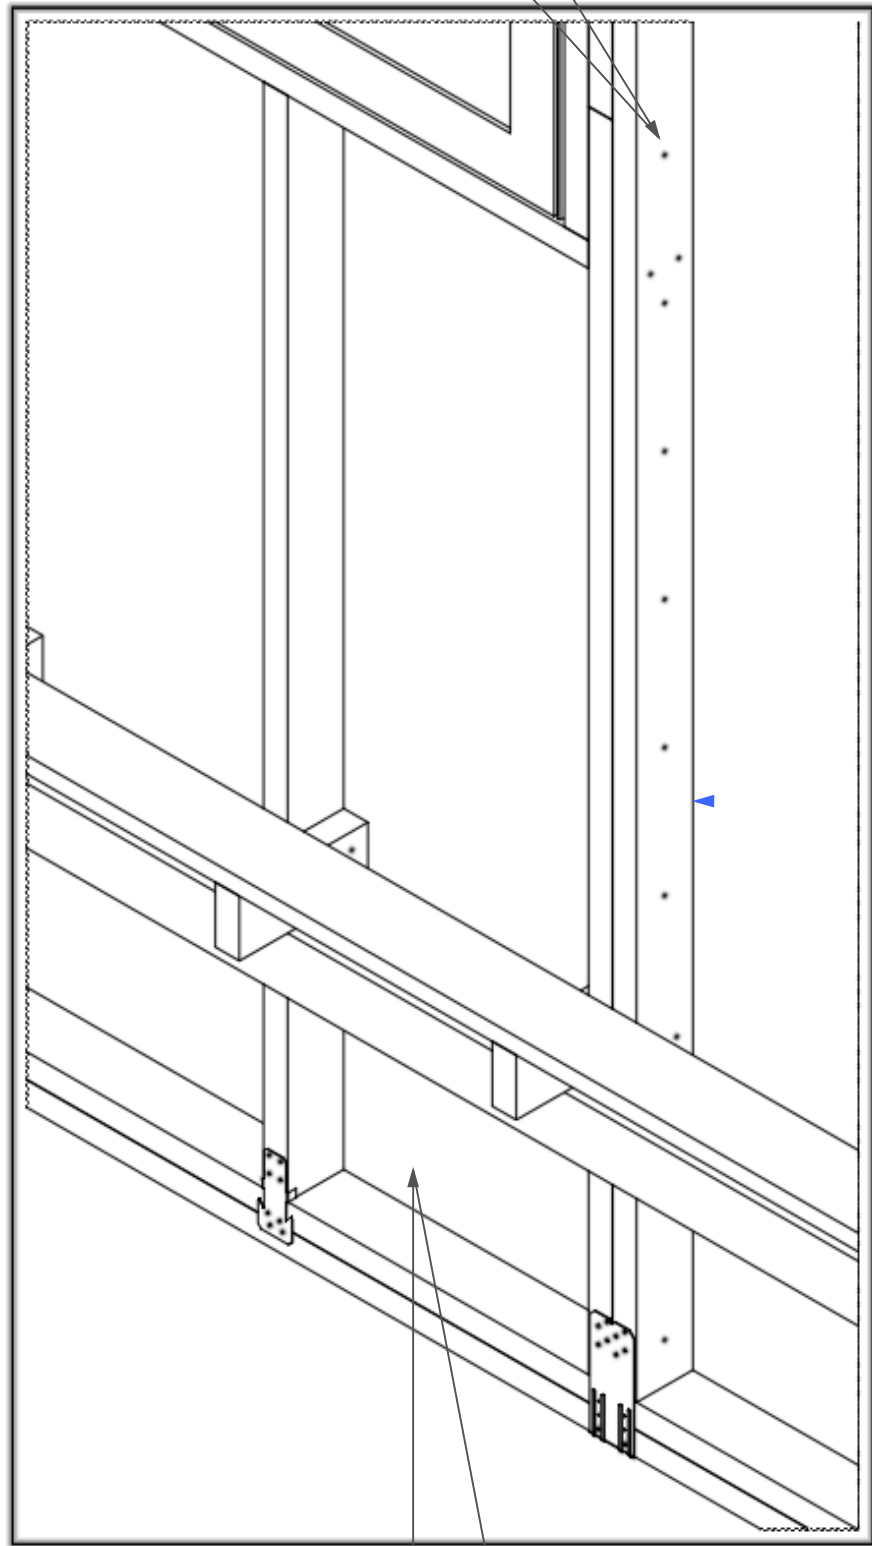
A5.1

- Scale applies to detail view - parametric view is approximately same scale.
- Existing window header to be inspected. If not meeting minimum code requirements for a load bearing exterior wall opening (minimum (2) 2x6 per FBC-R602.7(1) for current

- conditions- it will be replaced with a header sized per FBC-R602.7(1).
- Adjacent top plate-vertical member connections not depicted, but will join in equal manner to depicted in this detail.
- All structural framing is 2x4 (MatTag 02) unless otherwise indicated.
- See Addendum (sheet 7.1) for amplified interior repair guidance.

All wood-scabbing framing connections to use 10d x 3 in SSA10 nails (MatTag 08).
