Crashes on the Layfayette Bridge (Hwy 52), 2007-2018

A comparison of crashes before and after the 2011-2016 Layfayette Bridge project

John Henderson, jw.hendy@gmail.com

2019 September

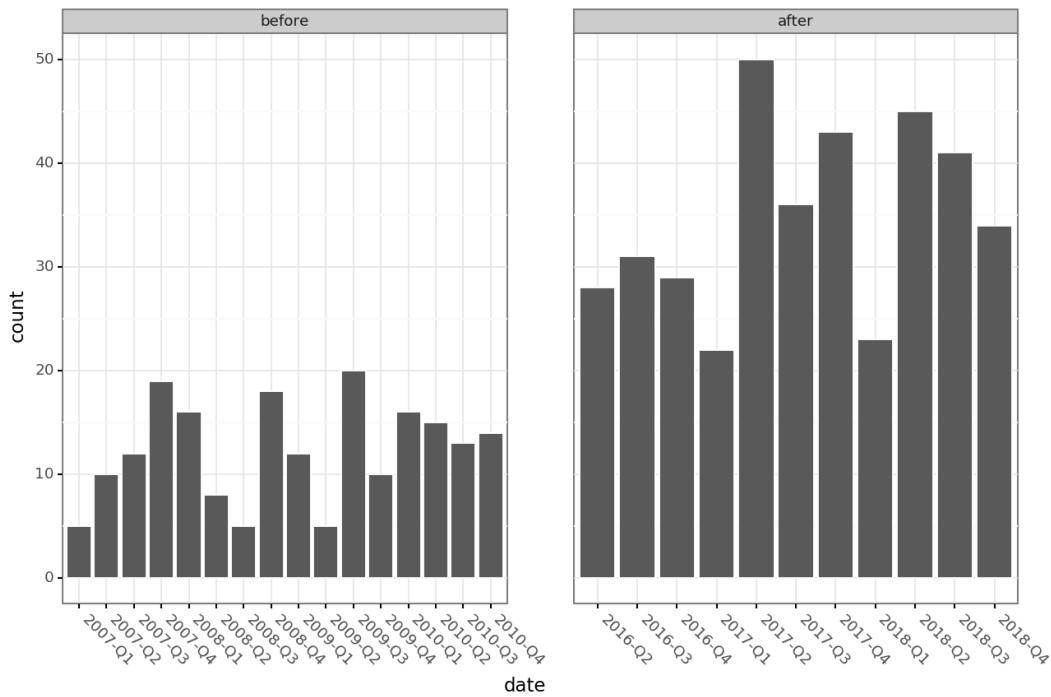
period	date			crashes	
	start	end	range, days	count	count/days
before	2007-01-28	2010-12-28	1430	205	0.143
after	2016-04-03	2018-12-26	997	391	0.392

The ratio of crashes per day between the two seasons is 2.741. Crashes have increased 2-3x since the Layfayette Bridge redo.

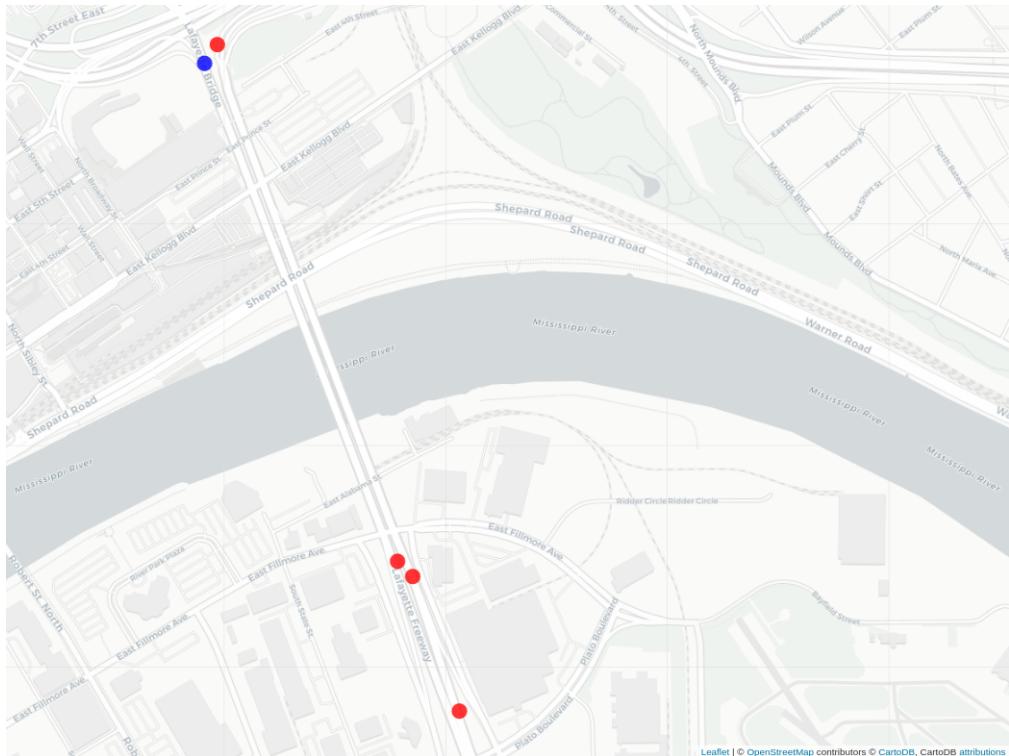
The rates are largely identical, though the increase from 1 to 4 serious injuries during a shorter time span may warrant attention. It is unclear which side of the bridge the crashes are on, but three are near the Plato on ramp to 52N where I believe the most chaotic conditions occur.

- finding a way to reduce the extreme speed disparities between lanes
- guiding the merging process with signage to reduce: closing gaps to prevent someone from merging, merging immediately following an onramp, drastically reducing speed to merge at the last minute, and passing an individual on the shoulder out of impatience
