ARCHAEOLOGICAL SURVEY OF MINE LANDS IN THE
RATON COAL FIELD FOR THE
ABANDONED MINE LAND BUREAU

Yvonne R. Oakes

LABORATORY OF ANTHROPOLOGY NOTE NO. 386

1987

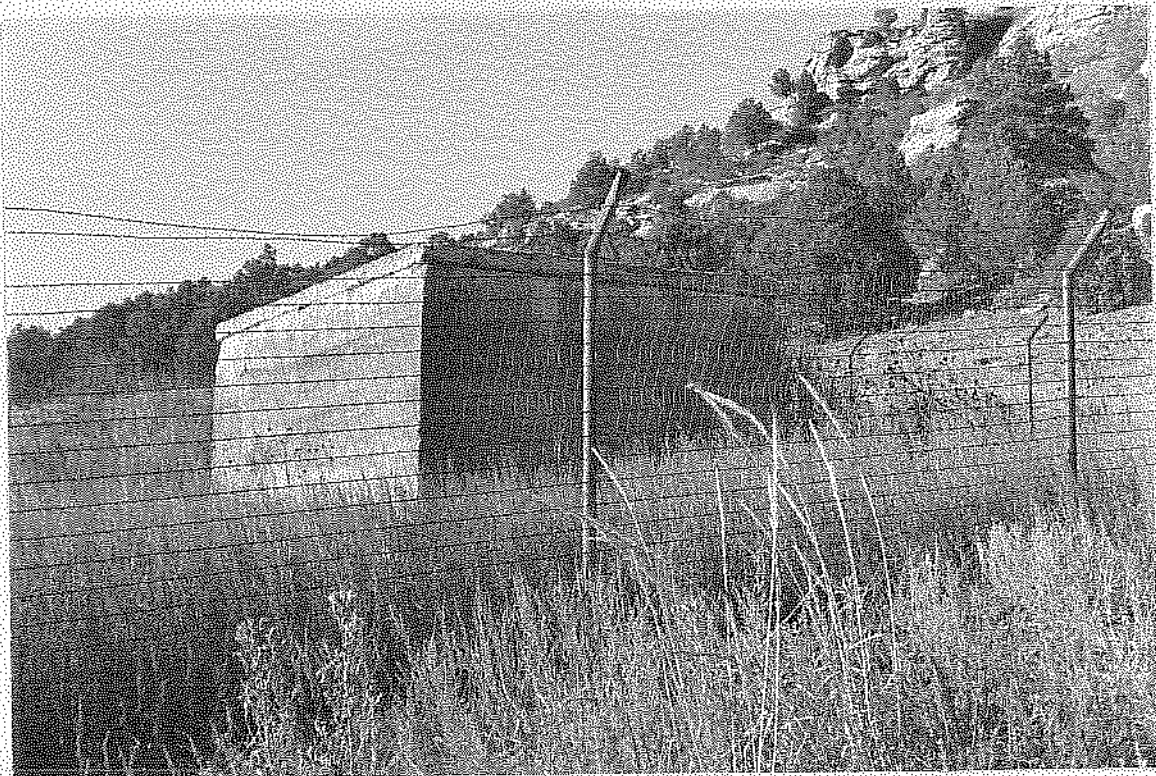
Cistern B is also a vertical, stone-lined hole measuring 2.0 by 1.0 m and dug over 30.0 m into the ground (Fig. 3). Historic trash and structural foundations are also situated in the open field near the cistern (Fig. 4).

FIG. 2. Swastika Mine opening, facing north.

FIG. 3. Blossburg Cistern B, in open field.

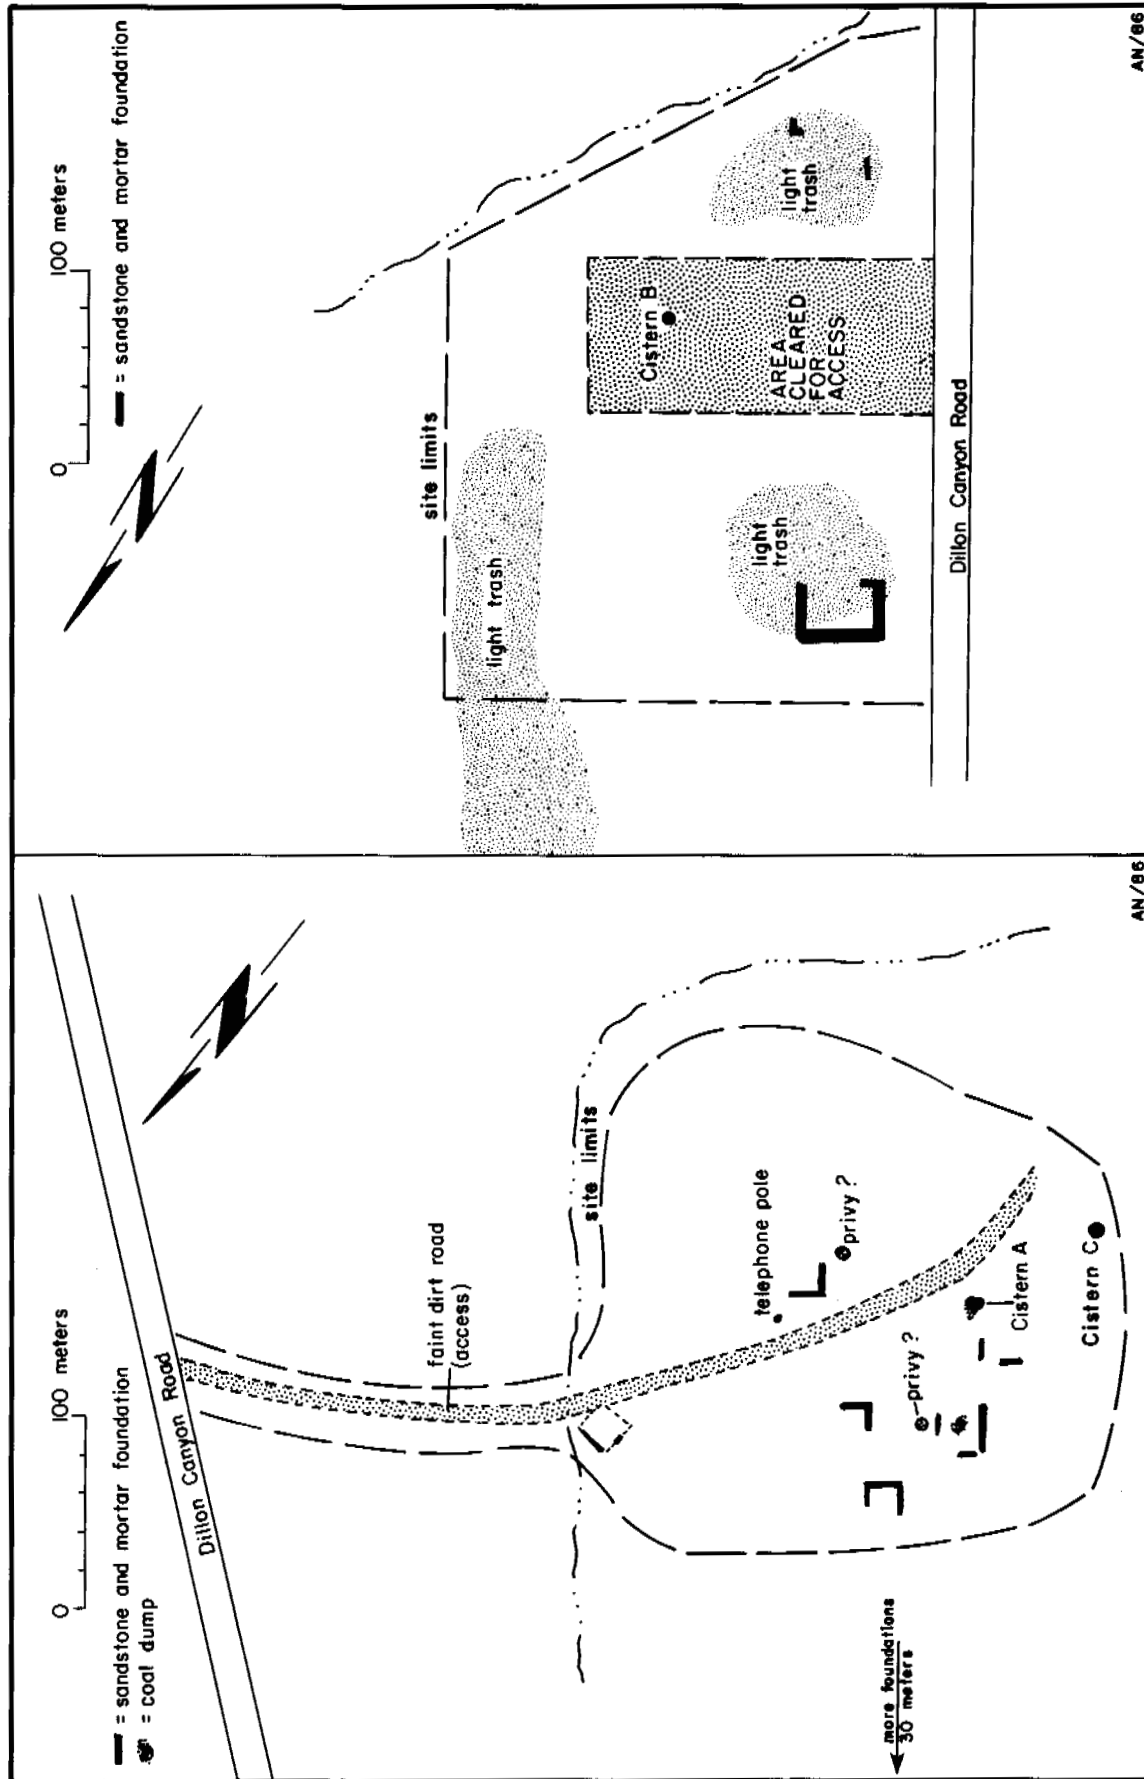
Figure 4. Blossburg Cisterns A, B and C, plan views.

Cistern A is a vertical hole 2.0 by 1.0 m wide dug 12.0 m into the ground. The opening is stone-lined in its upper reaches. A rusted car door and stove part lie near the opening. In the field surrounding the cistern are numerous structural foundations with light scatters of trash (Fig. 4). These are not visible from the main road, but are hidden from view by tall grasses.

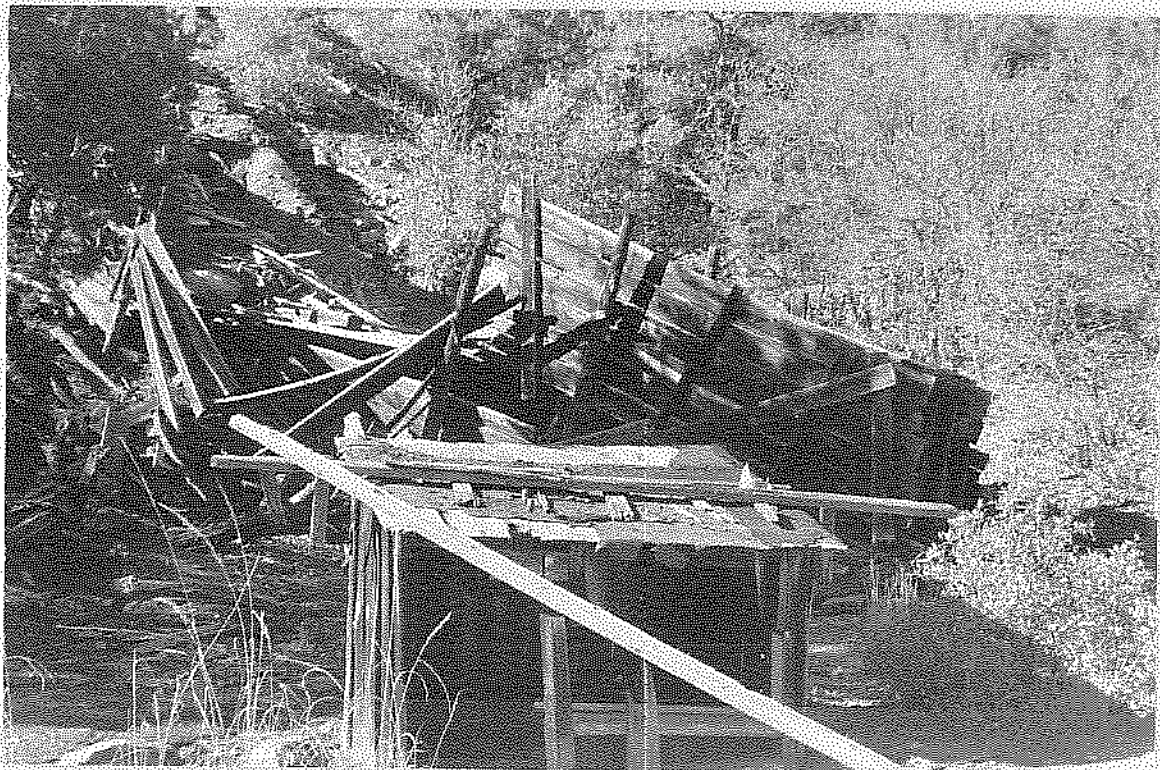
FIG. 5. Load-out and shed and Vellar Mine.

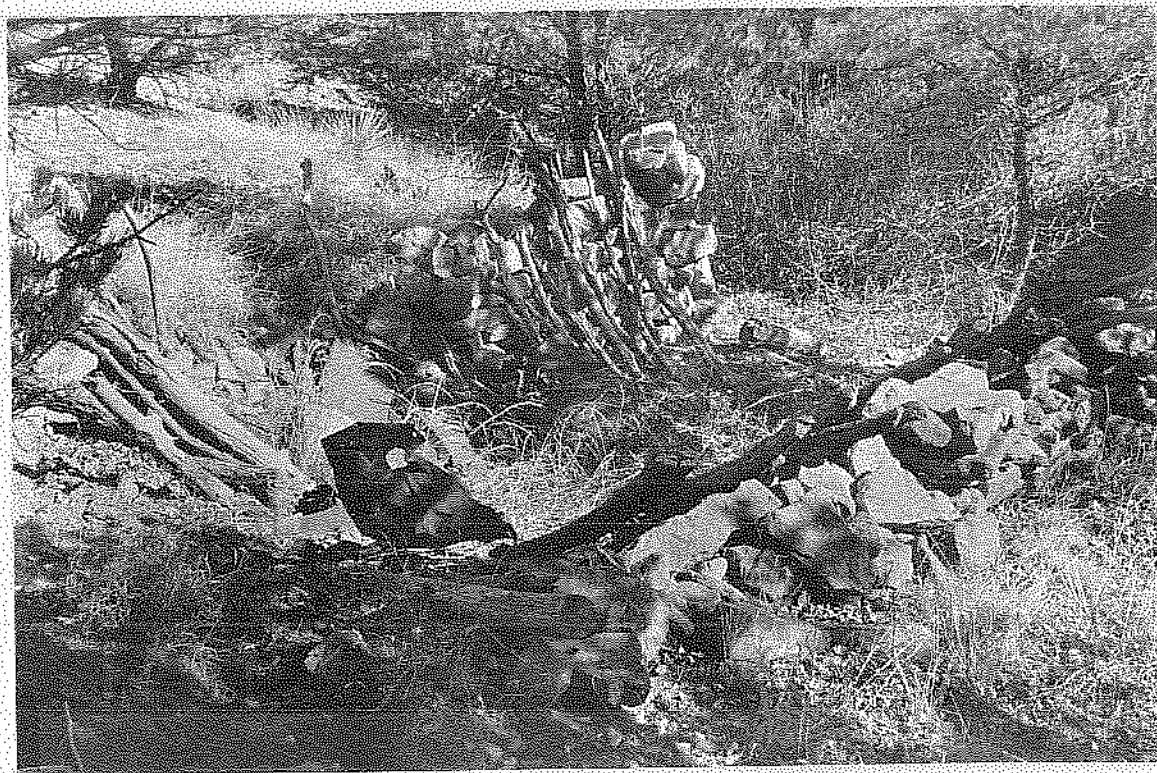
Five meters downslope from the dugout depression is a dry-laid collapsed rock structure of sandstone (Fig. 6). It measures 4.0 by 3.6 m with standing walls of 1.3 m height. The roofing has collapsed, but thin timber poles and tin roofing remain. Light trash of broken glass and ironstone are located behind the structure which has been dug into a low bank.

FIG. 6. Rock structure with collapsed pole roof.

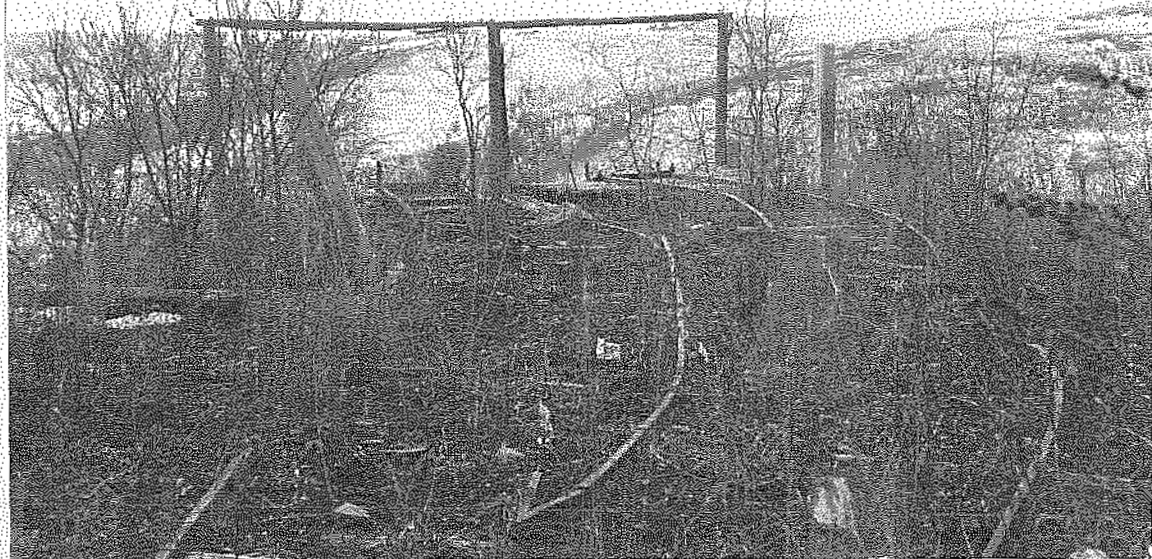
Five meters north of the fan house is a collapsed frame structure 4.0 by 6.0 m which may once have served as a shed. Pieces of large mine machinery are located between the fan house and the first adit. Railroad tracks lead from this adit to a load-out which extends downslope from the adit for 20.0 m to a leveled area (Figs. 8 and 9). The load-out is supported on 12 by 14 inch round posts and framed with 2 by 10 inch boards. It is fastened with machinery bolts and wire nails. Several wooden coal carts lie abandoned on the slopes of the hill which is also covered with coal. An access road leads to the

FIG. 8. Railroad tracks leading to load-out at Genta Mine.

FIG. 9. Load-out at Genta Mine.

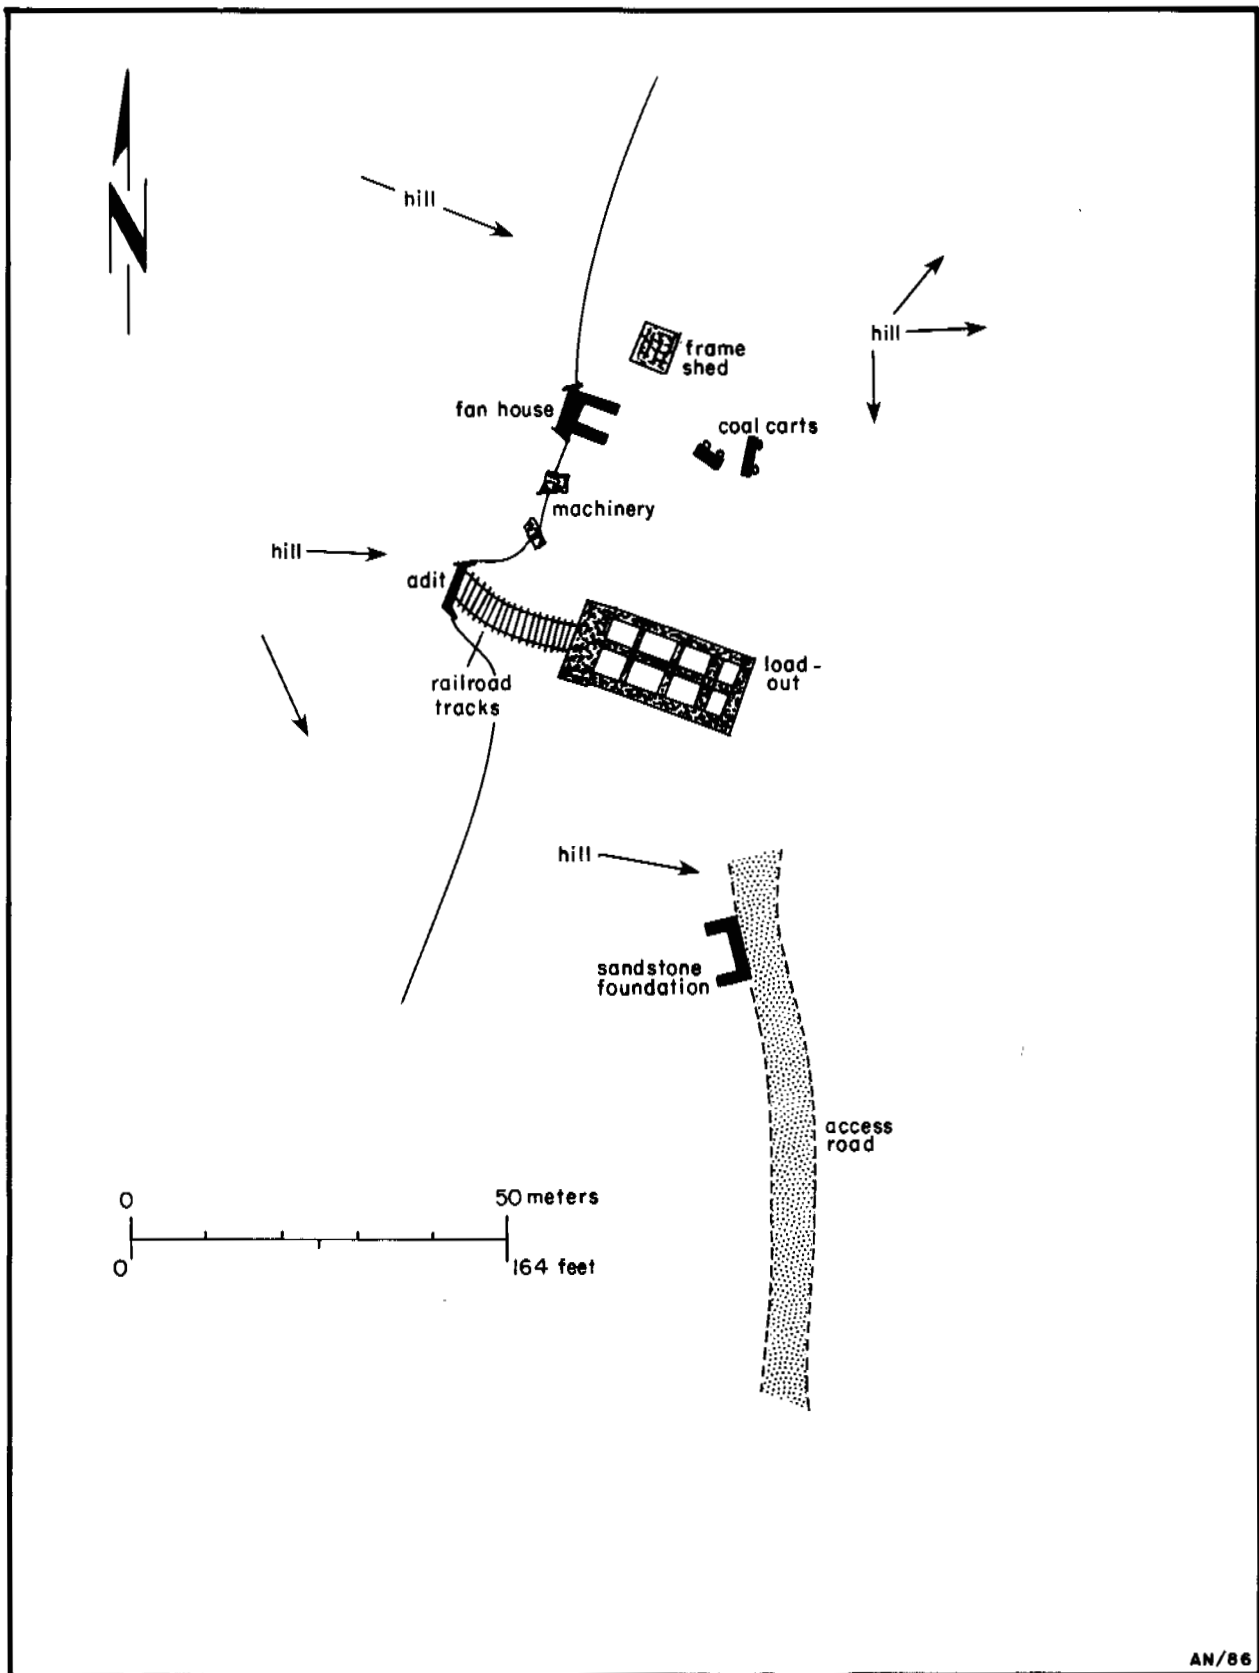
Figure 10. Plan view of Genta Mine.

Description: The site consists of two adits cut into the bank of a hill with associated structures. One adit was timbered but has now mostly collapsed. There is a wood post retaining wall associated with the adit. The other adit sits 20.0 m to the north and is part of a fan house structure which measures 3.0 by 5.0 m. Walls of the fan house are poured concrete.

The Abandoned Mine Land Bureau proposes to completely collapse the first adit opening by hand and to install a concrete closure over the adit associated with the fan house (Fig. 10). Research Section archaeologists have cleared the access road into the site and have been assured by Abandoned Mine Land personnel that site structures and cultural material will not be disturbed.

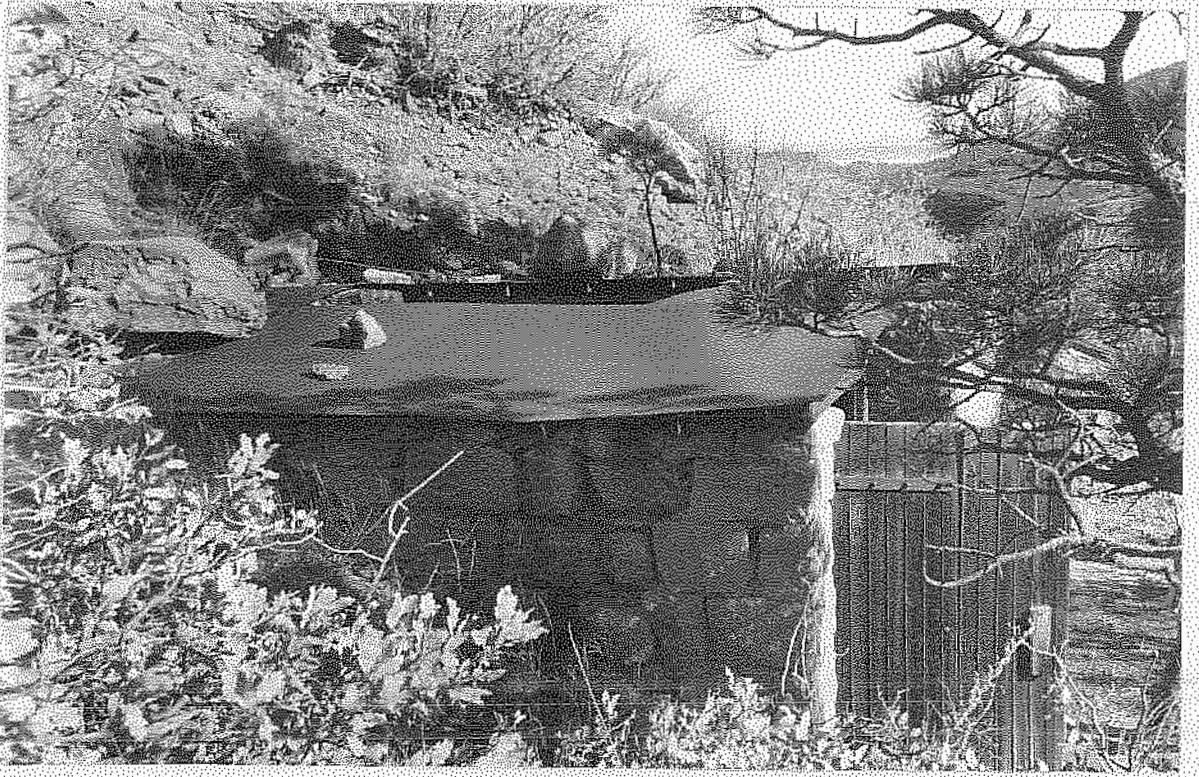
FIG. 12. Old Koehler Mine No. 1 fan house.
Adit is inside of structure.

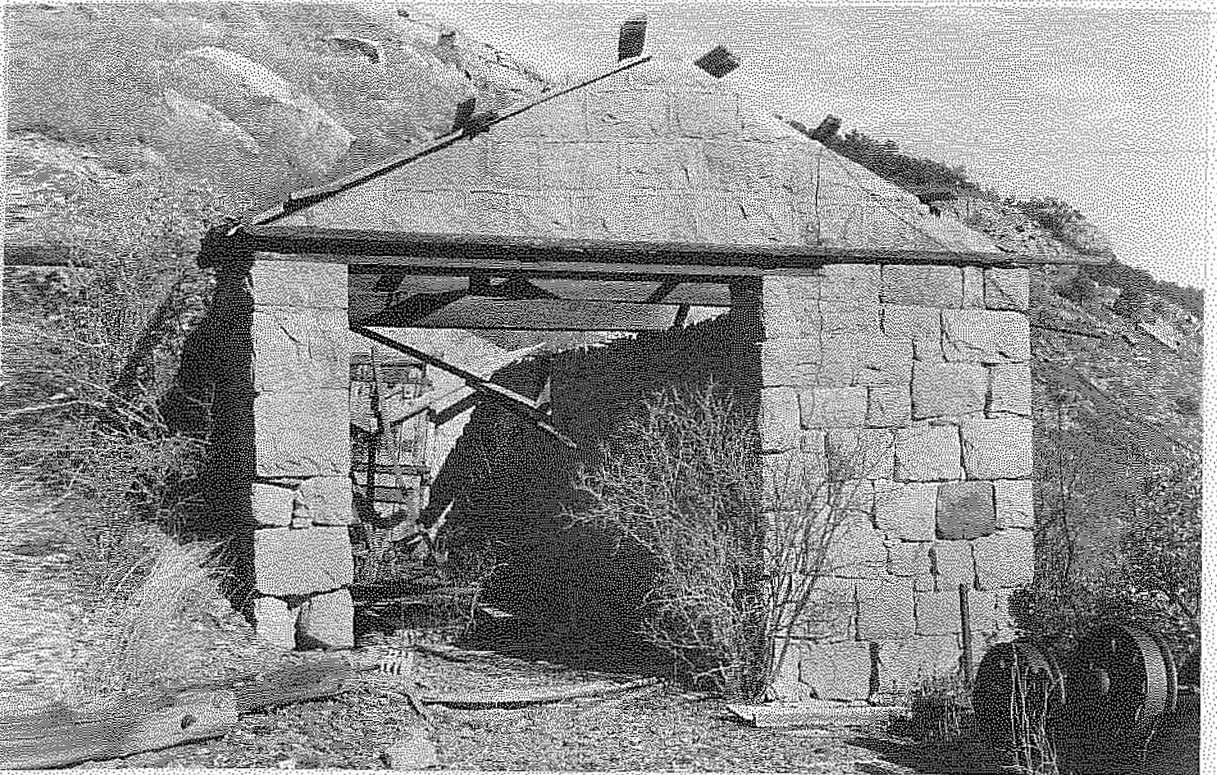
A winding house is situated 35.0 m downslope from the fan house (Fig. 13). It is also of sandstone block with a pitched roof of wood and asphalt. The structure measures 11.3 by 4.3 m and is ca. 2.5 high. Walls are 45.0 cm thick. The roof has partially collapsed; however, the 2 by 10 inch cross beams are intact. A metal beam above the front entry is stamped "Pat. 1915" indicating that the structure

FIG. 13. Old Koehler Mine No. 1 winding house.
Tram line extended up hill to fan house.

was constructed after this date. Wire nails are used in the exposed boards. Two single pane windows (82 by 76 cm) are located on each side of the building with one longer one on the rear wall. Set into the center of the floor is a concrete box of 2.8 by 0.9 m which once held the winding mechanism that hauled the wooden coal cars down the hill from the adit. Roof beams, metal machinery parts, and a wooden coal cart lie on the floor of the winding house. Purple glass, metal fragments, and a wooden coal cart are sparsely scattered around the outside of the structure.

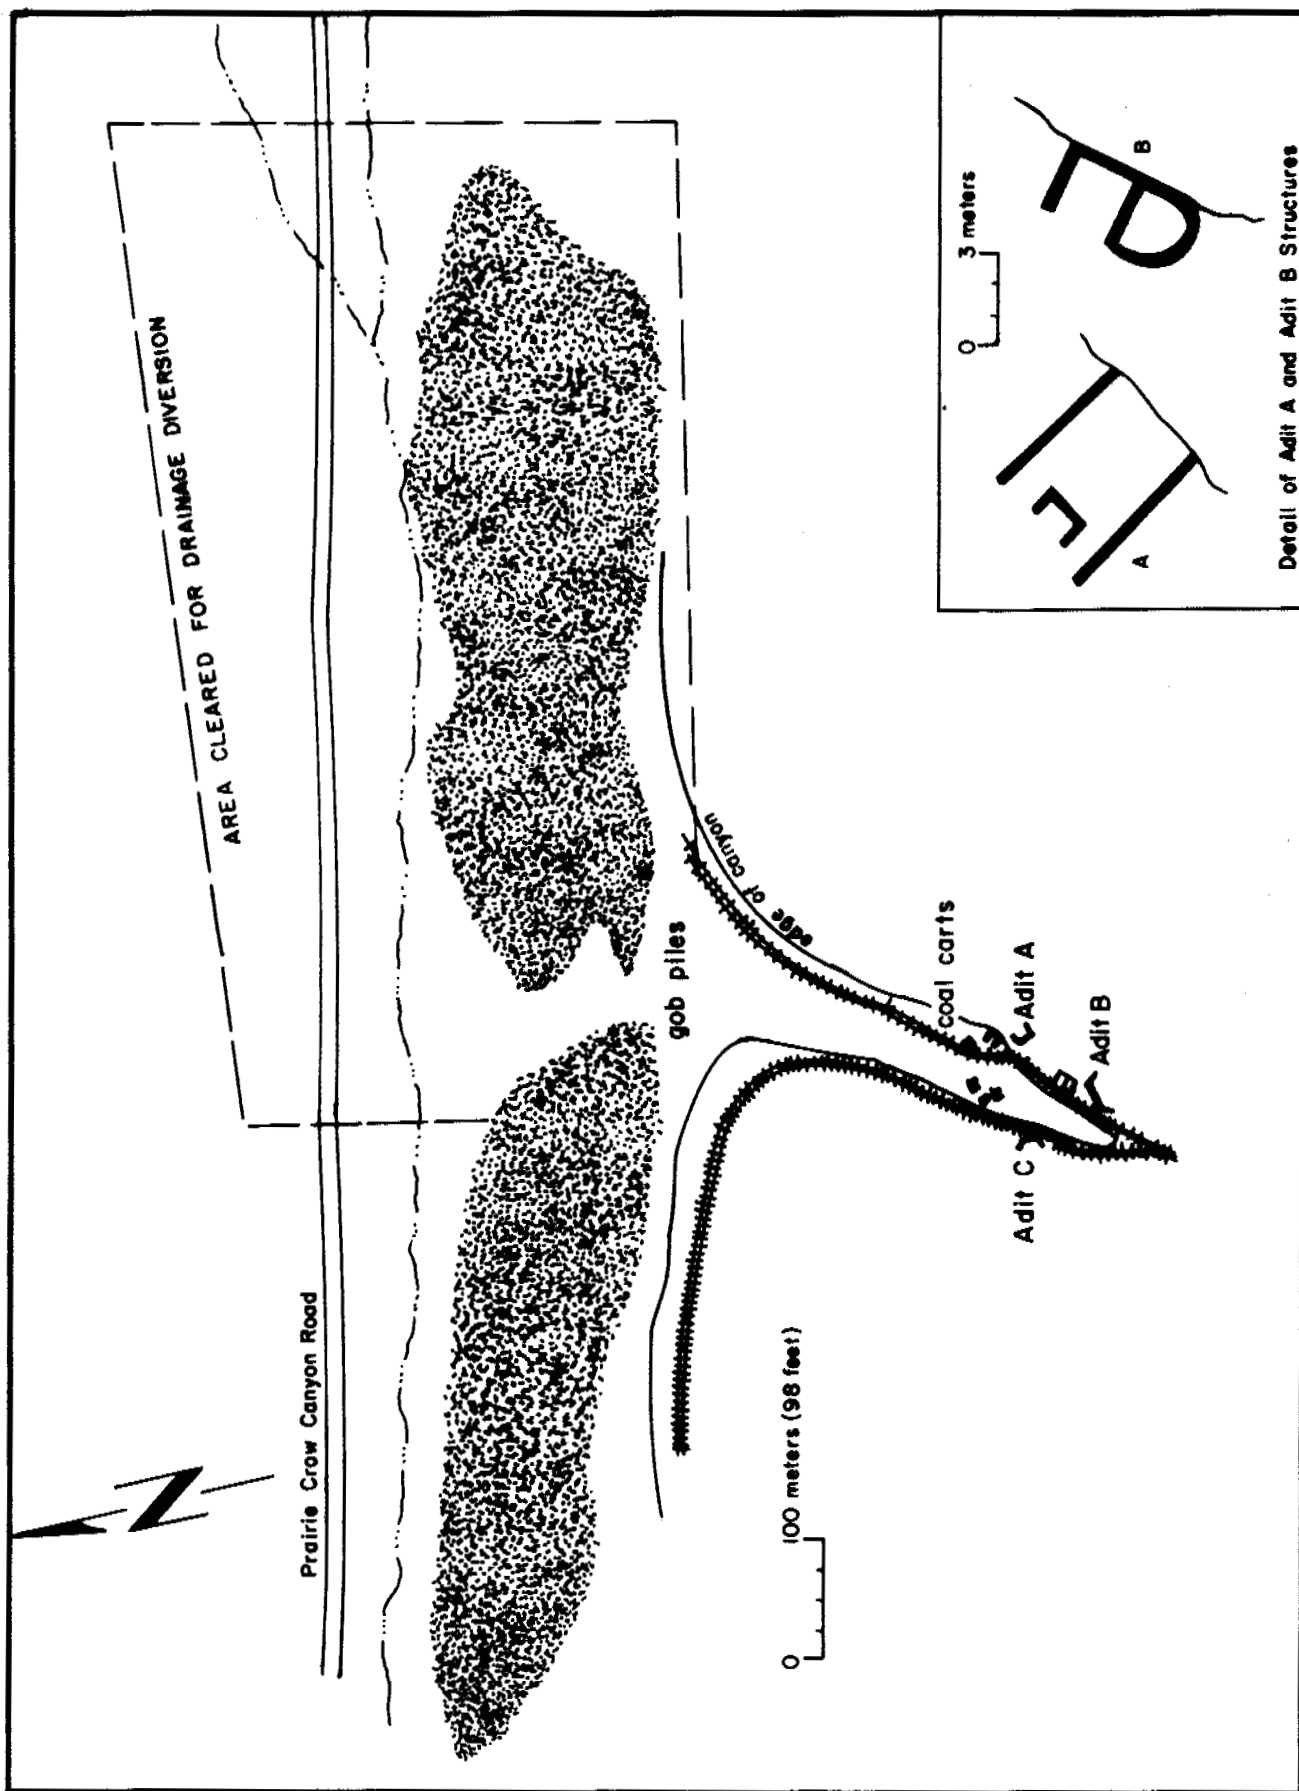
Figure 14. Plan view of Koehler gob pile and adits.

Description: A large gob pile (coal waste) located on the floor of Praire Crow Canyon is burning internally. It measures 1.2 by 0.2 km and is 15.0 to 20.0 m high. There is a small drainage along the north edge of the gob pile. No structures are located on or immediately adjacent to the pile (Figs. 14 and 15).

In a side canyon directly south of the gob pile are three adits located on an encircling bench. Adit A is a drift (a sloping adit) measuring 2.75 by 2.0 m. It is dug directly into the sandstone with no framework. Ten meters north of the adit is a rock foundation with partially standing walls of rock with concrete mortar. It measures 6.7 by 4.9 m with the back wall dug into the hill. There is an enclosed rock-walled area within the structure. A tin roof has collapsed into the interior so that the floor is not visible. No artifacts were observed in association with the building which is thought to represent a mine-related structure rather than residence.

FIG. 15. Koehler gob pile, currently on fire.

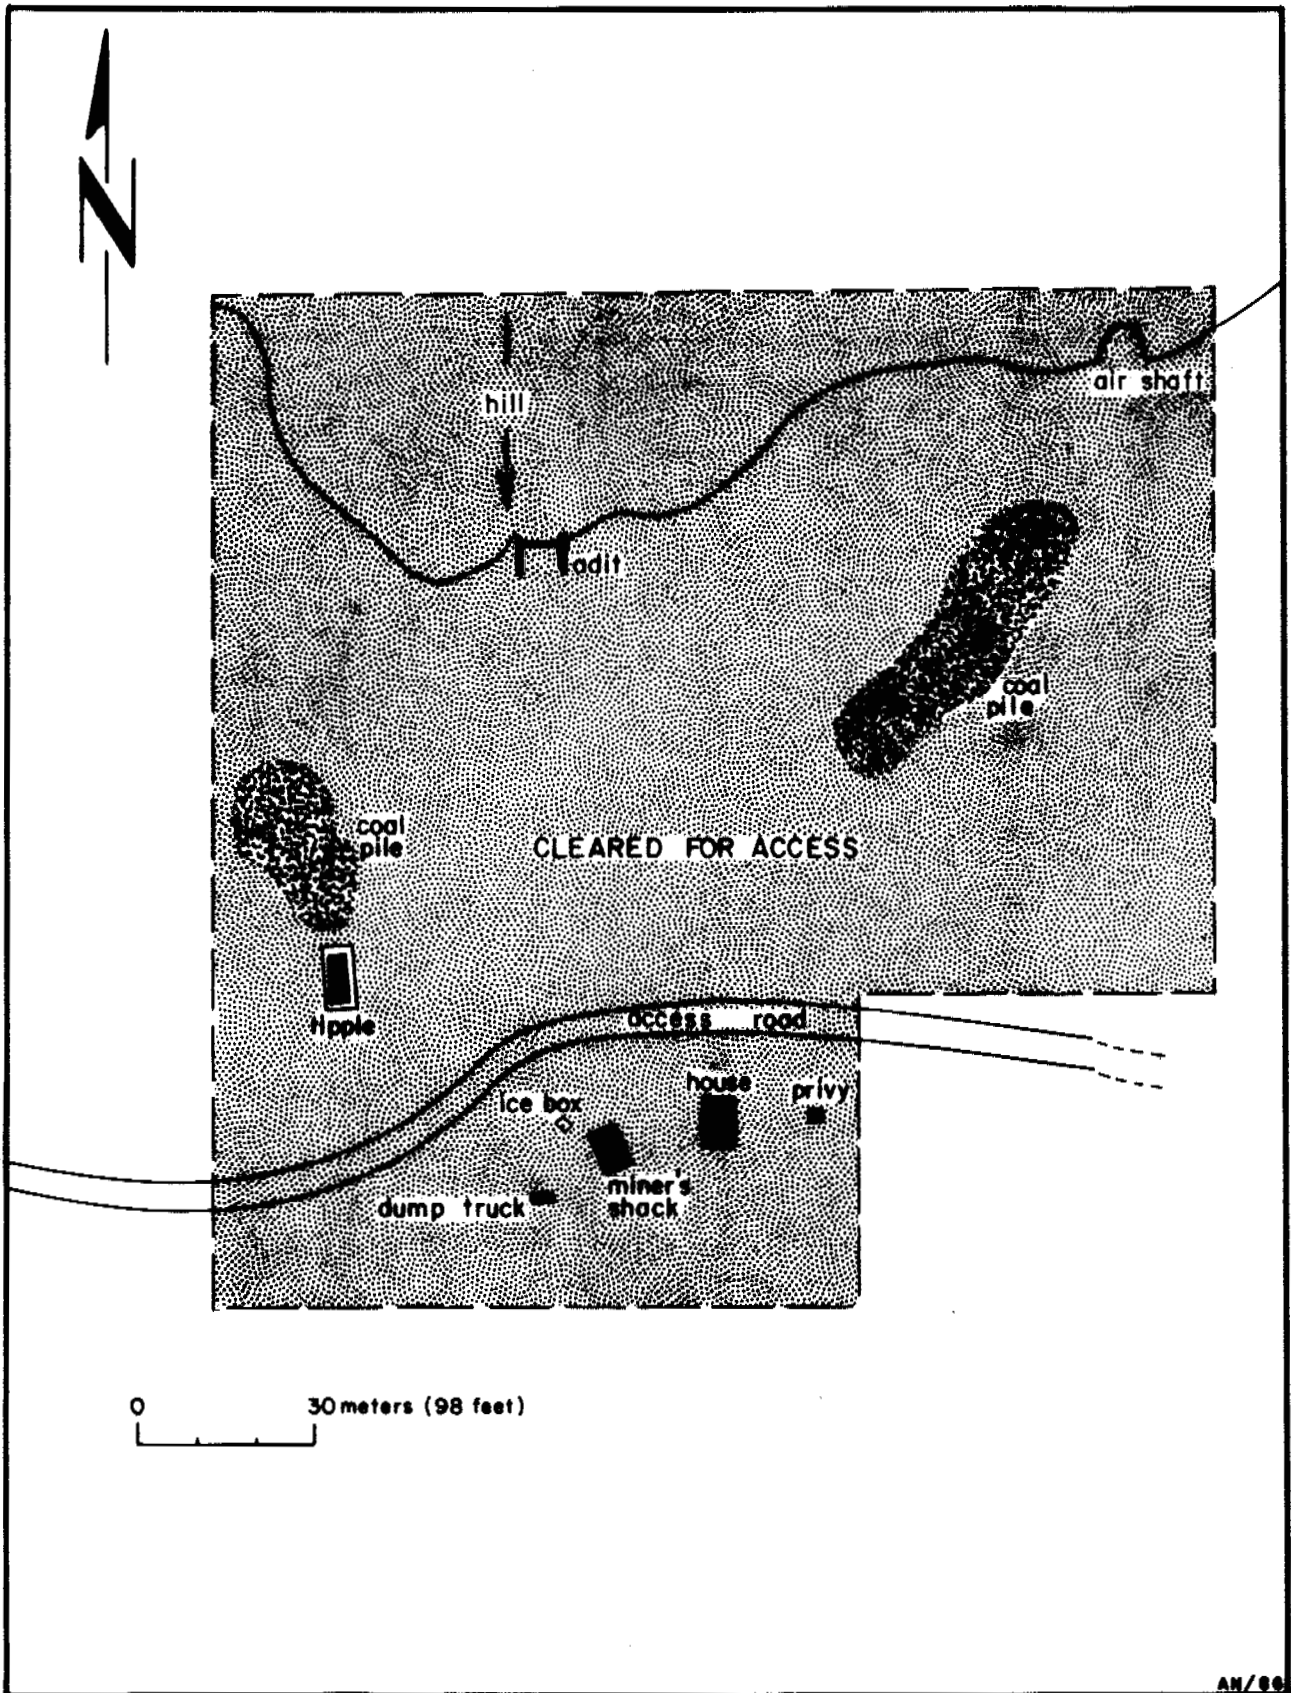
Figure 17. Plan view of Talbot Mine.

Description: The Talbot Mine consists of an adit, air shaft, a collapsed tibble, several residences, and a privy (Fig. 17). The adit is set within a small ravine at the base of a low rise (Fig. 18). It measures 1.4 by 1.1 m and has a timbered opening constructed from square beams which have been notched to receive the lintel. The adit has a log roof made from small poles. A locked metal gate extends across the adit opening. A dry-laid rock retaining wall extends 3.0 m out from the adit.

Three structures are located south of the dirt access road and are part of the mine operations. One is the residence of the former mine owner (Fig. 20). The building has completely collapsed. It had a board siding and a tin roof, presumably pitched. The foundation measures 8.0 by 5.0 m. Wire nails protrude from the loose boards lying on the ground. Immediately east of the residence is a still-standing privy measuring 1.5 square meters, with board siding and a pitched roof.

The remaining structure on the site is a former miner's shack. It is in complete disrepair and partially collapsed (Fig. 21). It is constructed of vertical boards covered with asphalt siding in a yellow brick design, and has a pitched roof of wood. Remains of a red brick chimney lay on the ground nearby along with an old refrigerator, metal wash tub, and a Model T dump truck with a wood frame. The building foundation measures 7.0 by 4.0 m. According to the present owner of the land, the miner's shack was moved to the site ca. 1940 from the former mining community of Brilliant.

The Abandoned Mine Land Bureau proposes to backfill or seal the entry to the adit. The air shaft will also be backfilled. With the landowner's permission, they propose to remove the remaining portions

of the tibble, mine owner's residence, and miners shack. The loose boards from the structures contain numerous protruding nails which, according to the landowner have injured cattle and wildlife. The privy will be left standing. Research Section archaeologists have archaeologically cleared the surrounding lands and access road for the entry of heavy equipment on the site.

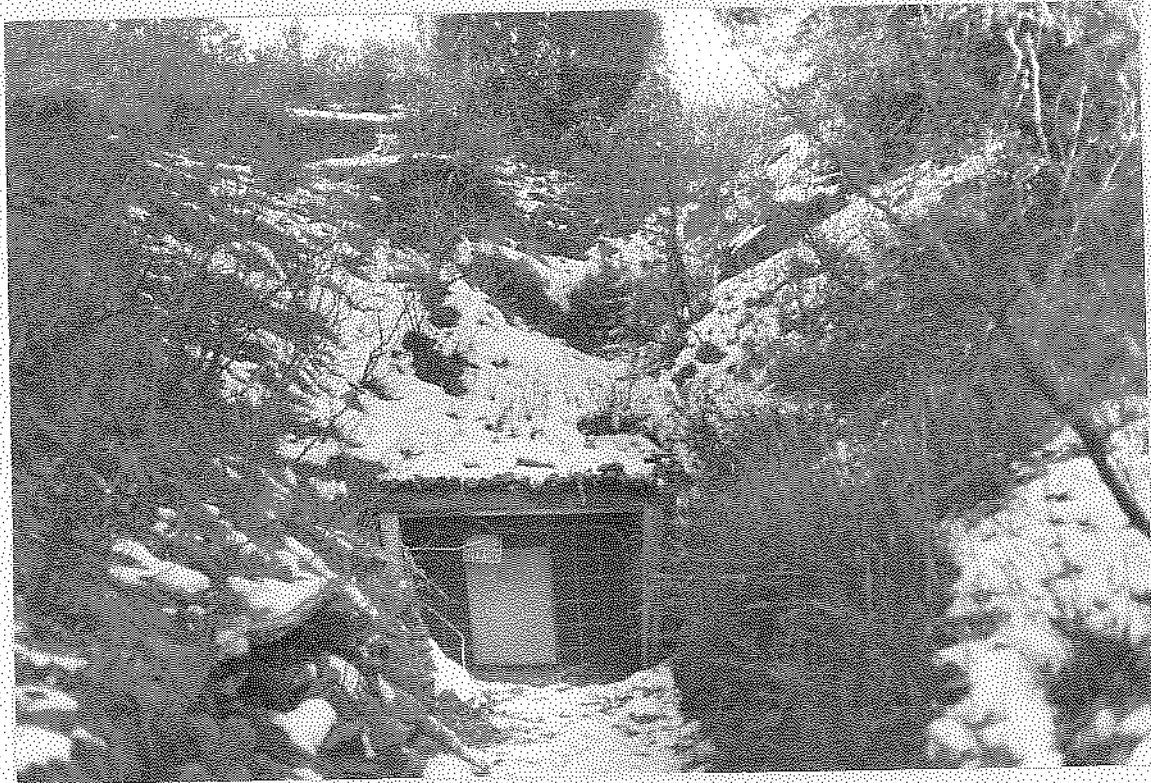
FIG. 18. Adit at Talbot Mine.

FIG. 19. Remains of tippie, Talbot Mine.

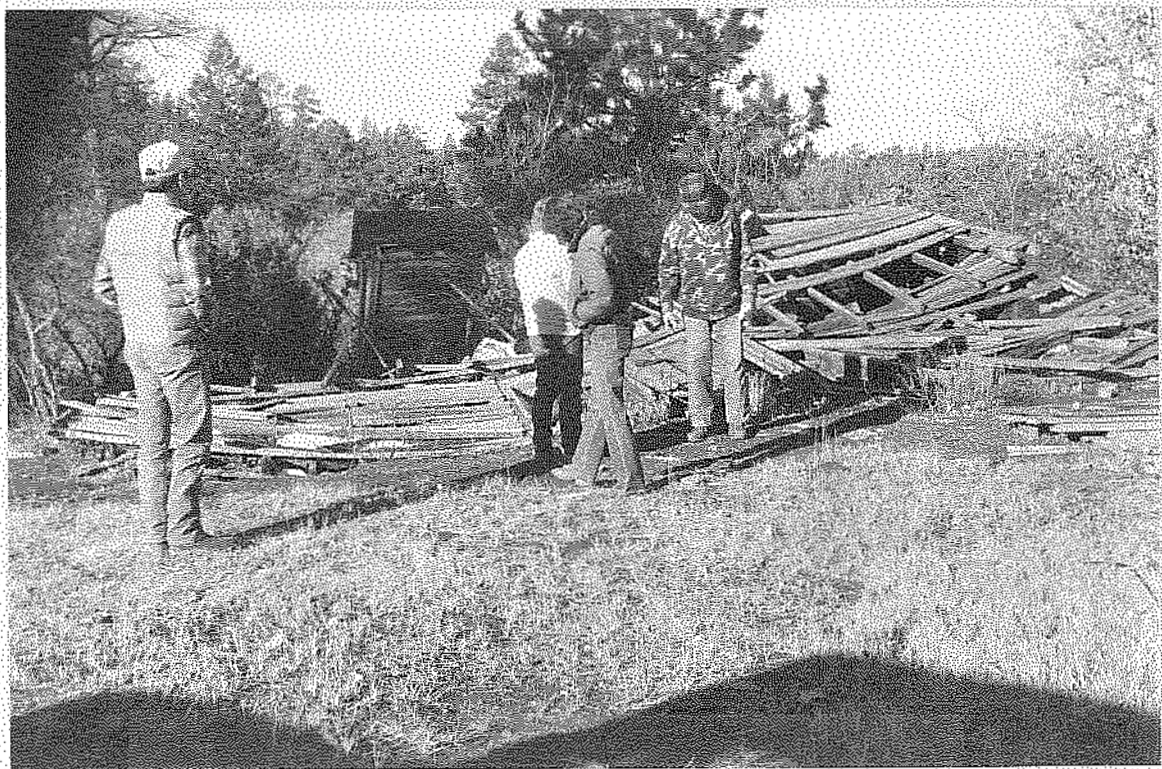
FIG. 20. Mine owner's residence, Talbot Mine.

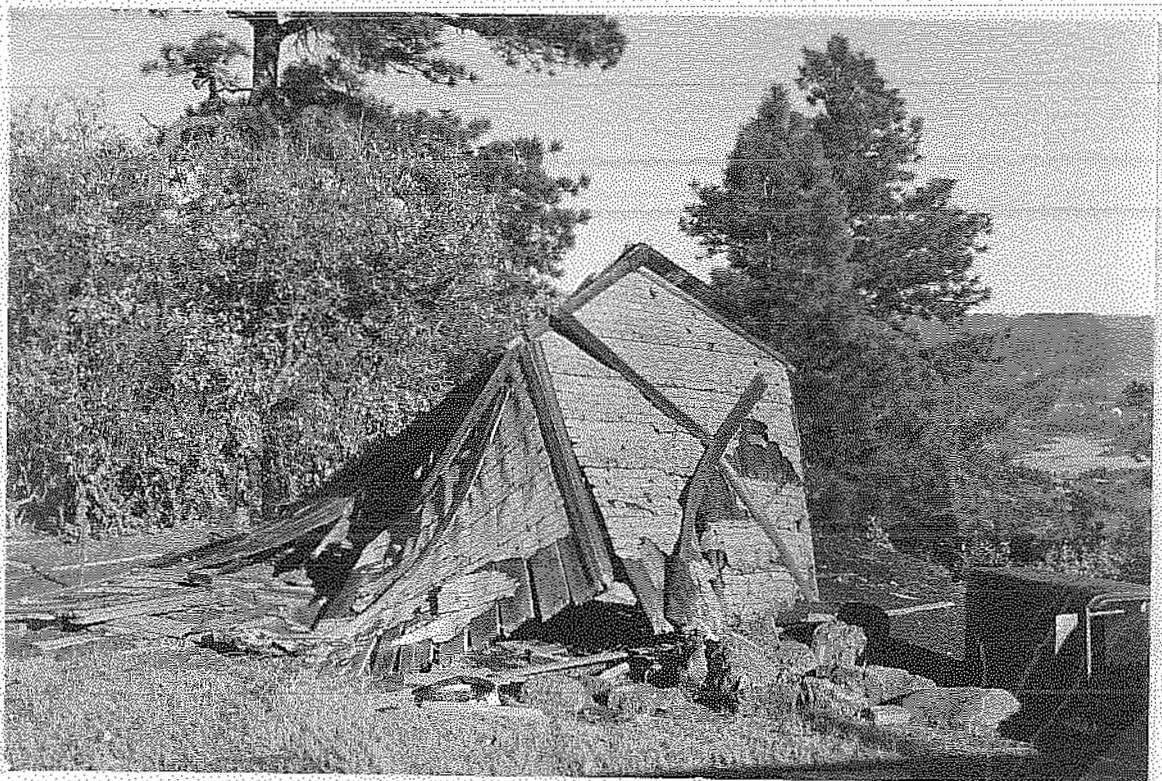
FIG. 21. Miners' shack, Talbot Mine.

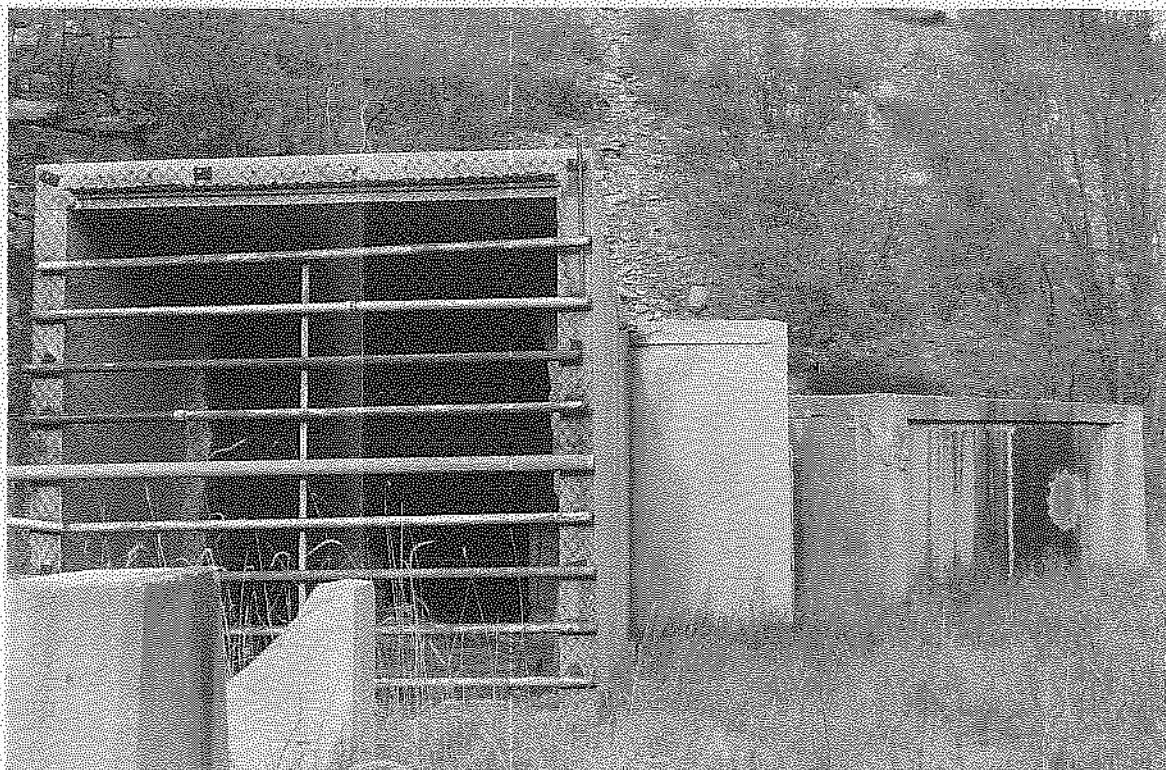
FIG. 23. Adit No. 1 and air course, Waldron Canyon.

FIG. 24. Adit No. 2, Waldron Canyon.

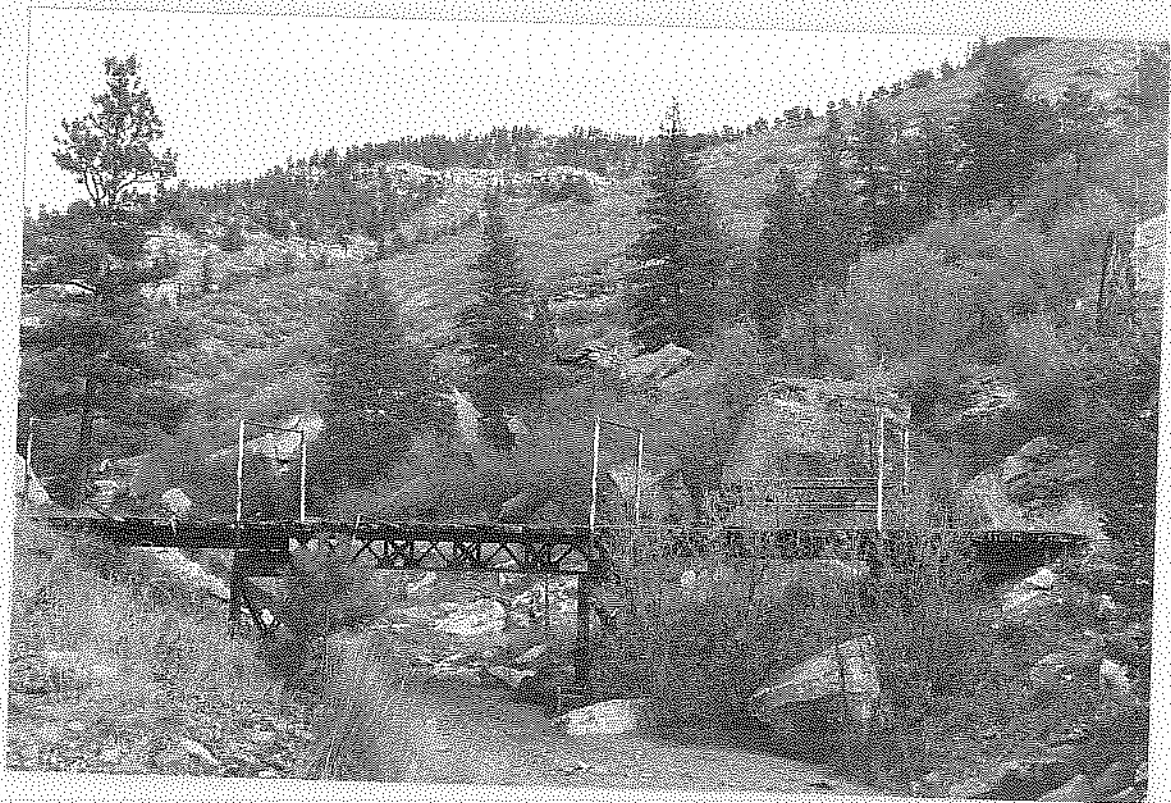
Approximately 0.3 km south of the adits are the remains of a railroad trestle which crosses the arroyo (Fig. 25 and 26). The bed is constructed of board planking placed over steel girders.

FIG. 25. Railroad trestle, Waldron Canyon.

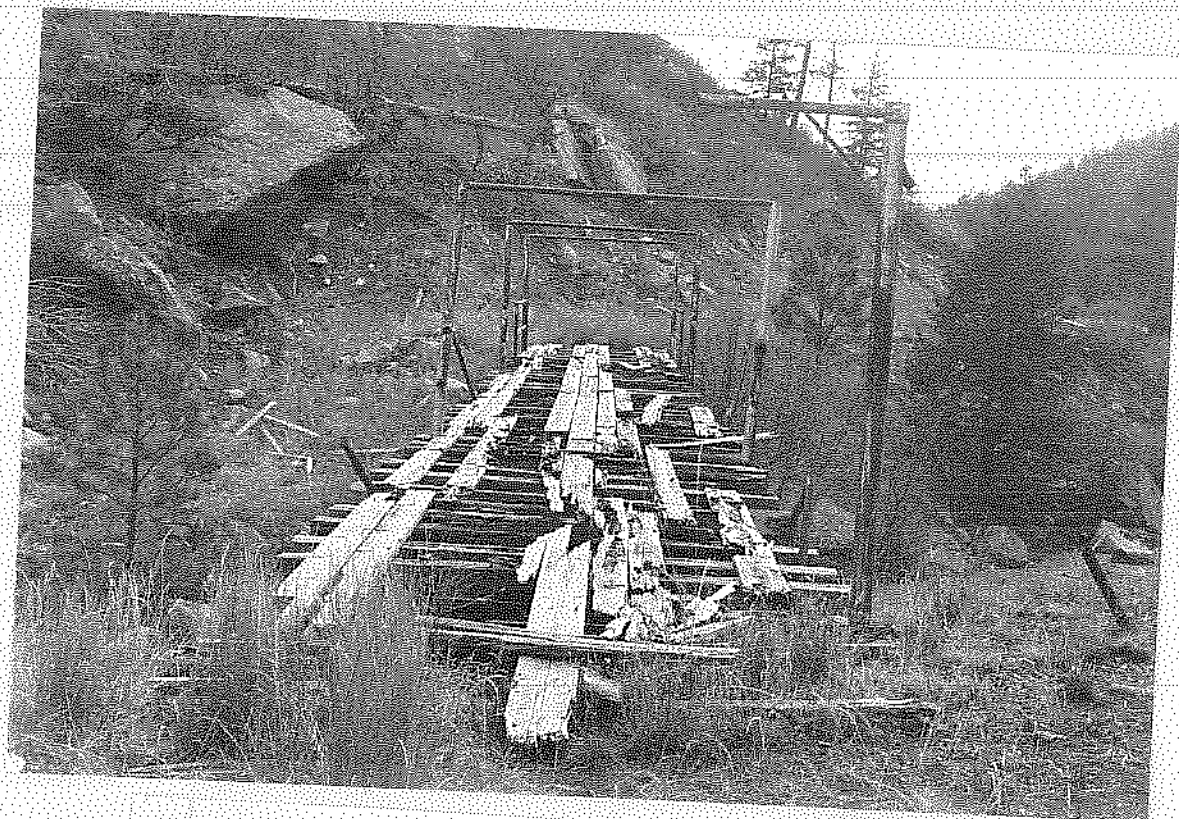
FIG. 26. Close-up of railroad trestle, Waldron Canyon.
