ARCHAEOLOGICAL SURVEY OF MINE LANDS IN THE
RATON COAL FIELD FOR THE
ABANDONED MINE LAND BUREAU

Yvonne R. Oakes

LABORATORY OF ANTHROPOLOGY NOTE NO. 386

1987

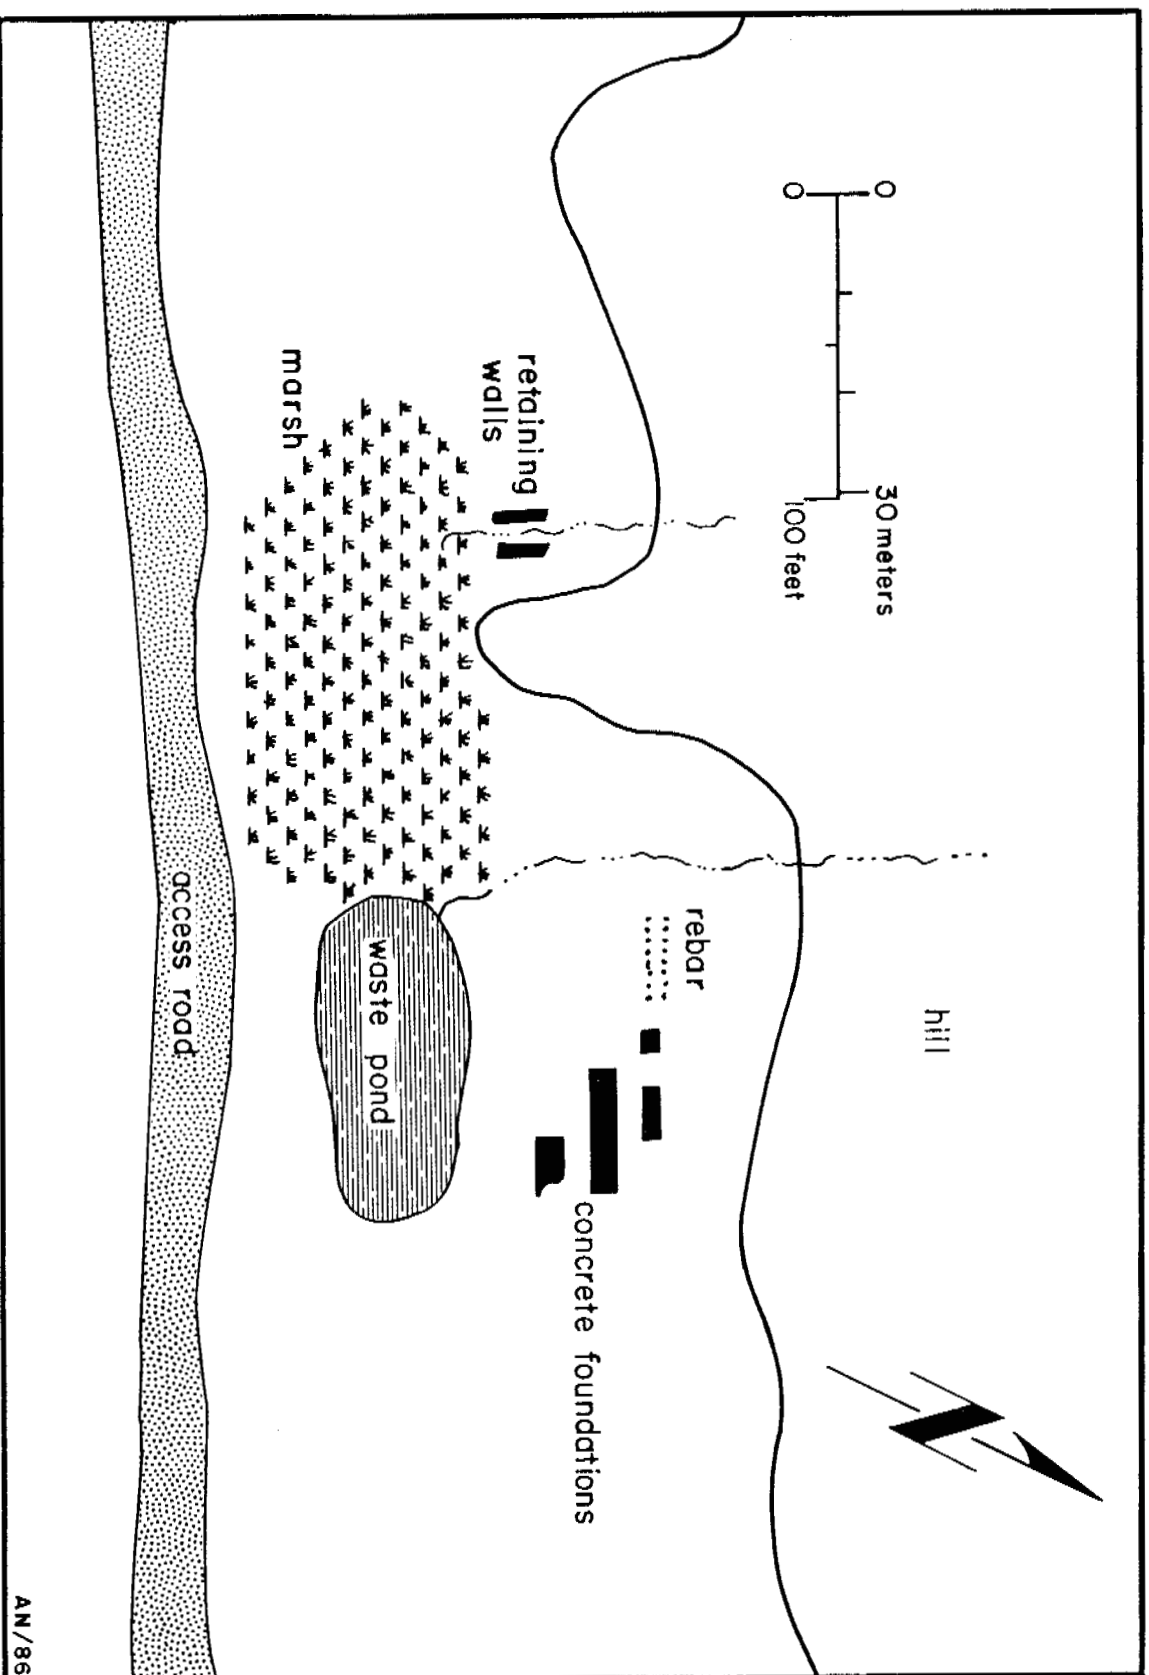
Figure 27. Waste pond and structures, Dutchman Mine.

Description: The site consists of the remains of a tram loading dock, several retaining walls, and a waste pond (Fig. 27). The sandstone and mortar foundations to the tram loading dock are reinforced with rebar and located at the base of a moderately steep hill and adjacent to a waste pond (Fig. 28). Measurements of the structure are 18.0 by 10.0 m. The soil around the structure is marshy and continually wet. No artifacts were found near the structures. The waste pond measures 25.0 by 12.0 m and is acidic.

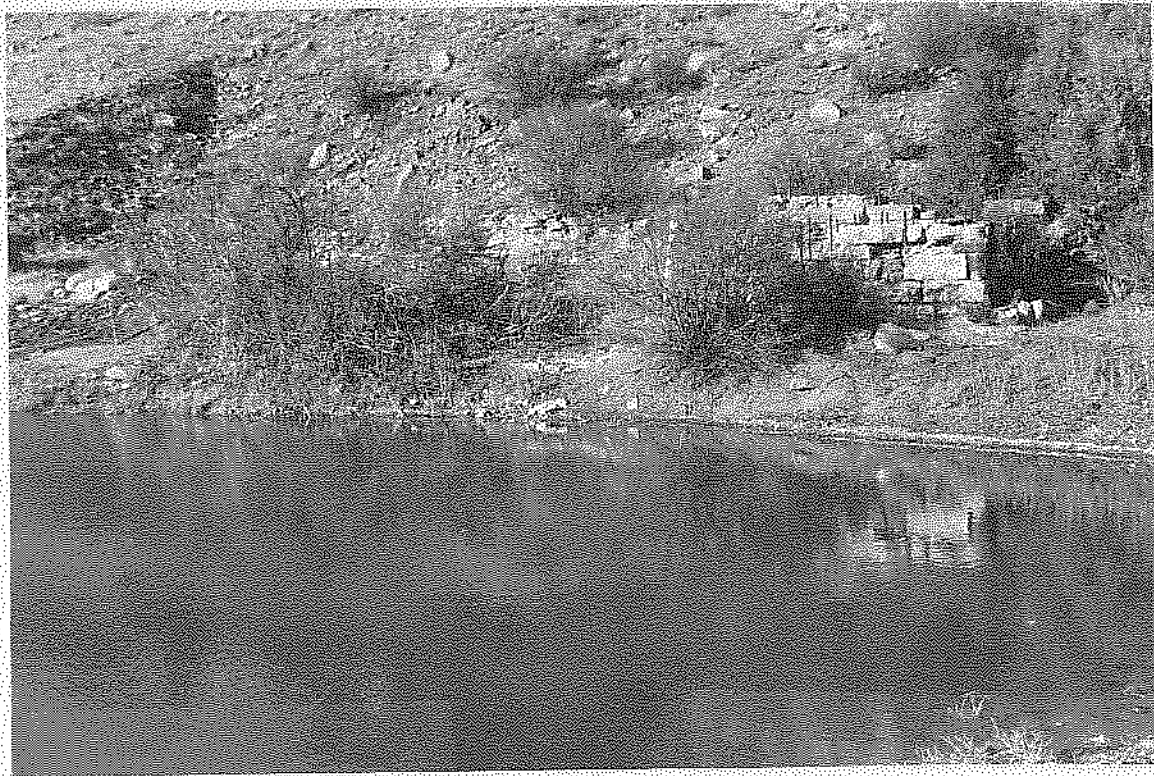
FIG. 28. Waste pond and structure at Dutchman Mine.

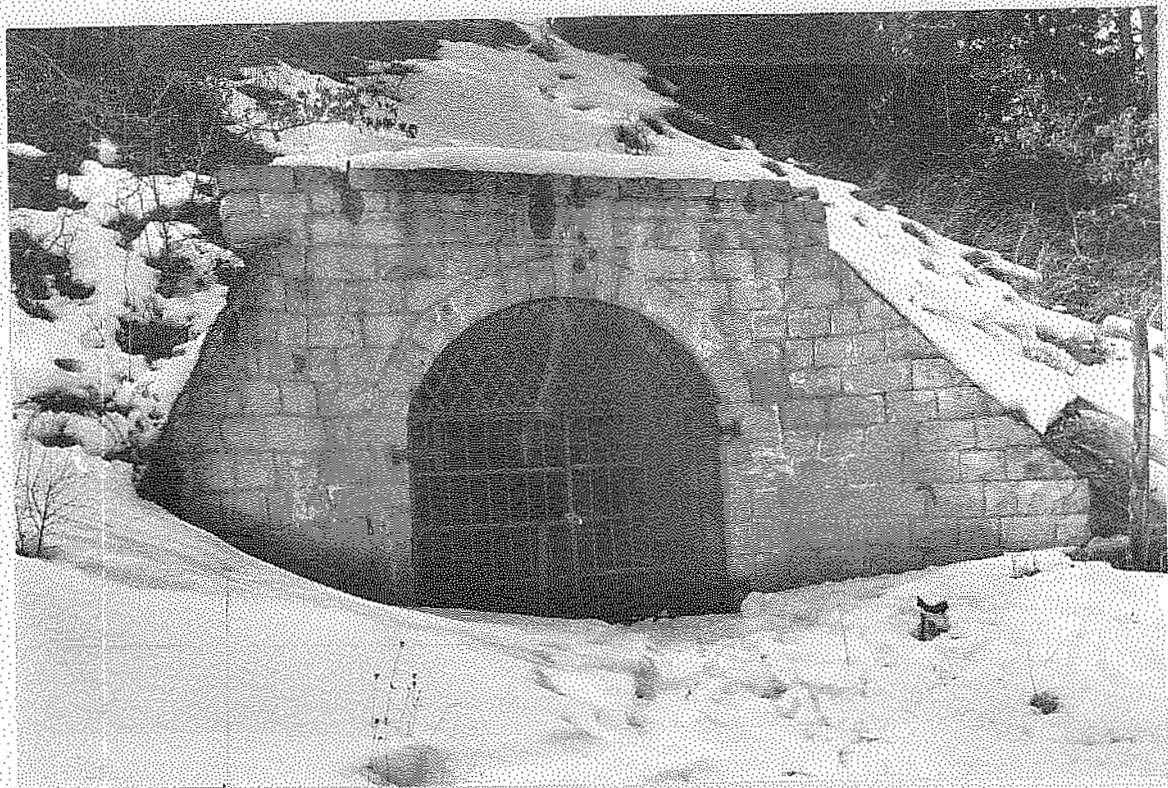
The adit is 30 m west of RR 34 gob pile. It sits against the hillslope, facing northeast (Fig. 34). It is a masonry adit with a rounded arch opening 4.0 m wide and 5.75 m high. The adit was in use from ca. 1902 up to 1954. Interior of the opening is vaulted stone. A heavy locked iron gate closes the entry, and mortar retaining walls extend 3 m out from the opening. "Adit 02" is seen in metal figures above the entry. A dirt road leads to the adit opening.

FIG. 33. Van Houten cistern, facing north.

FIG. 34. Adit RR 2, Van Houten.

The Abandoned Mine Land Bureau proposes to backfill the cistern from local stockpiles which they will dredge. The cistern has no standing walls and poses a hazard to wildlife and National Rifle Association members. The open field and a 35.0 by 35.0 m area around the cistern have been cleared for access by the archaeologists.

Fifteen meters east of the adit is a small cinderblock structure 4.6 by 4.6 m with a shed roof. It has two side window frames and a wood-frame entry. It sits 5.0 m south of the road. The abandoned Mine Land Bureau proposes to install a masonry seal, instead of the metal gate, across the opening to the adit to prevent entry by passersby and wildlife.

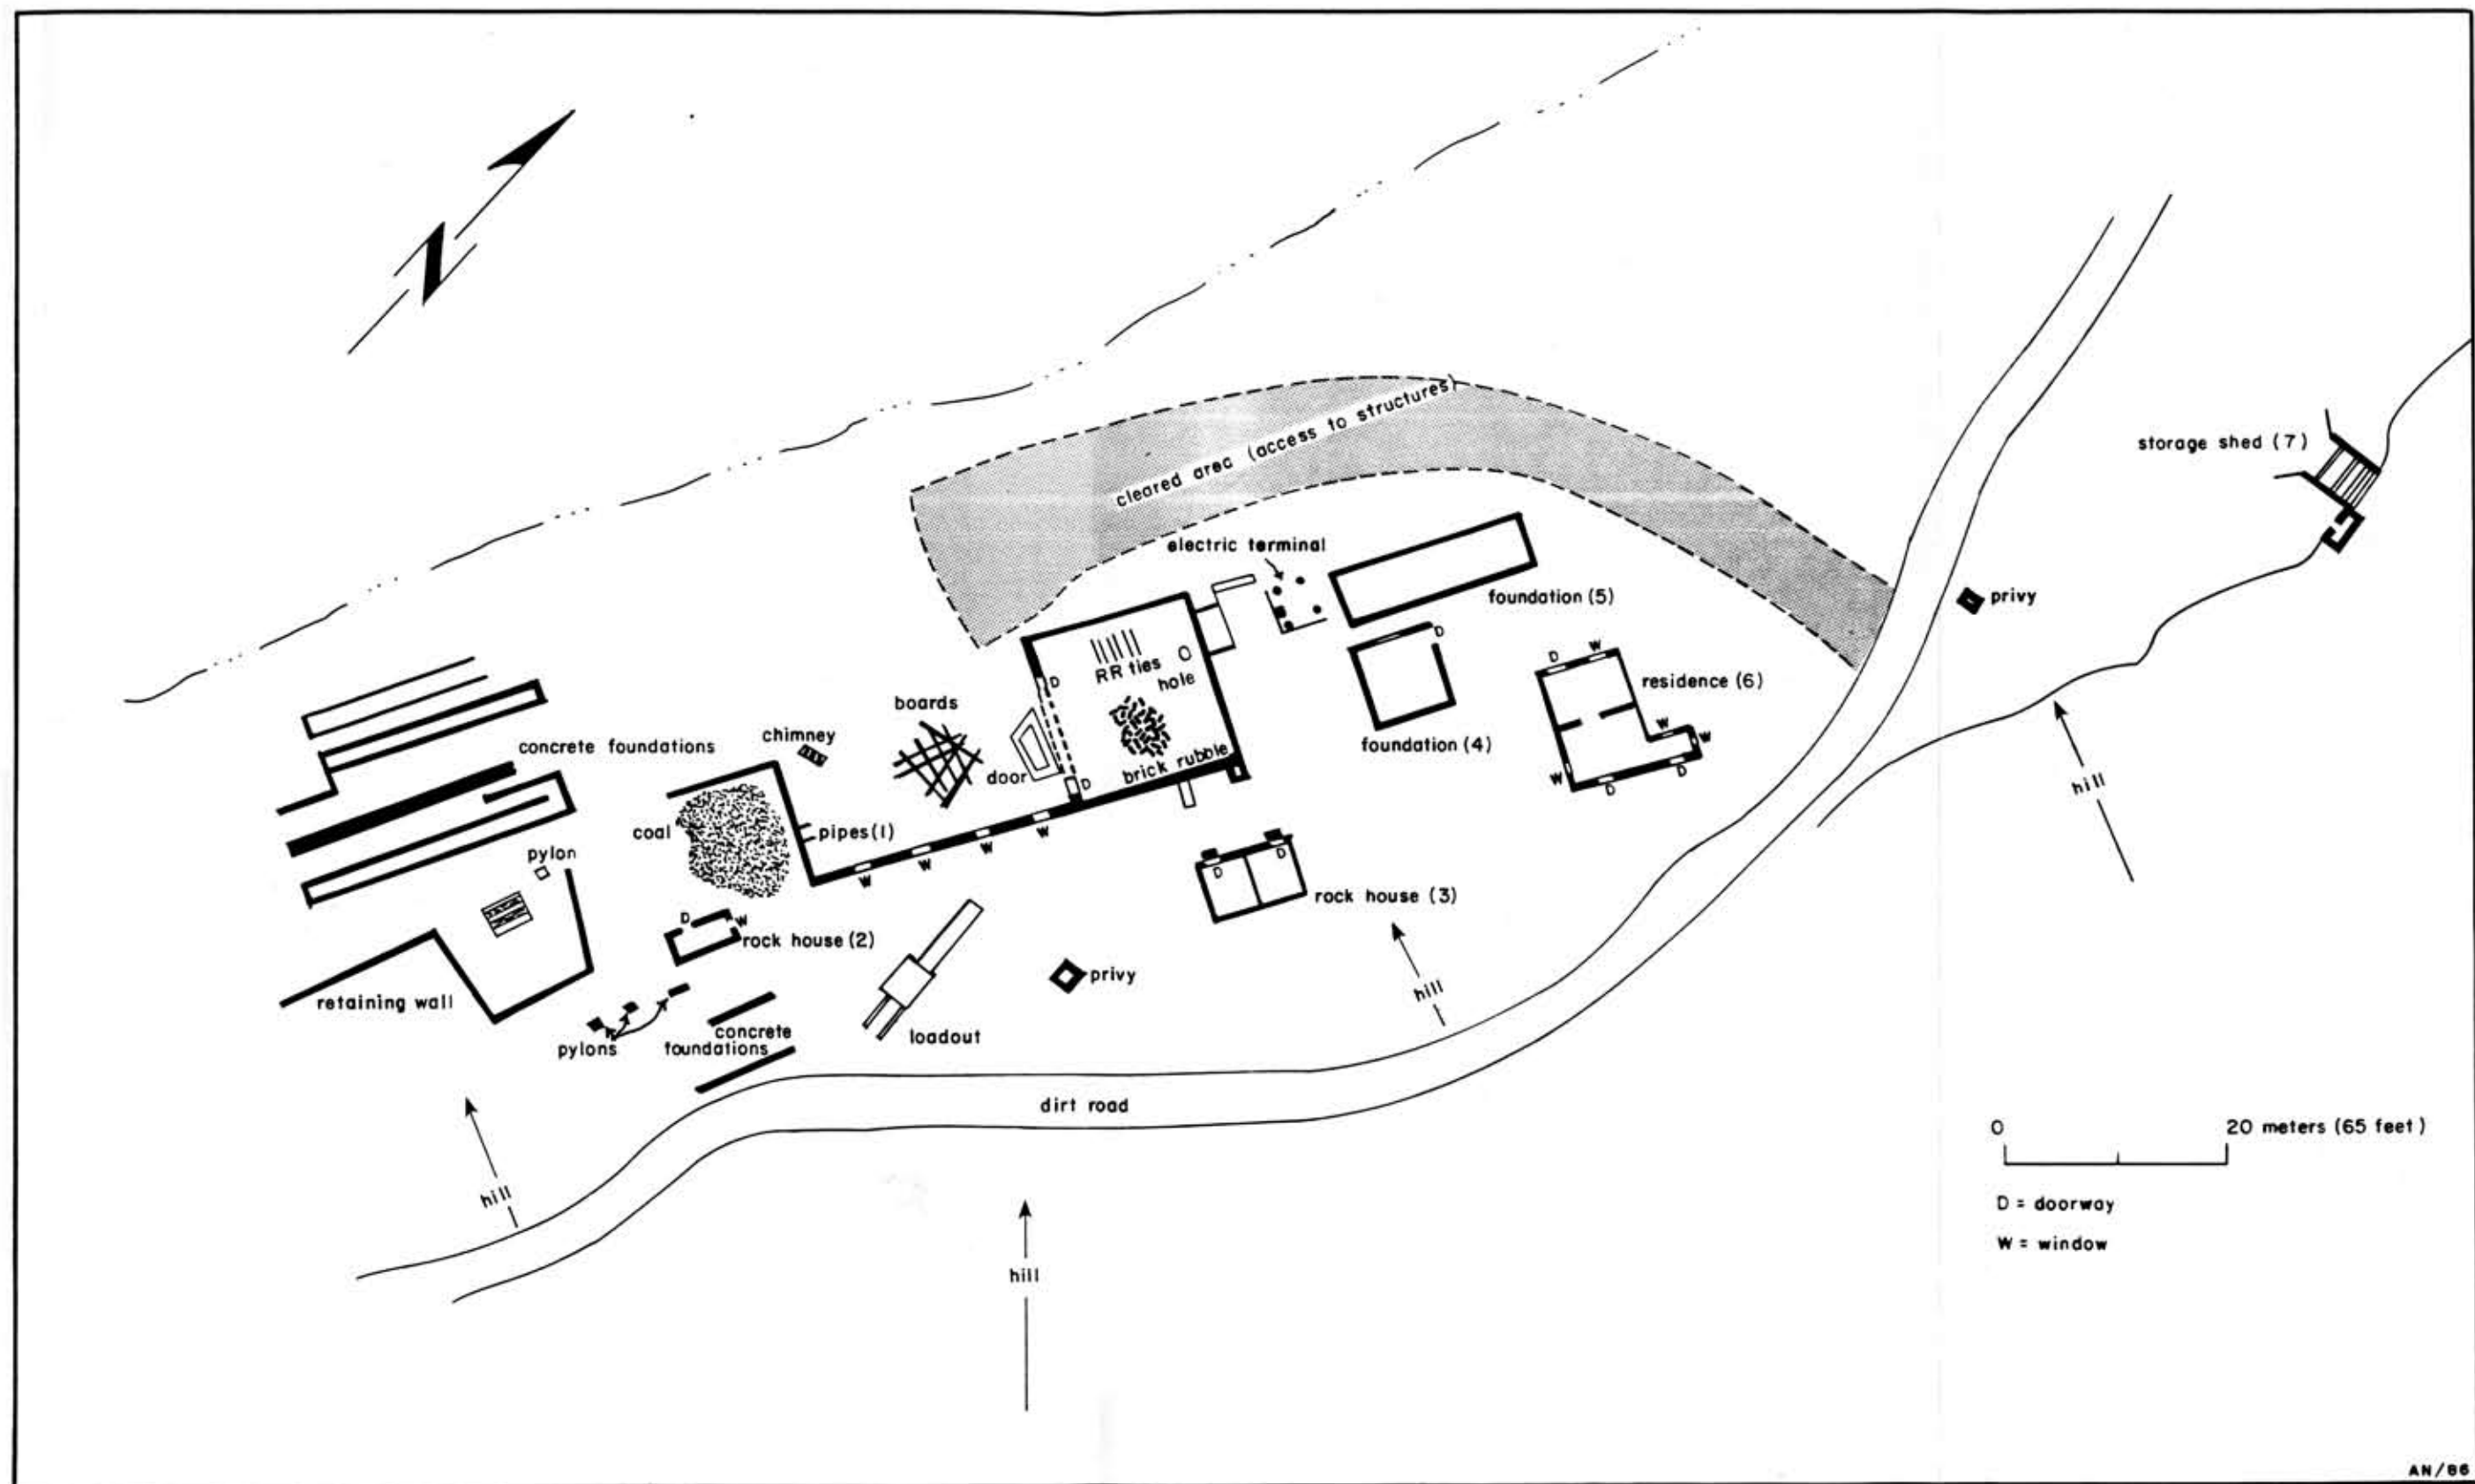
A complex of mining structures and residences are situated at a wide spot in Van Houten Canyon (Fig. 35). A wood frame load-out is immediately adjacent to the access road (Fig. 36). It is constructed of 2 by 8 inch timbers that are fastened together with heavy bolts. Several of the timbers are loose. The load-out stands ca. 10.0 m high and extends 12.0 m downslope. It sits on 3 rock and mortar supports. A 4.0 by 3.0 m platform with collapsed side rails remains on top of the load-out and is accessible from the slope against which it stands. The 2.0 by 2.0 m wide chute is lined on its sides with sheets of tin and is floored with corrugated tin. Ten meters east of the load-out is a collapsed privy.

Figure 35. Plan view of RR 13, mining complex.

FIG. 36. Load-out at RR 33.

The Abandoned Mine Land Bureau proposes to dismantle the load-out because of its loose timbers and easy access to the collapsing platform by curious National Rifle Association members. (Last year 10,000 persons had access to the area for recreational purposes). All work will take place adjacent to the existing dirt road.

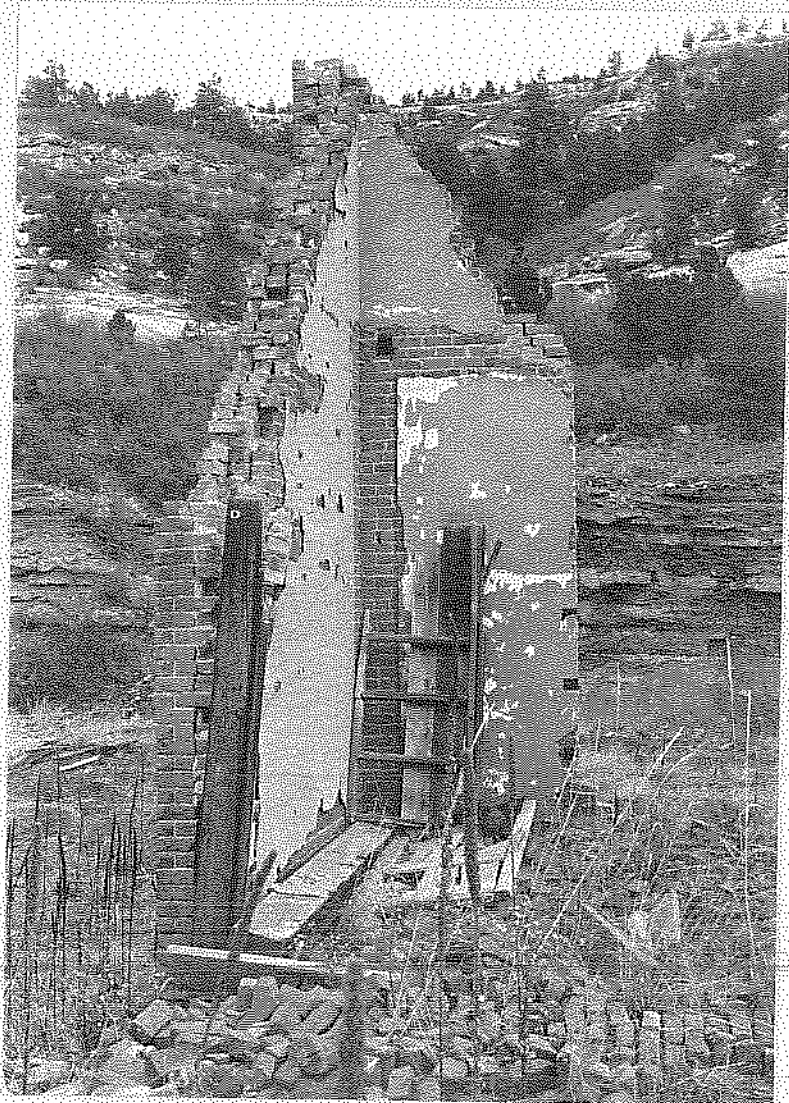
FIG. 38. Standing brick wall of screening plant.

FIG. 39. Structure No. 2 at RR 33.

The Abandoned Mine Land Bureau also proposes to remove the 9.0 m high standing corner of the brick screening plant (Fig. 38). Collapse of the corner is imminent and presents a hazard to persons walking through the ruins. Access to the corner is by an old dirt route at the east end of the complex and across an open field. This area was cleared by the archaeologist (Fig. 35).

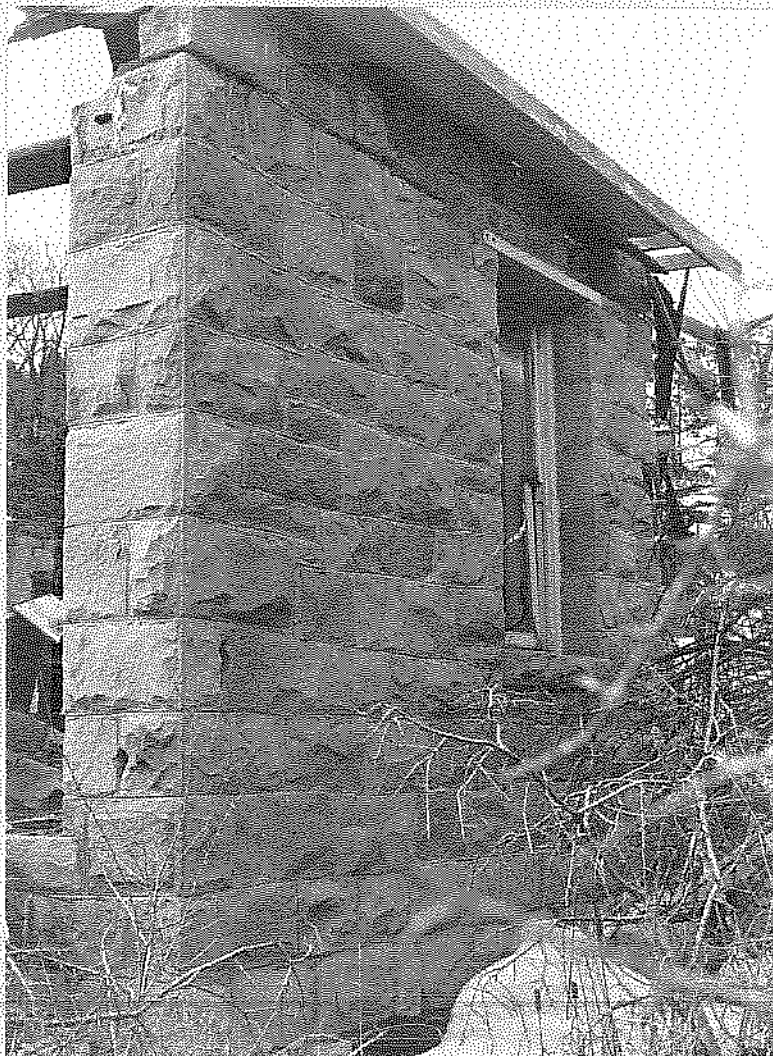
Structure #4 is an 8.0 by 8.0 m foundation with a portion of standing walls 6.0 m in height. White plaster is visible on the interior of the walls. A shingled roof covered with green asphalt sheets has collapsed into the interior. One double-hung window remains in the northwest end. A wood eave remains on this end of the structure (Fig. 40).

Structure #6 sits at the east end of the mining complex. It appears to have served as a two-room residence (Fig. 41). It is L-shaped with the main area measuring 12.0 by 8.0 m. The roof is pitched and is made of wood shingles covered with green asphalt. The side addition has a shed roof. A portion of brick chimney remains on the pitched roof. The building is constructed of wood framing overlaid with gray concrete stucco. The flat ceiling has wood slats. Plaster on the interior walls is cream-colored. Wood plank flooring remains but is fragile.

FIG. 40. Structure No. 4
with eave at RR 33.

FIG. 41. Structure No. 6, a residence at
RR 33.

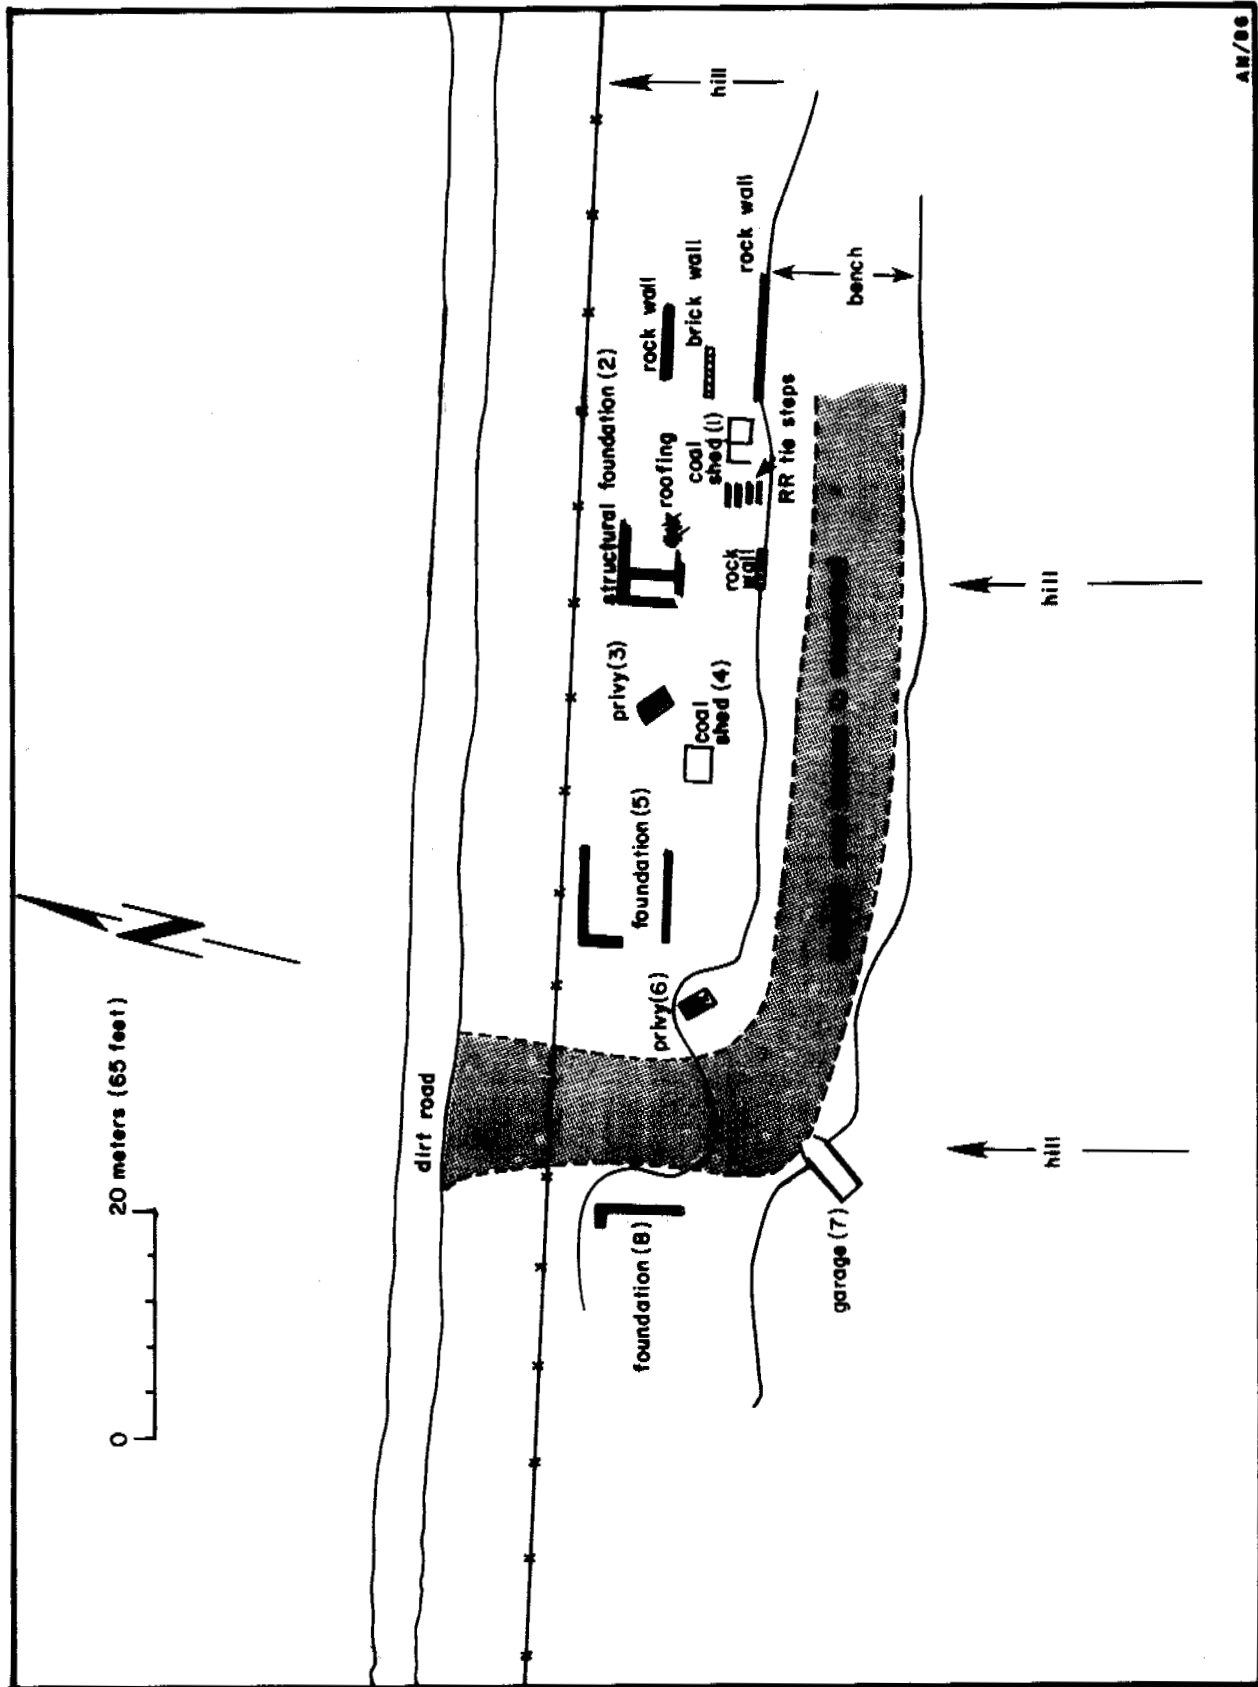
Figure 42. Plan view of RR 35, residential complex.

A small residential area is located directly north of the canyon access road situated at the base of a hill (Fig. 42). A fallen barbed wire fence separates the structures from the road. Many loose boards and metal debris cover the area. There are some fragments of aqua glass around the structures. No trash areas were found. Structures #1 and #4 appear to be coal sheds constructed of wood boards, each measuring 2.2 by 2.0 m and 1.3 m high with shed roofs. West of structure #1 is a rock retaining wall with another rock and brick wall south of it suggesting a structural foundation.

Structure #2 consists of a rock foundation measuring 8.0 by 6.2 m. It is divided into two rooms and was probable a residence. A collapsed board roof with green asphalt covers a portion of the foundation. To the east is a collapsed privy (Structure #4). Remains of a pitched roof covered with tin lie on the ground.

Structure #5 is a rock foundation partially eroded away. No interior features are visible. Another privy (Structure #6) is northeast of the structure. It also has collapsed. Northeast of the privy, against the hill, is a garage-like building (Structure #7) of wood board measuring 5.6 by 3.0 m by 2.5 m high (Fig. 43). A few 2 by

The Abandoned Mine Land Bureau proposes to mechanically remove several of the collapsed structures at the site. Specifically, the two privies (Structures #3 and #6) and the possible garage (Structure #7) may be torn down in order to remove the numerous boards with protruding round nails from the area. Access to these structures has been archaeologically cleared (Fig. 42) through a 10.0 m wide path between them.

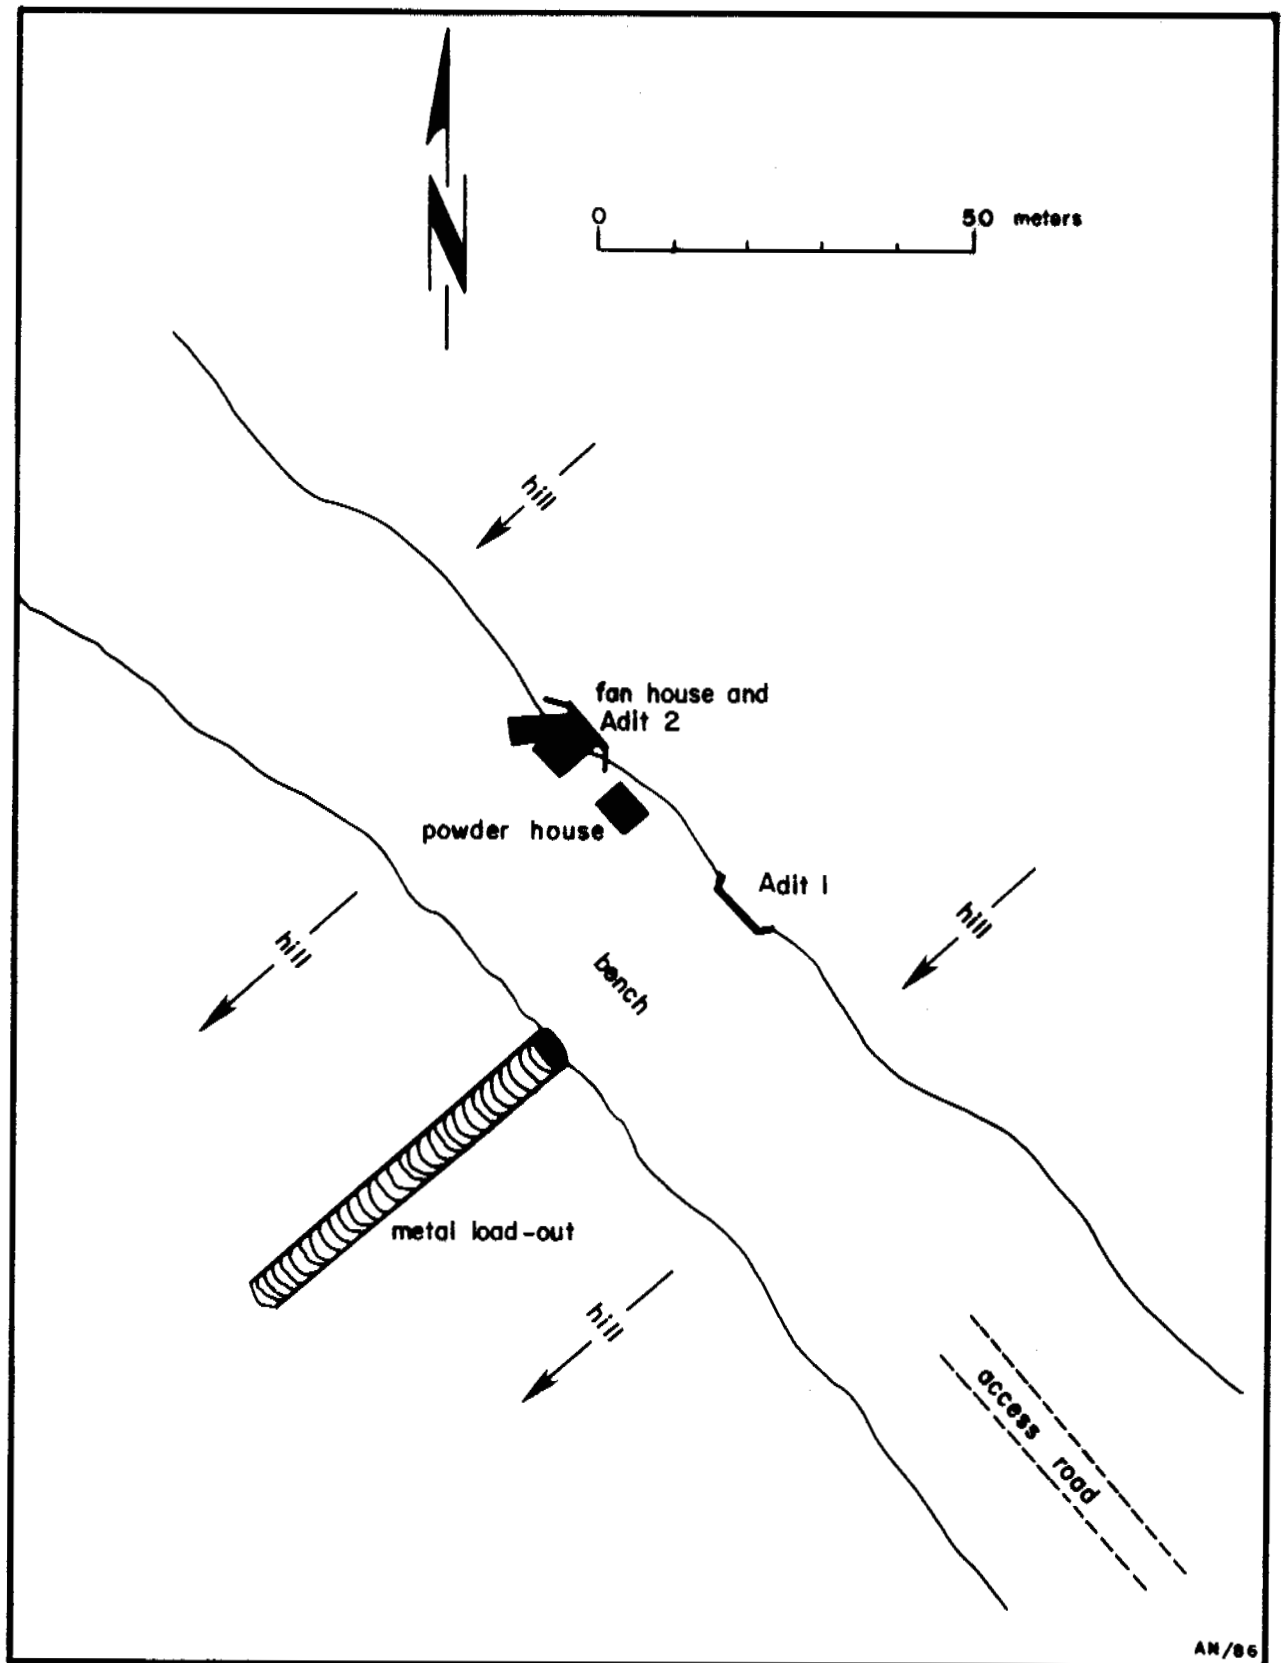
Figure 44. Plan view of Ox Canyon Mine.

Description: The Ox Canyon Mine is located on a bench on the slope of a steep hill reached by a single-lane dirt road. The site consists of two open adits, a power line, and a load-out (Fig. 44). Adit #1 is framed with steel beams. Notched timbered posts extend at least 30.0 m into the mine opening (Fig. 45). The entrance measures 6.0 m by 1.0 m. Thirty meters in front of Adit #1 on the edge of the bench is an opening to a load-out made of steel pipe, 1.2 m in diameter, which extends ca. 50.0 m downslope.

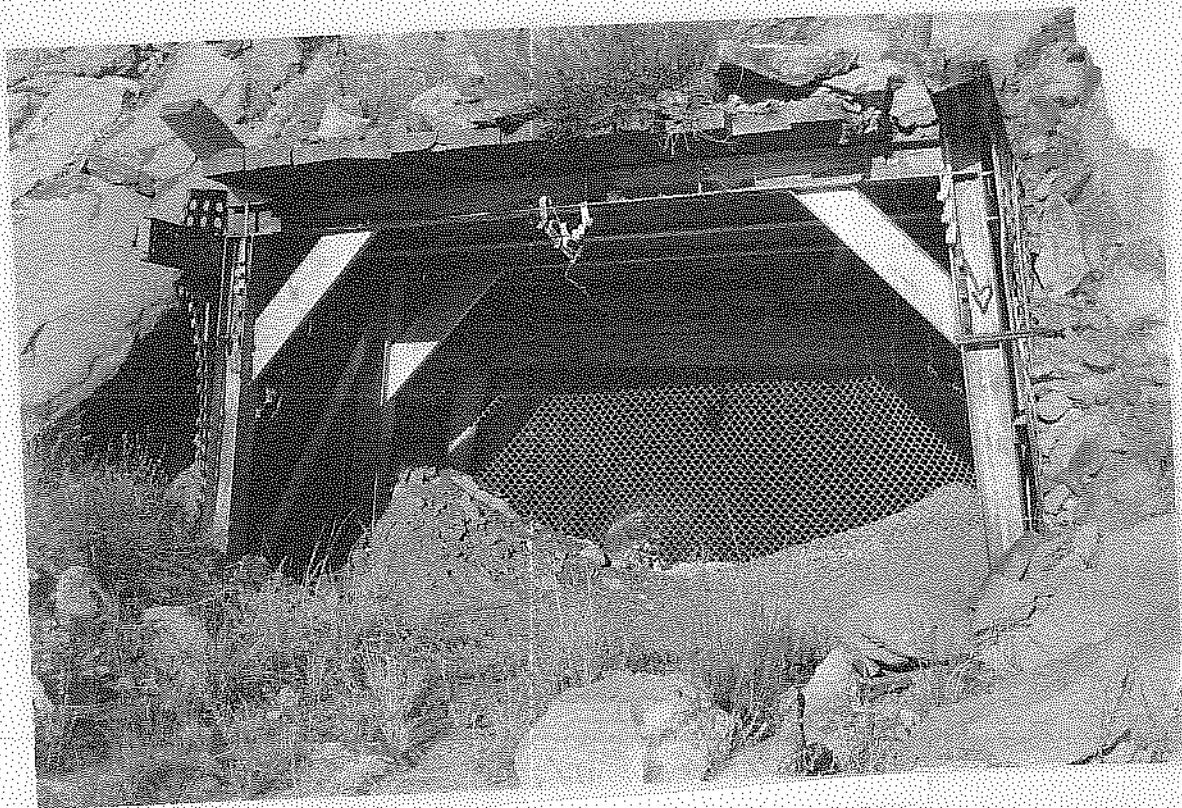
FIG. 45. Adit No. 2, Ox Canyon Mine.

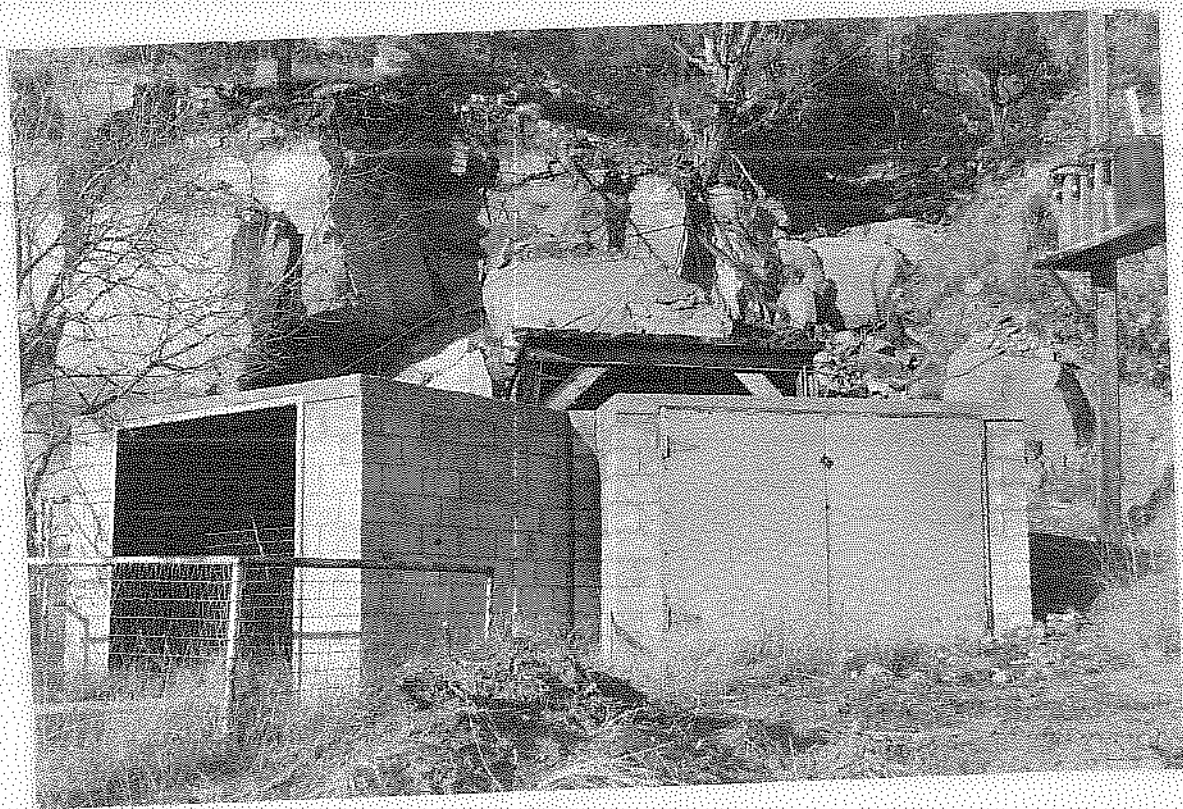
FIG. 46. Adit No. 1 and fan house, Ox Canyon Mine.
