**ELECTROMAGNETIC TERRAIN
 CONDUCTIVITY MAPPING:
 OKANAGAN UNIVERSITY COLLEGE,
 KELOWNA, B.C.**

October 1999

992-1897

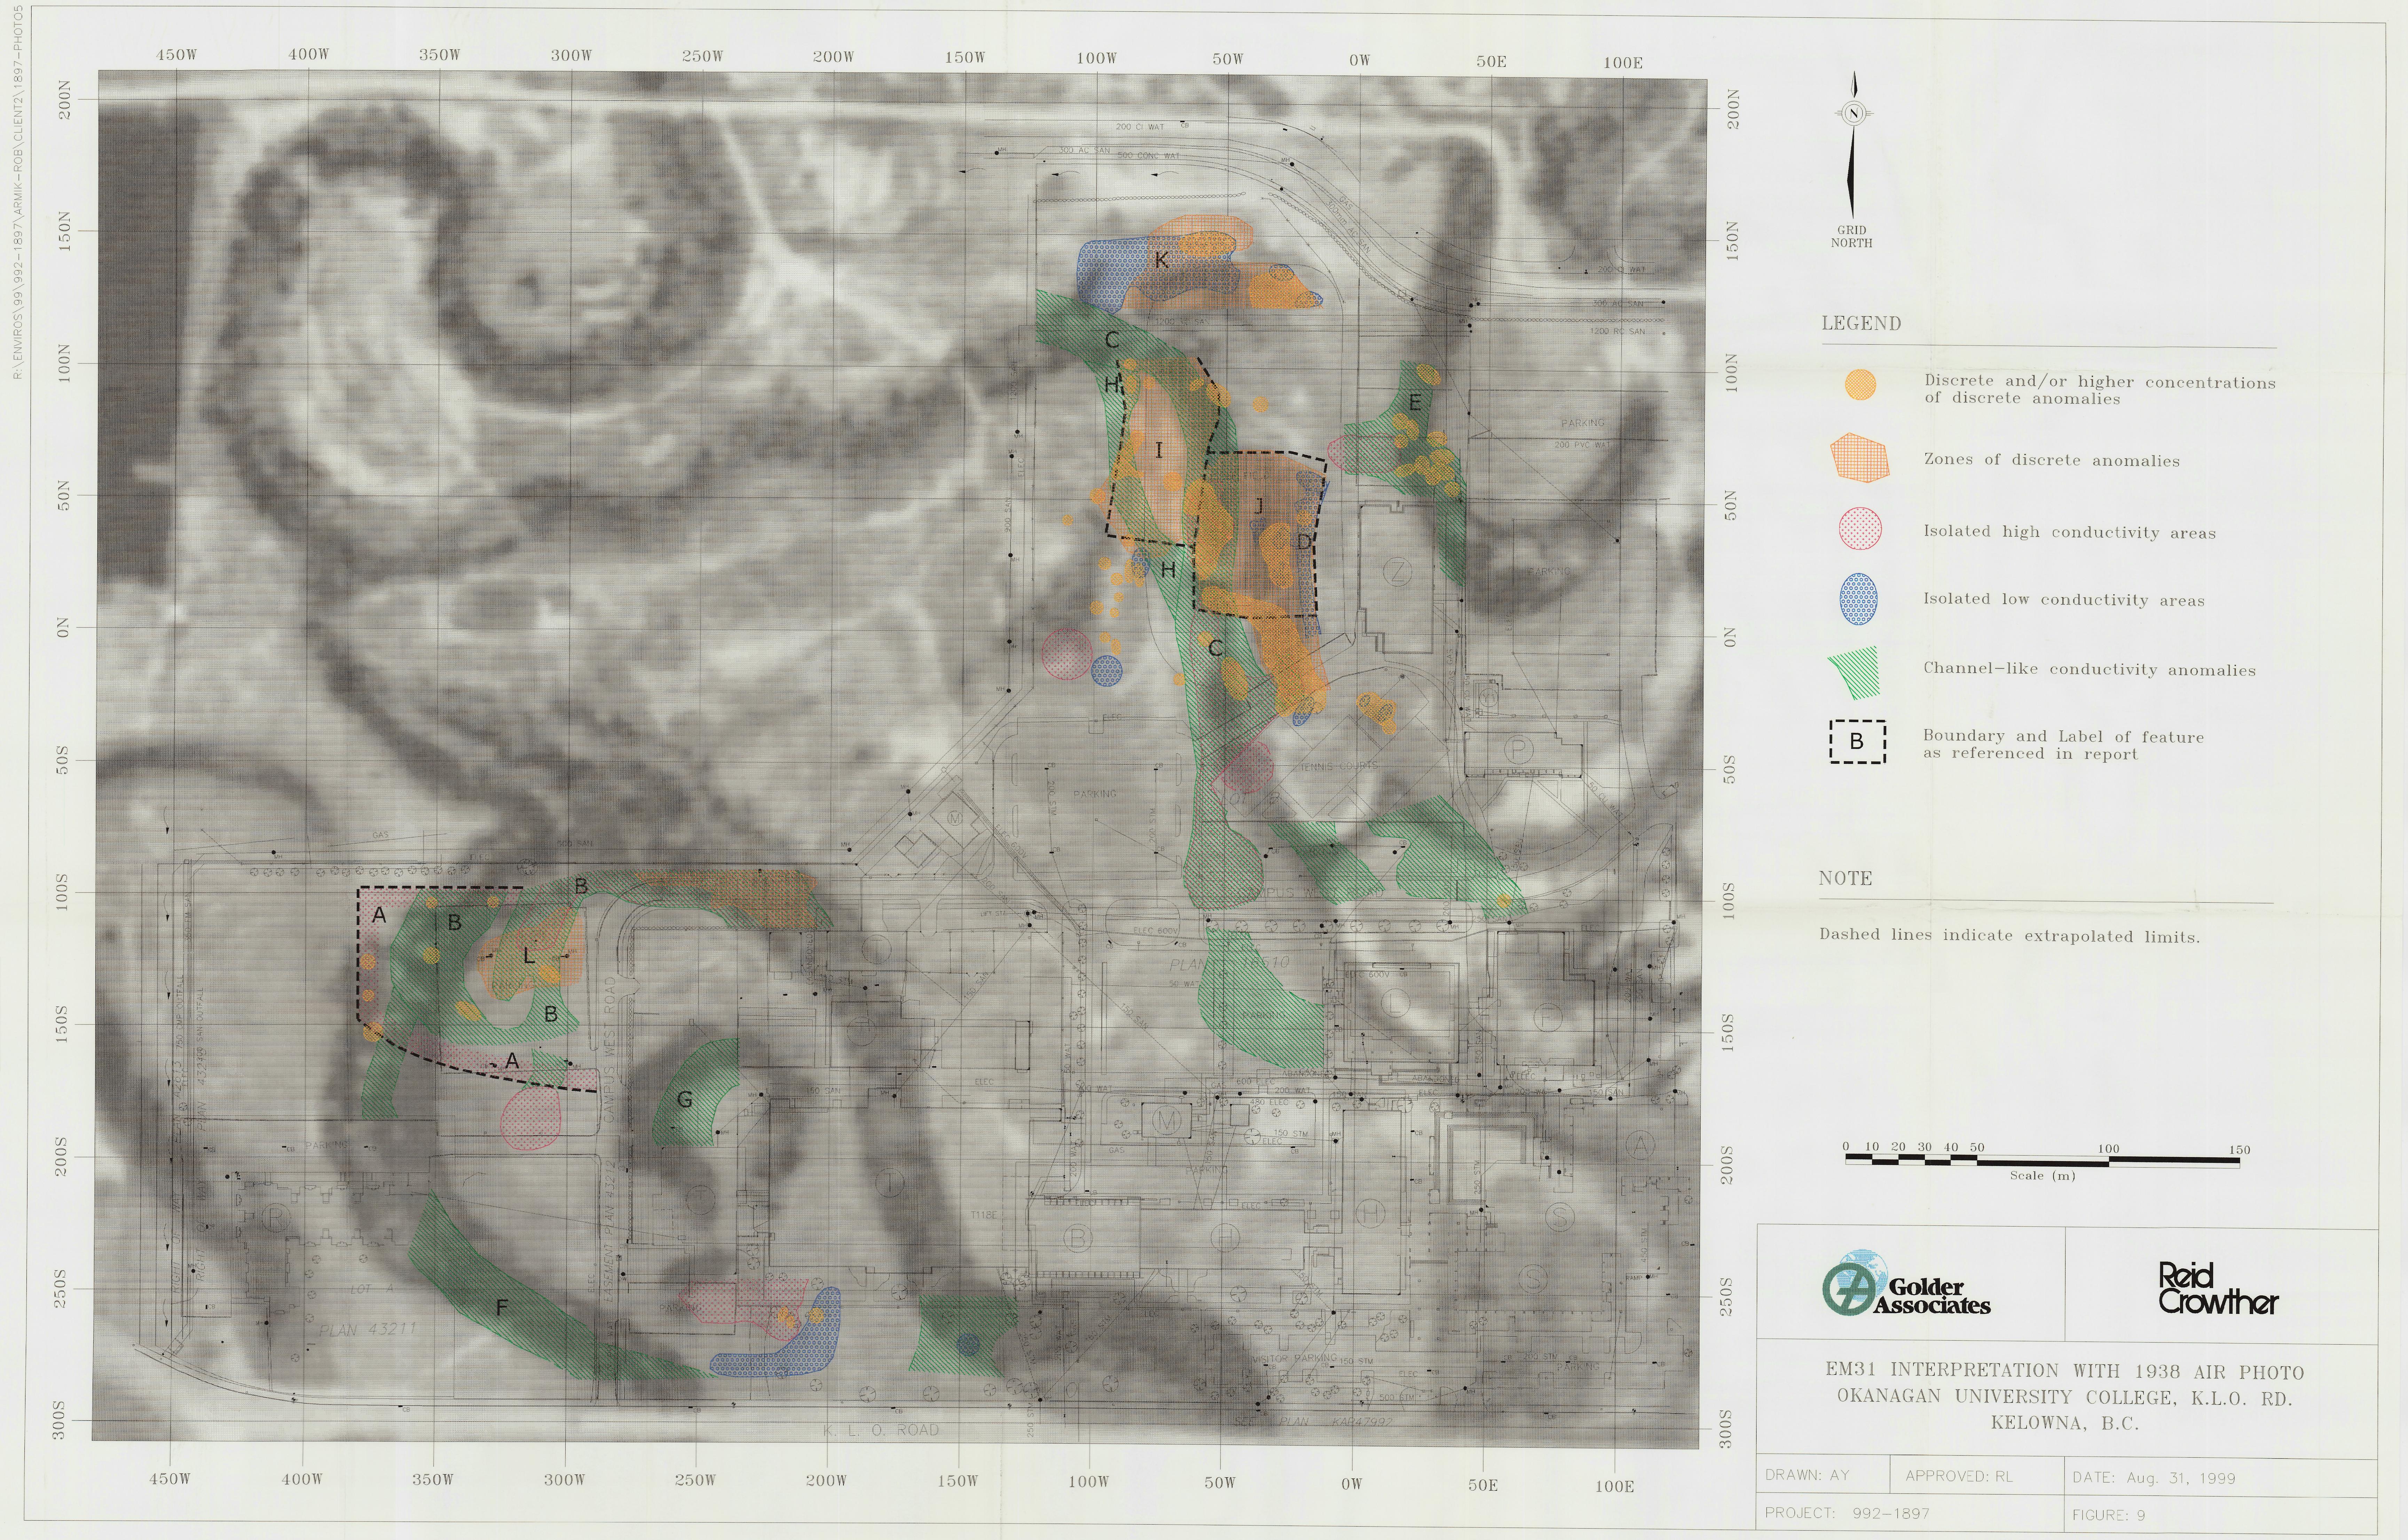
DRAWN: AY	APPROVED: RL	DATE: Aug. 31, 1999
PROJECT: 992-1897		FIGURE: 8

Note that the interpretation legend in Figure 8 consists of conductivity and in-phase anomalies which include zone features, channel-like features, and isolated targets. To aid in explaining the legend some examples are noted here while a more detailed discussion of particular features follows. An example of a region or zone feature is the extensive region of abruptly higher conductivity (above 24 mS/m within Feature A), north of the residence building (Building R), which encompasses some examples of channel-like features of even higher conductivity (greater than 30 mS/m in Feature B). This example, and others of extensive zones of buried metal, indicates that some areas exist where landfill debris were not restricted to the oxbow channels. In some areas the boundaries of the channel-like features are not well defined, such as west of the library (Building L) where the boundaries are dashed, due to interference from infrastructure such as buildings, chain-link fences, and buried services, or due to limited coverage. Of primary importance, the interpretation map also identifies isolated anomalies, some of which are

clearly metallic, due to their extreme and/or erratic values in both components such as at (34W, 30N) within the soccer field (Figures 6 – 8). These discrete anomalies usually occur in clusters, or zones, of numerous individual targets ("Zones of discrete anomalies" in Figure 8) and in some areas the cluster may be too concentrated to resolve individual targets and are mapped as "Discrete and/or higher concentrations of discrete anomalies" in Figure 8).

Although clearance within the trades compound was limited (as noted in Section 2.3) due to caches of scrap metal and numerous buildings, a highly conductive channel-like feature (Feature G in Figure 8) appears to correlate with the small oxbow in the southwest section of Lot 38 (Figures 3 and 9). The extremely high conductivities within this channel suggest a large concentration of buried debris and impacted soil.

Along the west side of the soccer field a very clear high conductivity channel-like feature, (Feature H) that is not observed in the air photo, produces an approximate mirror image of the main channel meander (Feature C) thereby enclosing a lens shaped "island" of predominantly background conductivity values (about 60N to 95N and 66W to 86W) (Figures 6 and 8). This "island" is, however, included in one of two rectangular zones (Feature I, Figure 8) observed in the in-phase map (Figure 7) due to minor erratic variations that suggest buried metal exists within the "island."

Within the soccer field area much of the buried metal is concentrated within 2 adjoining roughly rectangular regions (Features I and J in Figure 8). These rectangular regions have an overall mottled in-phase appearance (erratic high-low readings in Figure 7) encompassing trench-like zones of even more extreme high-low in-phase responses (zones in orange in Figure 8). These higher concentration trench-like zones appear to occur primarily within primary channel features, while the areas of lowest concentration, within the rectangular zones, appear to "bridge" the primary channel features, possibly as a thinner layer of fill. Although these particular trench-like zones are probably landfill material they exhibit an in-phase character similar to buried metallic services, however they are not as sharply defined as services. Another significant zone is mapped at, and beyond, the north end of the soccer field (Feature K, Figure 8) which encompasses both a low conductivity area and a mottled in-phase response together indicating higher concentrations of buried debris particularly metal. The southern half of this zone also correlates with an oxbow channel in the air photo (Figure 9). Other isolated occurrences of debris, and probably metal, (shaded orange in Figure 8) include locations within the berm west of the soccer field along 100 W (primarily between 0N and 50N), and numerous discrete anomalies within the channel that intersects Building Z (Feature E).

The area north of the residence (north of 160S and west of 280W, i.e. Feature A) exhibits an extensive area of elevated conductivity and increased erratic variation of the in-phase response indicating numerous occurrences of buried debris including metal. Within this extensive area a more concentrated zone of buried metal (Feature L, Figure 8) extends beyond the boundaries of one of the additional channel-like features. To the east, the main meander channel within Campus West Road exhibits a high and somewhat erratic in-phase response (Figures 7 and 8) suggesting some of the highest concentrations of buried debris, particularly metal.

The interpretation map (Figure 8) outlines the significant features revealed by the EM-31 survey. The five feature types in the legend are arranged in approximate order of importance from discrete targets or high concentrations of targets, particularly metal, to the interpreted channel boundaries. The first two feature types are mostly derived from the in-phase response, thus they are most indicative of buried metal. The third and fourth feature types identify areas of isolated or notably extreme values of conductivity and in most cases delineate significant variations within the oxbow channels. These anomalous conductivity zones may contain greater concentrations of debris, possibly including metal, and/or possibly impacted soil and water. Although some of these conductivity

anomalies (the third and fourth feature types) could be due to natural variations in soil type and saturation, the larger their magnitude, the more likely their cause to be man-made. The areas of highest priority are where the in-phase features (legend feature types 1 and 2) overlap with the conductivity features (feature types 3 and 4).

We emphasize that the foregoing findings should be verified and constrained by direct investigations. In particular, the geophysical mapping reported here should guide the location of subsequent intrusive investigations. The intrusive investigations will, concurrently, provide an assessment of the nature of conductivity anomalies such as the distinct conductivity highs and lows within the channels.
