Replace the defective power net

Replace the defective Pitch position sensor and defective cables

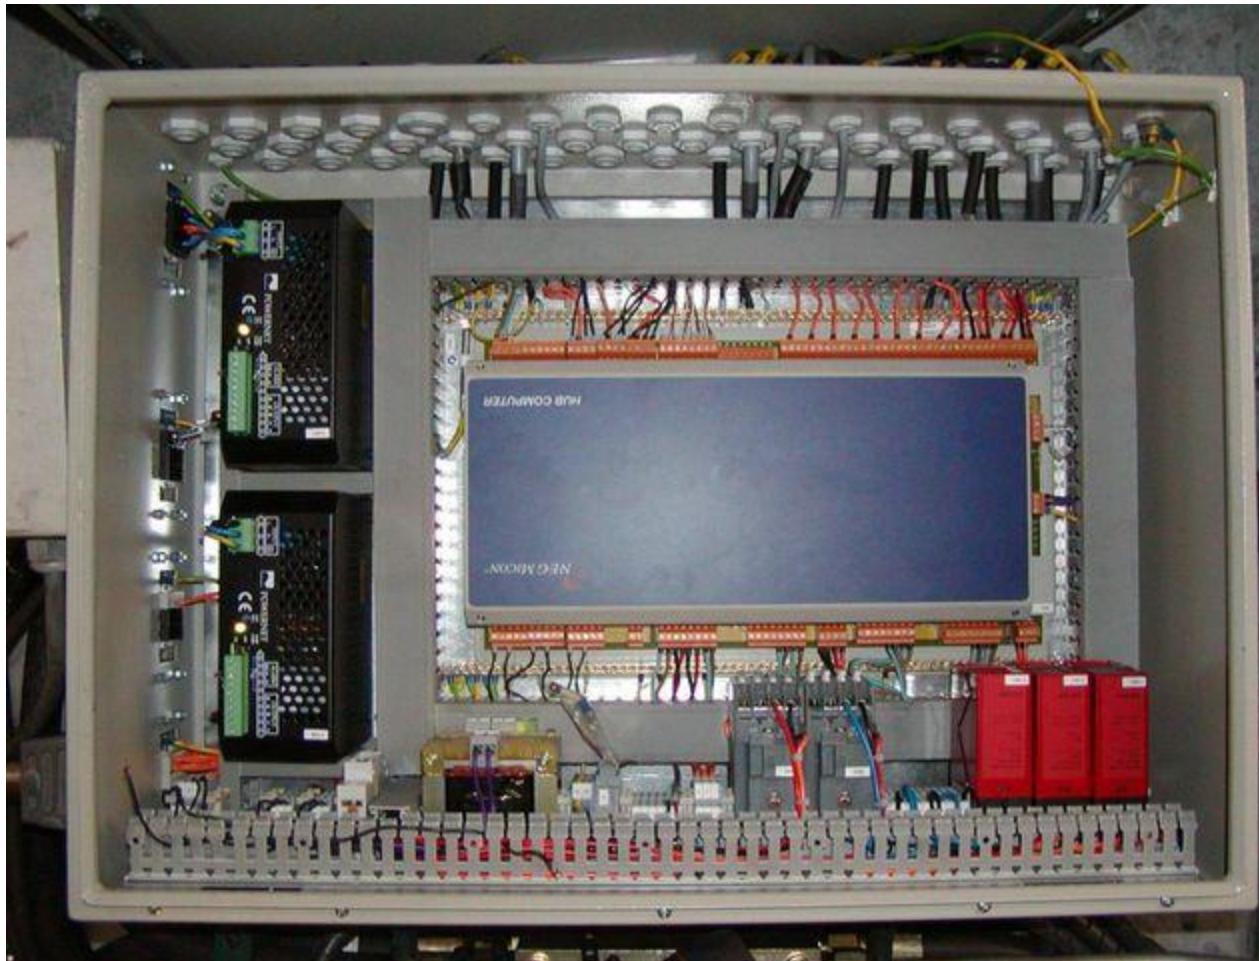
Check for any loose connections in the hub computer terminal X19.

Check for any loose connections on the Blade position sensor.

Swap the signal wire to the position transducer (Balluff) on the hub computer. If the fault follows to the new blade then the fault is either in the position transducer or one of the cables.

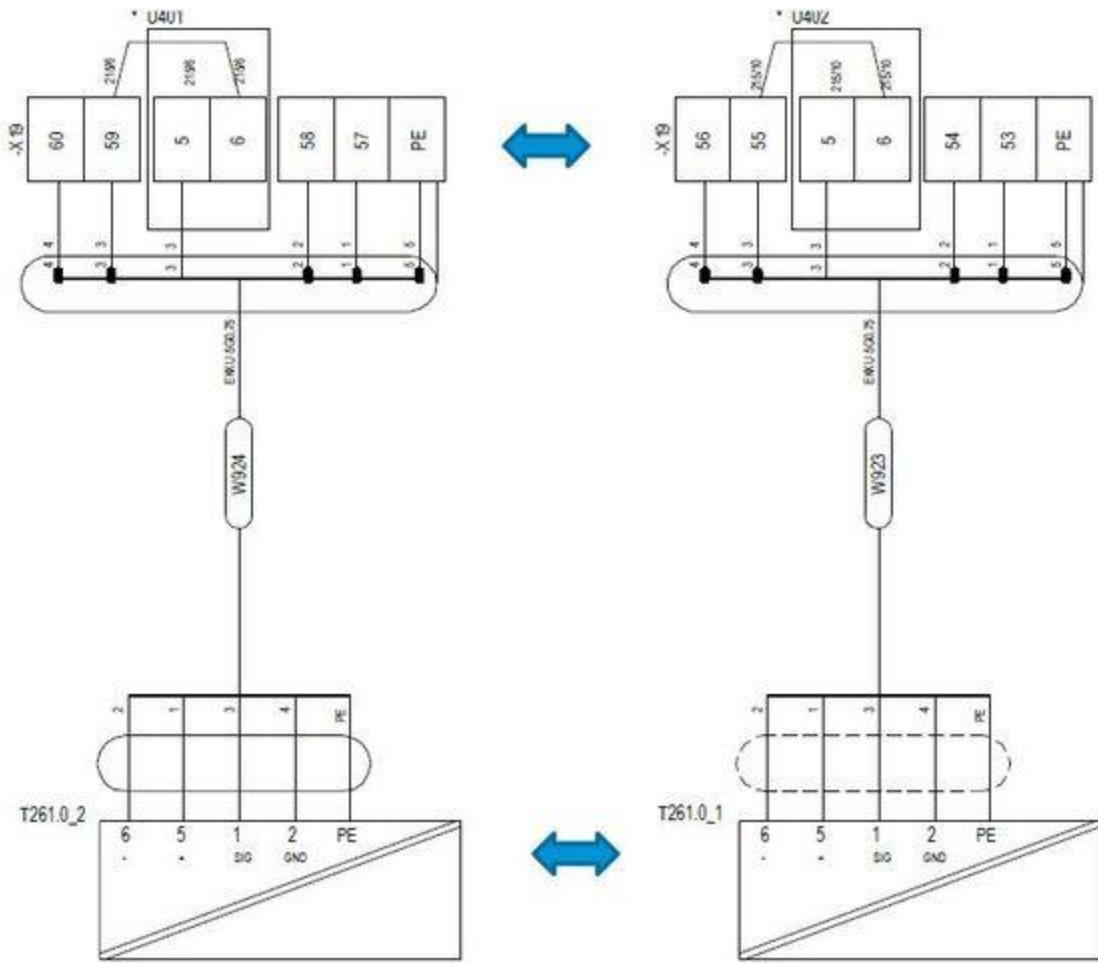
In the example below, we are swapping the plugs between blades C and B.

Place the cables back to their original position and then swap pitch position sensor from affected blade to another working blade.

If the alarm follows the valve to the other blade, the pitch position sensor is defective.

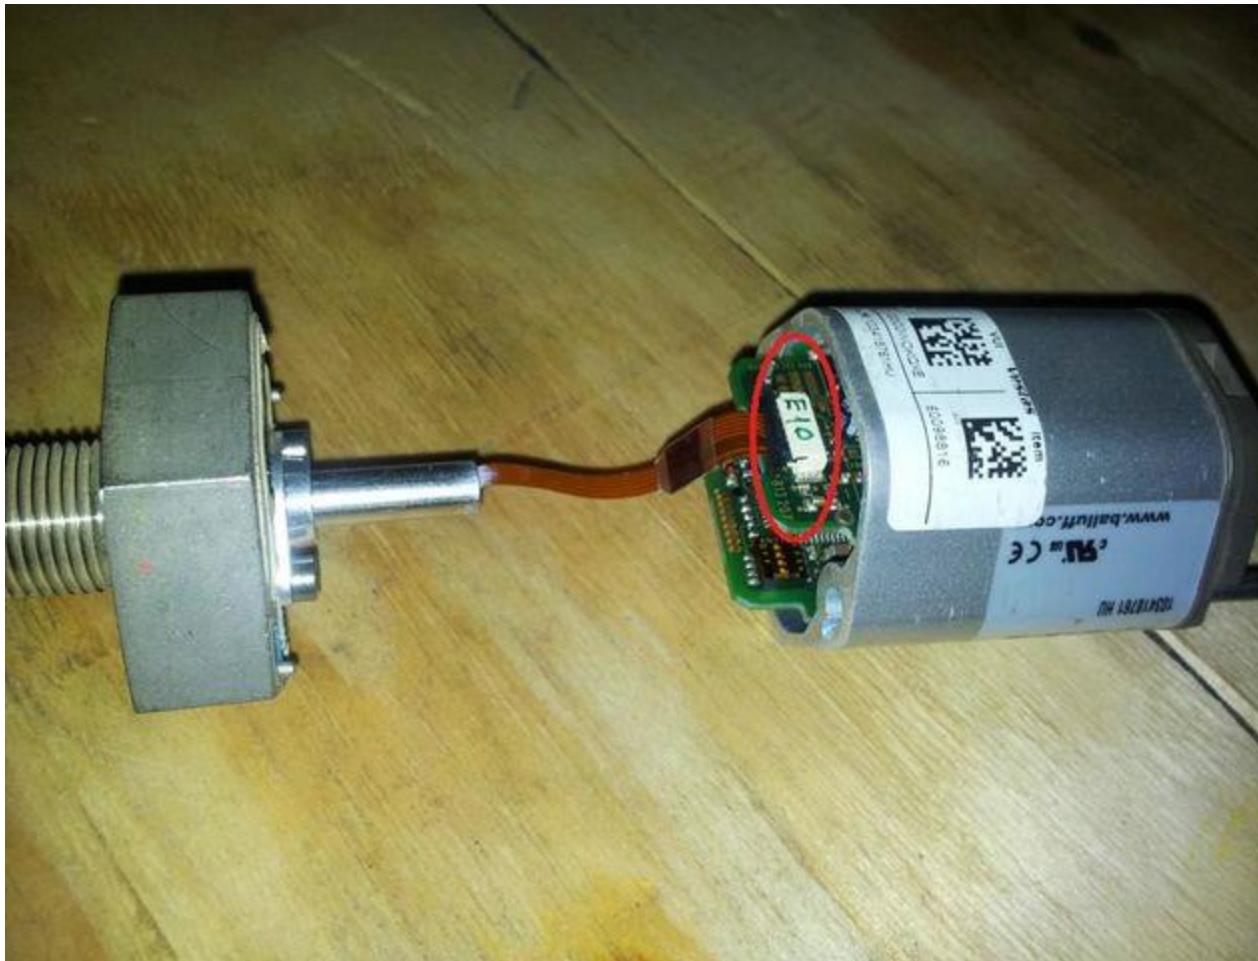
Check the cable for any or short due to the cable rubbing near the hub casting or friction between the cable and the hydraulic hose.

Replace any defective cables.

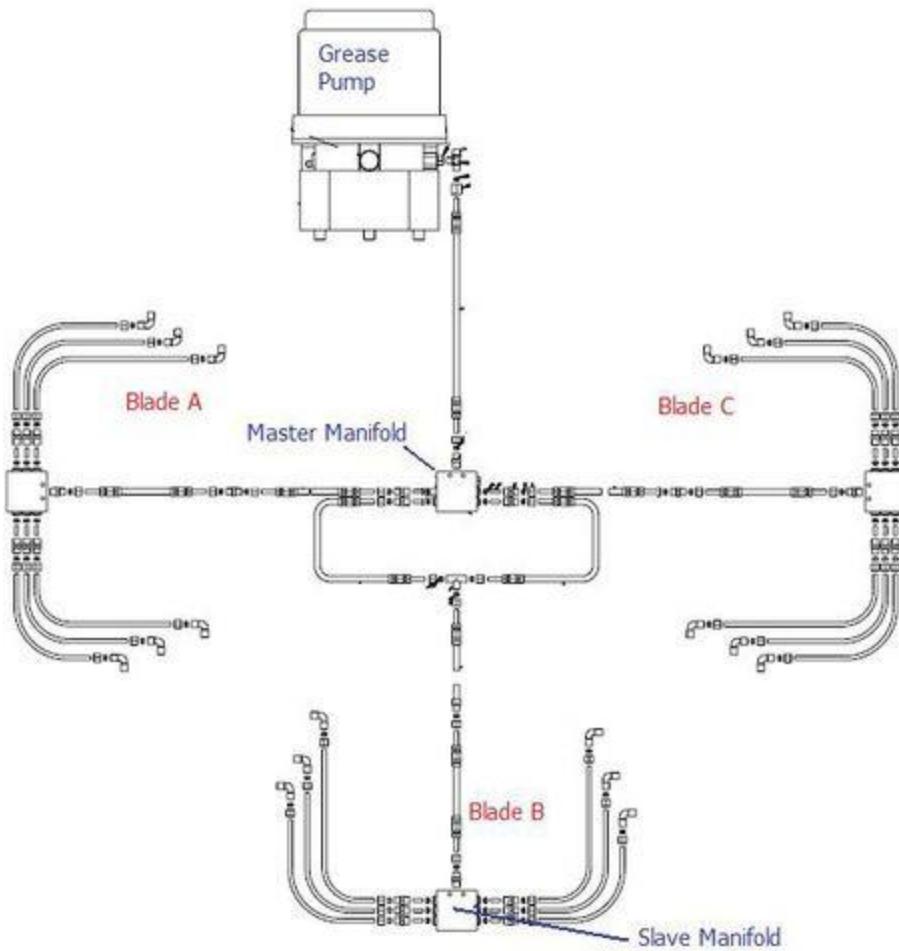
Check that the grease flows from all of the ports:

Inspect for any damaged hose fittings, manifold grease blockage or hose damage.

If necessary replace the manifolds and hoses.

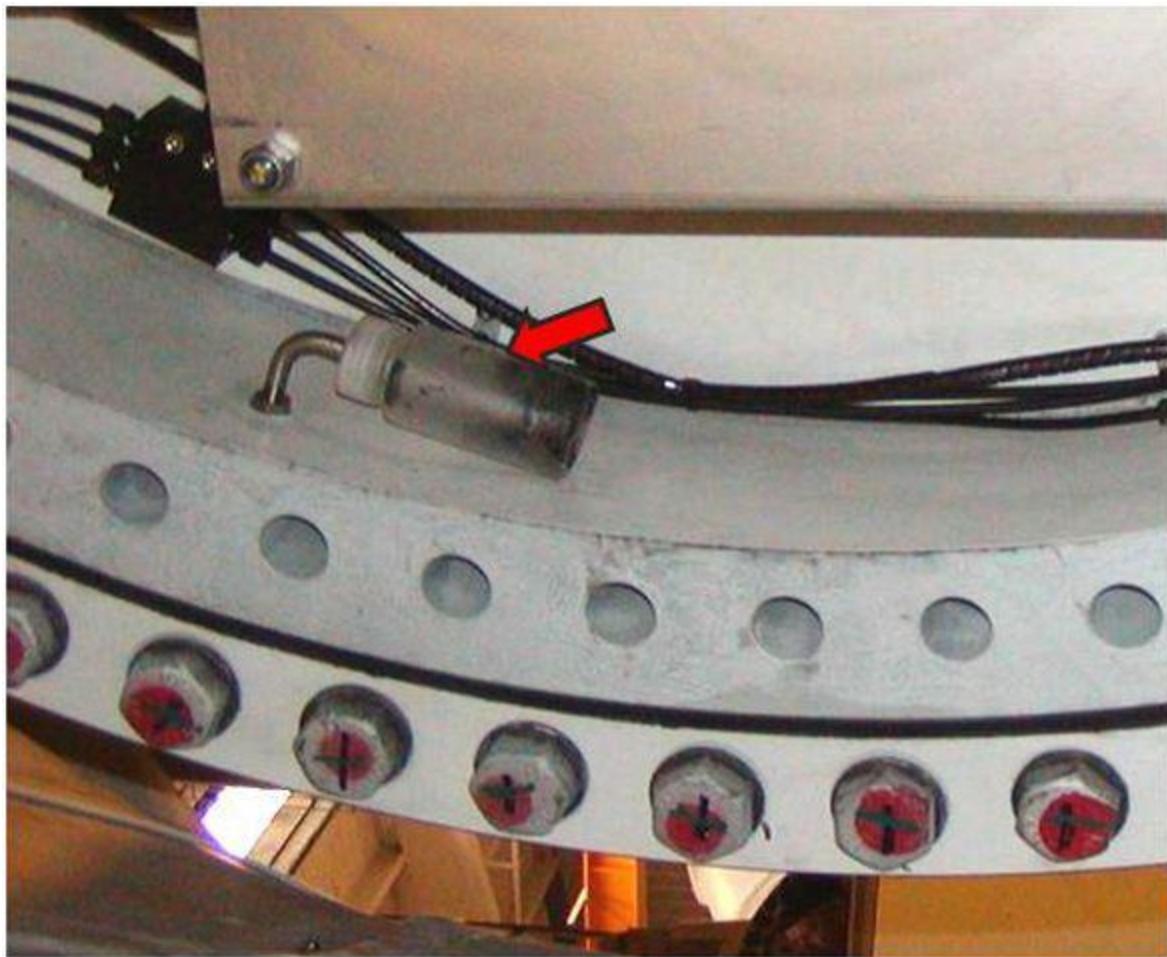
Check blade bearings for any grease leak.

Check for grease or oil stains on the blades and spinner.

Check the grease collector bottles in all blade roots. If there is a large volume of oil in the hub or evidence that oil has penetrated into the bearing, perform a manual greasing operation on all of the blades.

If there is any damage or heavy grease leak replace the seals.

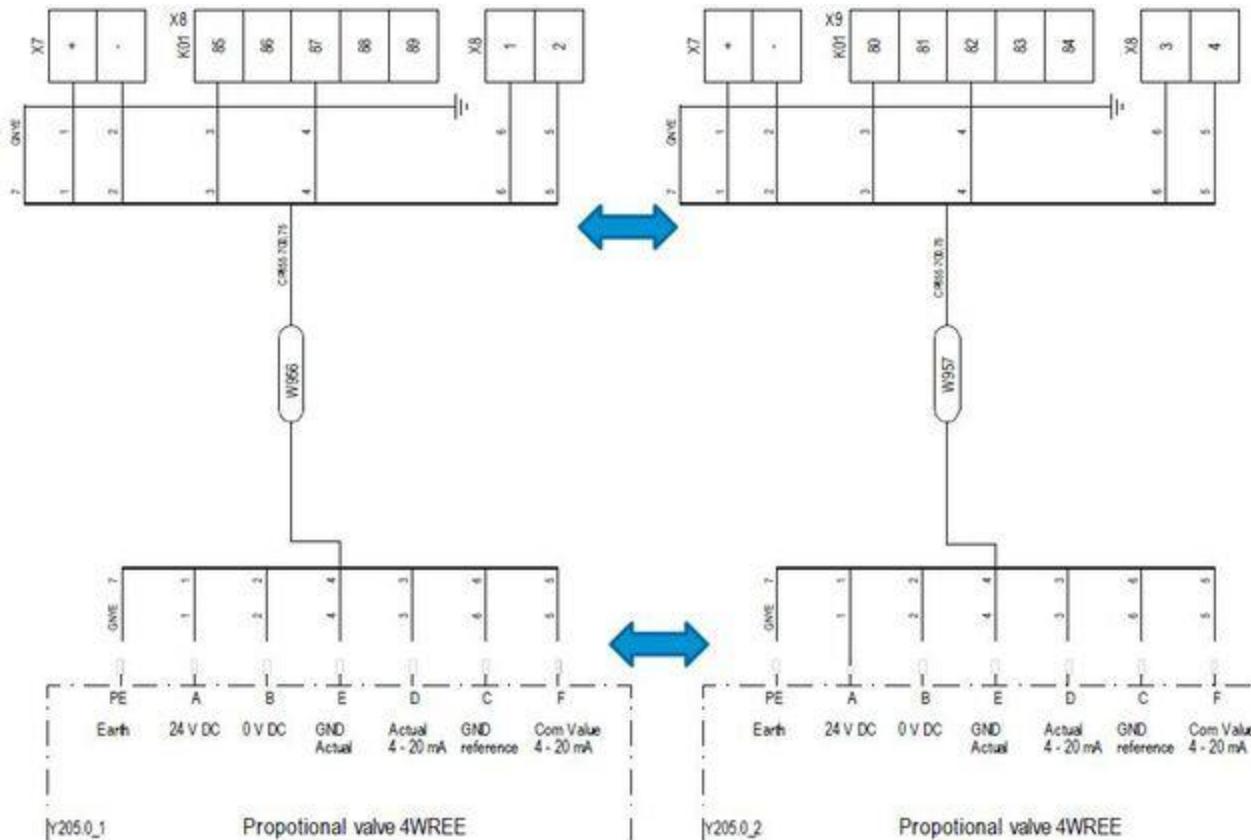
In the example below, we are swapping the plugs between blades A and B.

Place the cables back to their original position and then swap proportional valve from affected blade to another working blade.

If the alarm follows the valve to the other blade, the proportional valve is defective.

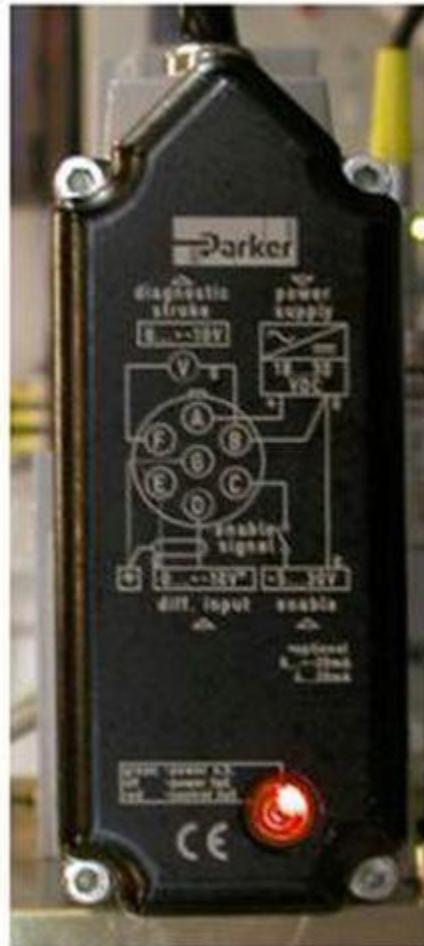
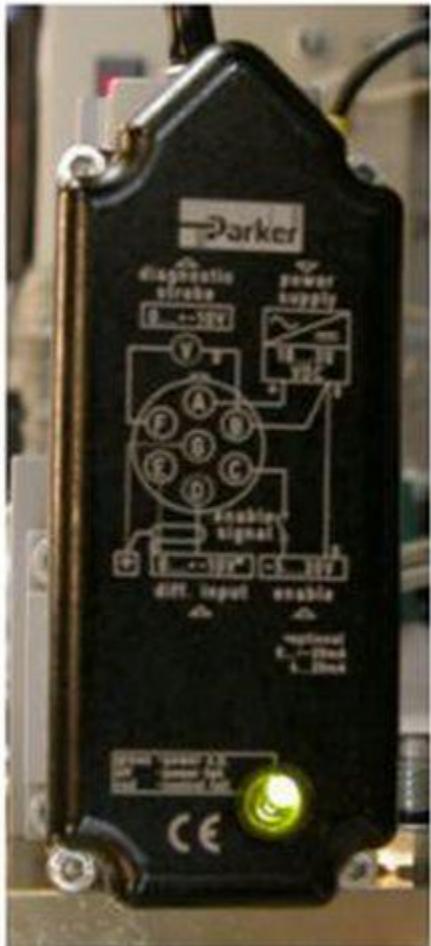
The LED should be green with the pitch system pressurized.

If it is red and there is pressure verified on test port MP, then the valve may also be defective.

Replace proportional valve using below **SWI**

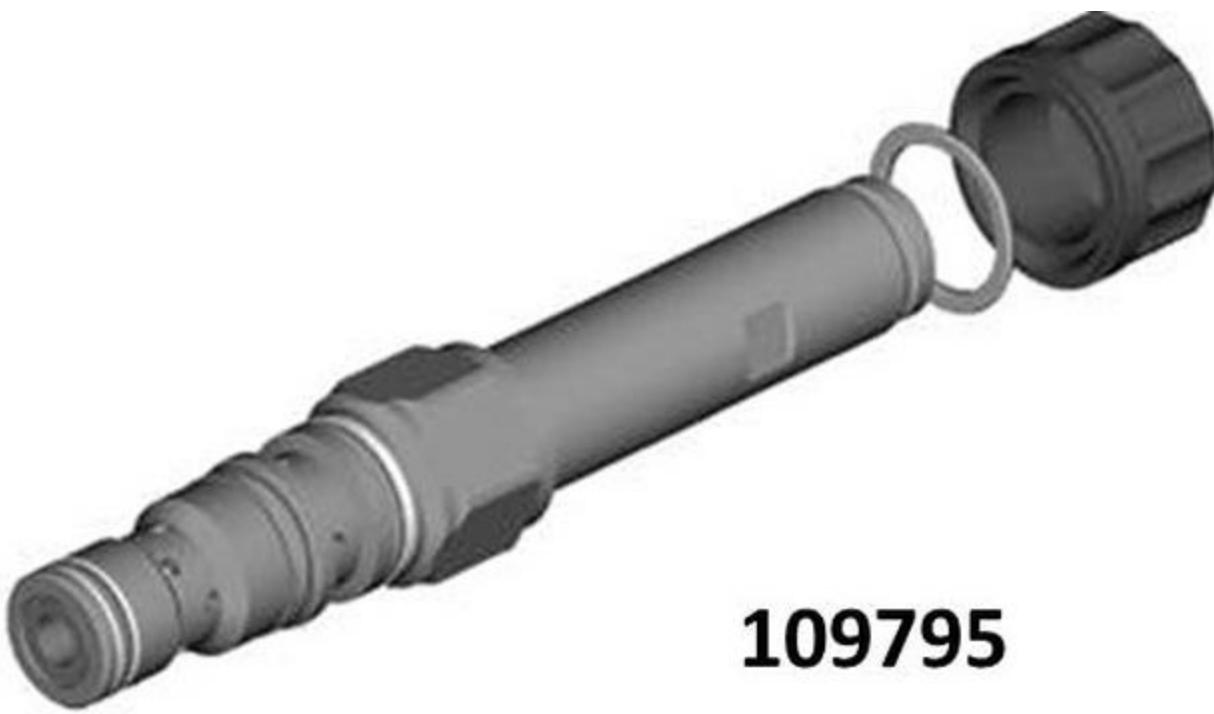
(Rexroth) Valve/Solenoid- 215

The part No.60096475 is phased out and henceforth replaced by 109795 & 60106201.

If the valve operates normally, replace the original faulty valve.

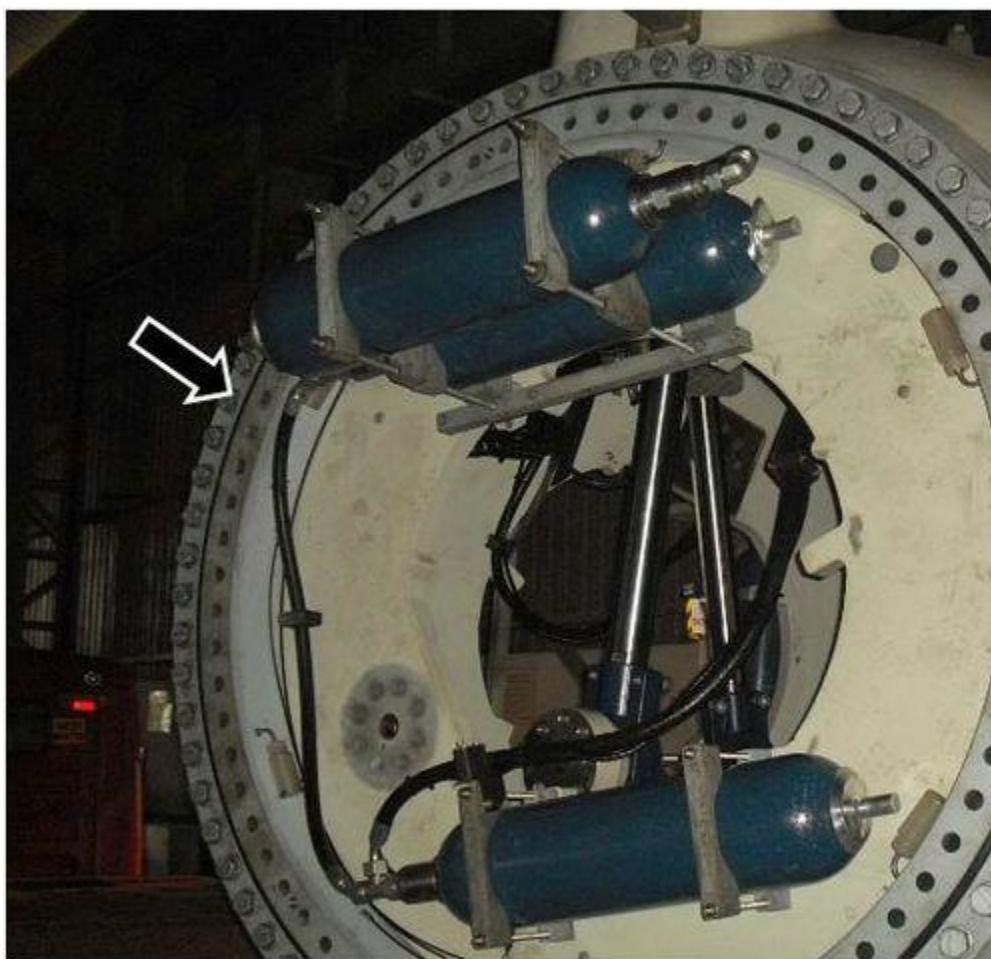
If manual greasing does not solve the issue, likely it is the cause of blade bearing failure. Consult the SBU Engineering group to determine course of action and correct item number for the applicable blade bearing.
