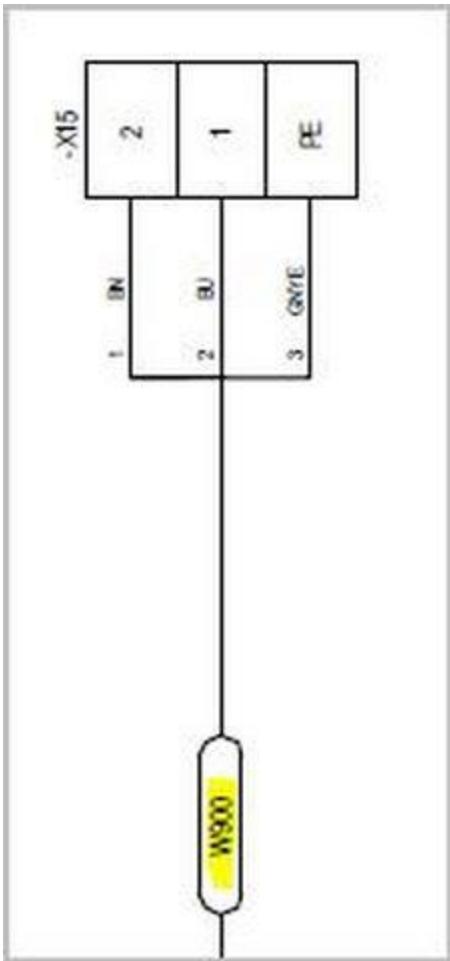
Check the cable for obvious physical damage.

Check the connection from the sensor switch connector to X15 in hub computer panel AK4.

Check the continuity of the cable. If the cable is found to be damaged, replace the cable.

Replace the cable

Relevant spare parts	
Description	Item No.
CABLE W900 FILTER CLOG -B406	60021519

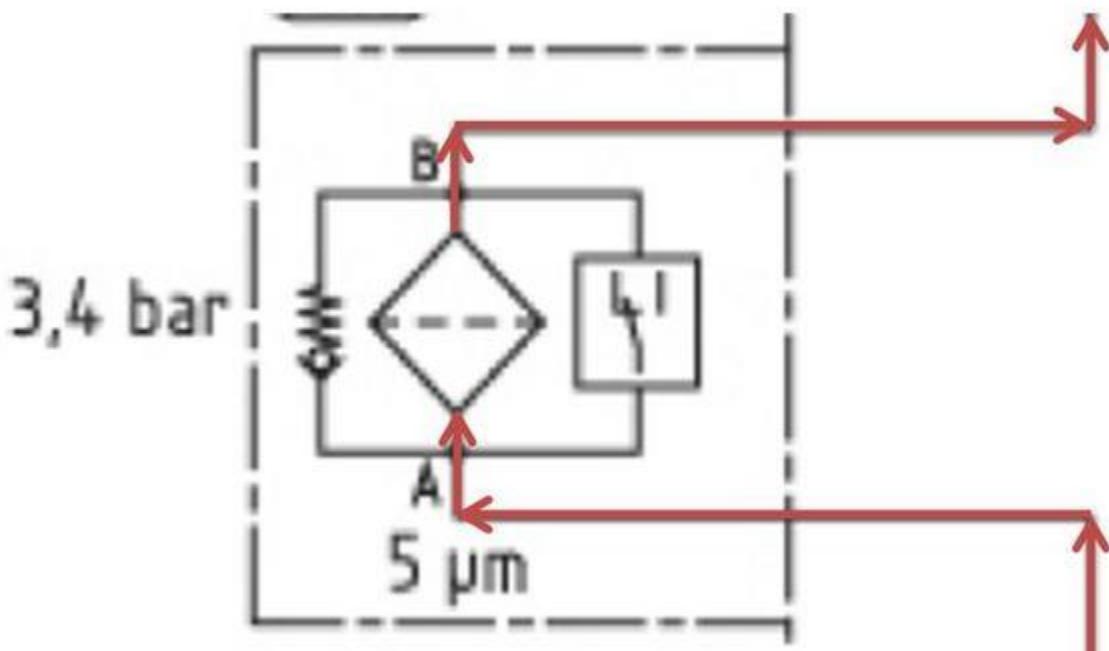
The high pressure filter in the hub is replaced at every service and therefore is not commonly contaminated to the point of setting this fault. If through the process of elimination, it is determined that the filter is clogged, replace the filter.

Replace the Filter

Relevant spare parts	
Description	Item No.
FILTER ELEMENT, 5MY, FC7007.Q005.BK - PARKER	60112661
FILTERELEMENT 0160 DN 006BN/HC – BOSCH REXROTH	60096498
