Troubleshoot/Replace valve

489 - Pitching to run fault blade 3 - V82

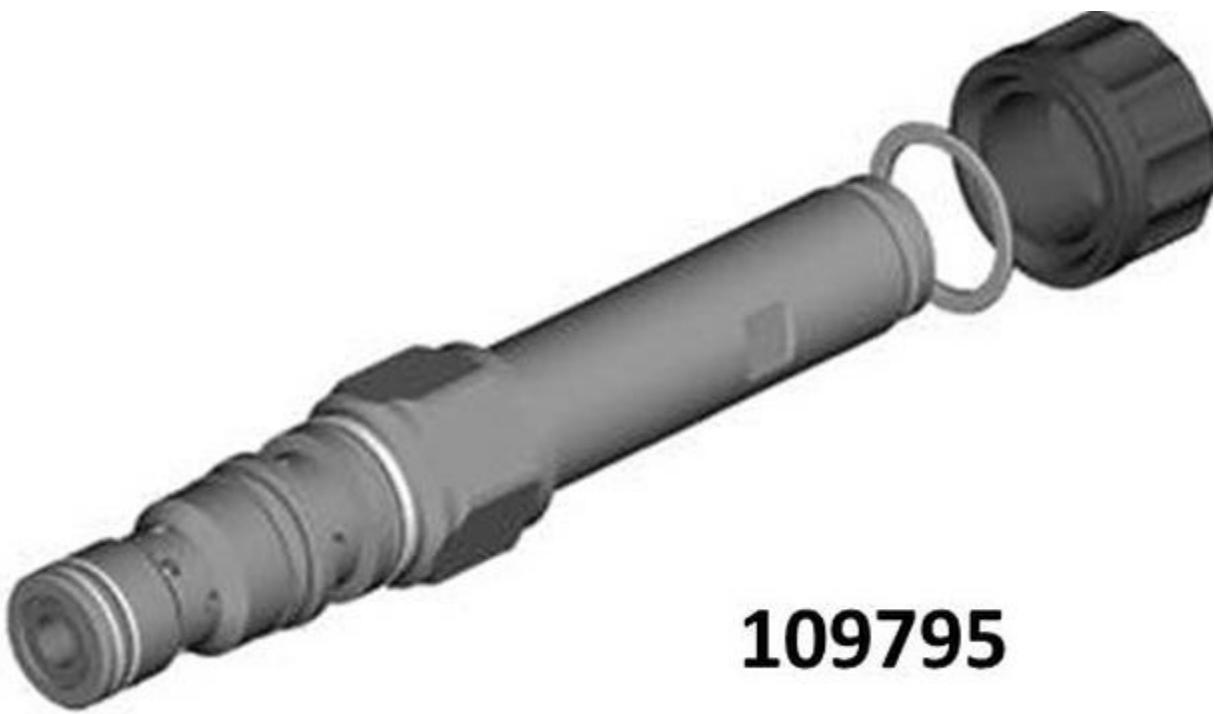
(Rexroth) Valve/Solenoid- 215

If a whistling sound can be heard from valve 215, valve 215 is not fully activated or deactivated.

If valve 215 is somewhere between activated and deactivated, it is leaking.

Measure pressure in Mx1 while valve 215 is deactivated - pressure is to be 0 bar.

Measure pressure in Mx1 while valve 215 activated pressure is to be equal to the acc. pressure.

If either of these values are not as specified the valve is defect and must be replaced.

The part No.60096475 is phased out and henceforth replaced by 109795 & 60106201.

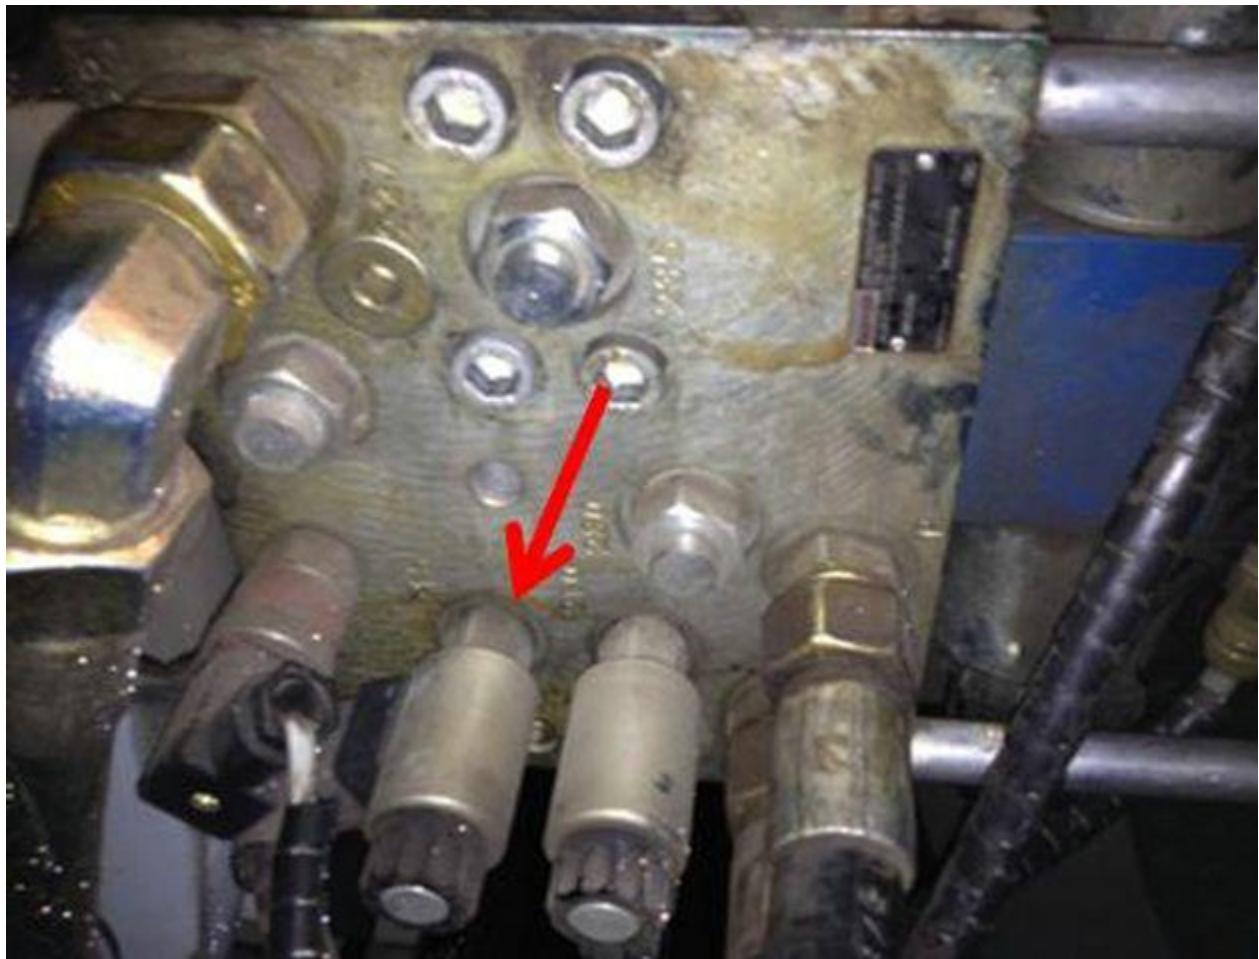
Cable, Shutdown valve-Pos.215

Damage to cables for proportional valves and solenoid valves can cause this alarm.

The wires in the cable to the shutdown valve (pos. 215) tend to break inside the insulation directly beneath the strain - relief near the connector.

During operation the offending blade will "flutter" a bit as the wire flexes in the hub. If it is broken badly enough you will hear the blade "hammer" as power to the valve is interrupted.

Troubleshoot pitch valve cables and connectors-repair or replace as necessary.

Flex the cable at this point on the cable while pitching to detect if a wire within the cable is broken.
