878 - PT100 fault hub panel - NM72,NM82,V82 Mk1-5

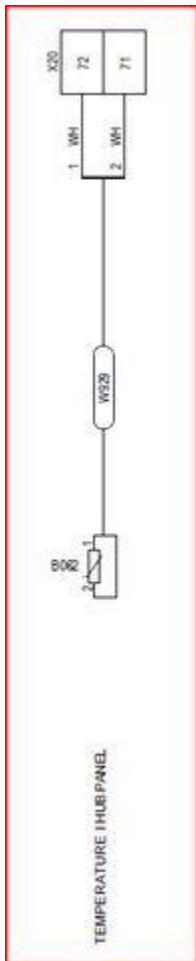
Change the PT100 if sensor is defect

Change the PT100 if defect.

Sparepart No.: 60009279

Connection see document no.: [0000-1638](#) page 408

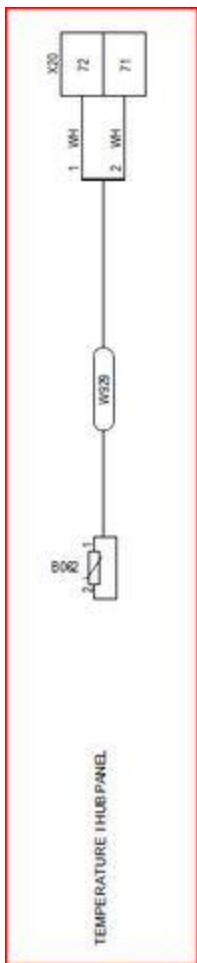
Change the PT100 if cable on sensor is broken

Broken wire from PT100
Change the PT100 if defect.
Sparepart No.: 60009279
Connection see document no.: [0000-1638](#) page 408
