## Perform the blade position calibration as per the WKI

## Replace the defective pitch position sensor

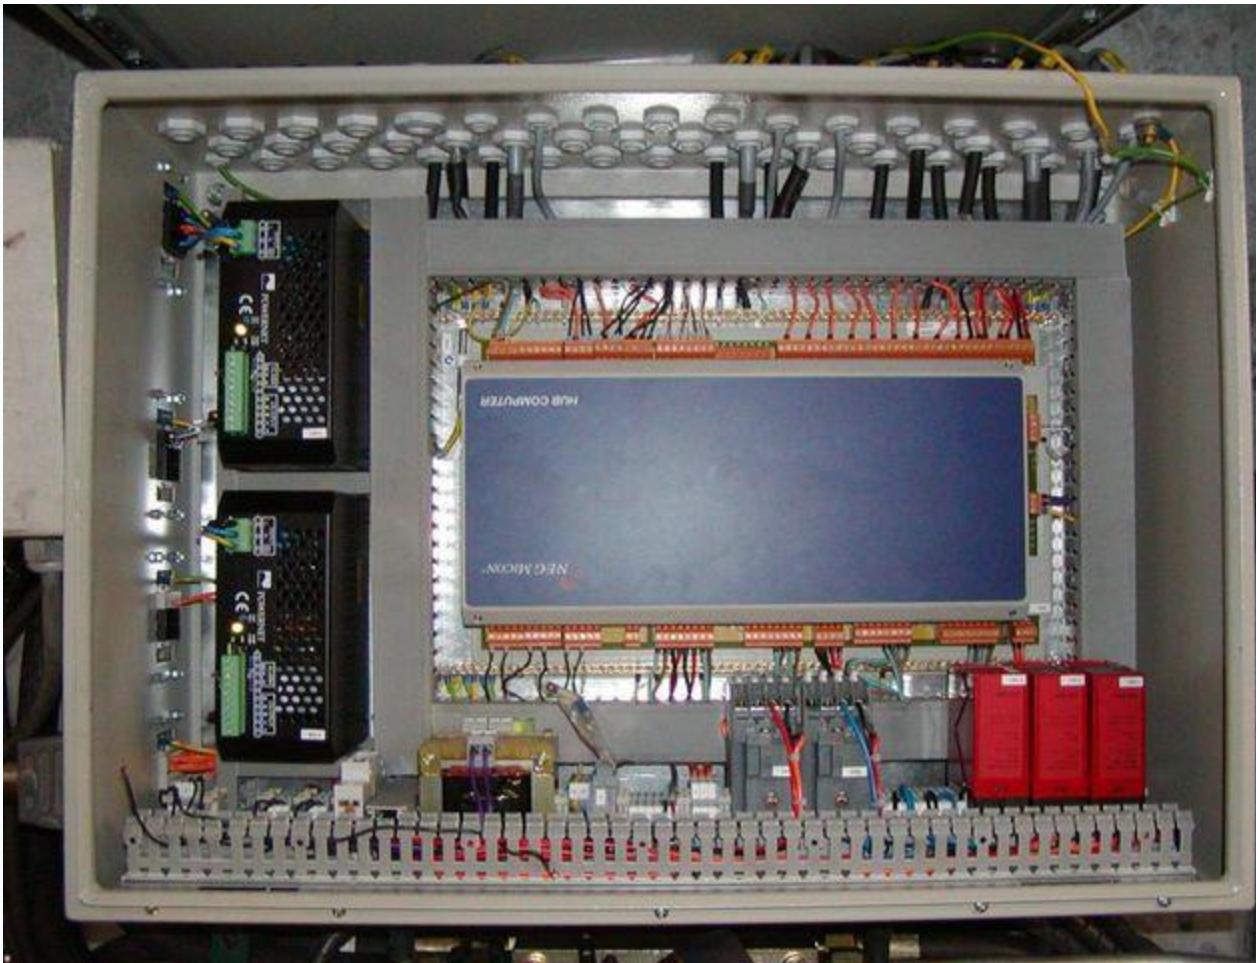
#### IN THE HUB PANEL +AK4

Check for loose connections in the hub computer terminal X19

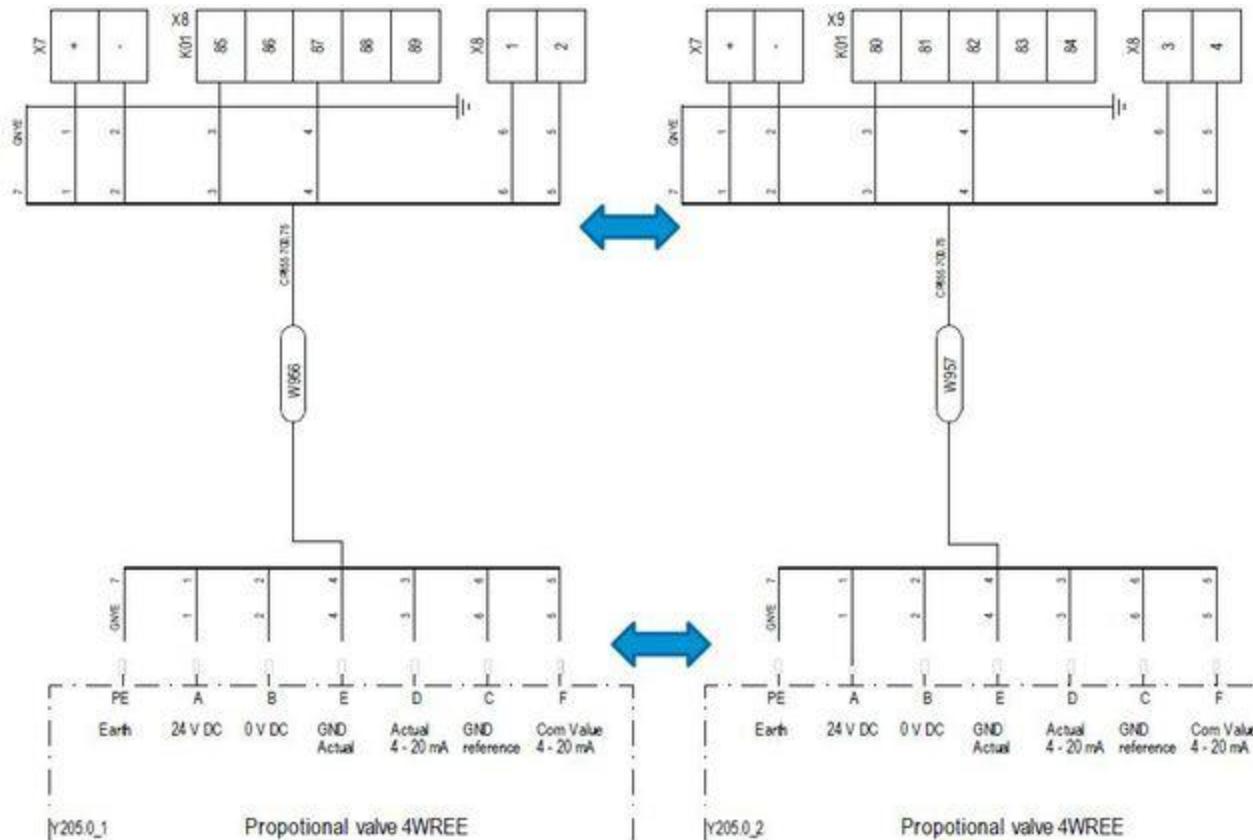
First swap the signal wire to the proportional valve on the hub computer.

If the fault follows to the new blade then the fault is either in the proportional valve or one of the cables.

In the example below, we are swapping the plugs between blades C and B.

Place the cables back to their original position and then swap proportional valve from affected blade to another working blade.

If the alarm follows the valve to the other blade, the proportional valve is defective.

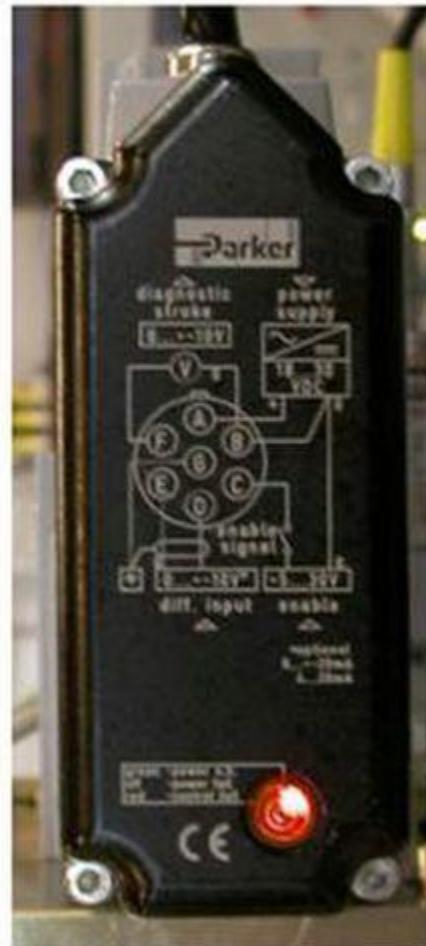
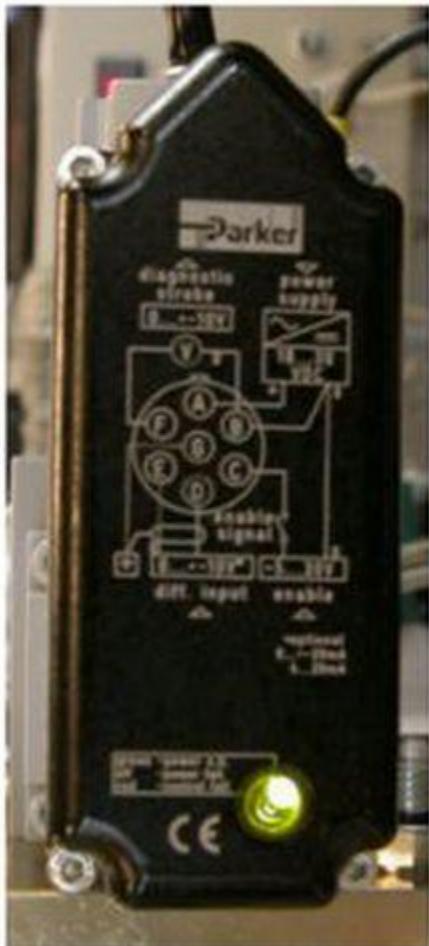
If it does not, the proportional valve is likely not the cause.

For Parker proportional valves check to see the color of the LED on the valve circuit board.

The LED should be green with the pitch system pressurized.

If it is red and there is pressure verified on test port MP, then the valve may also be defective.
