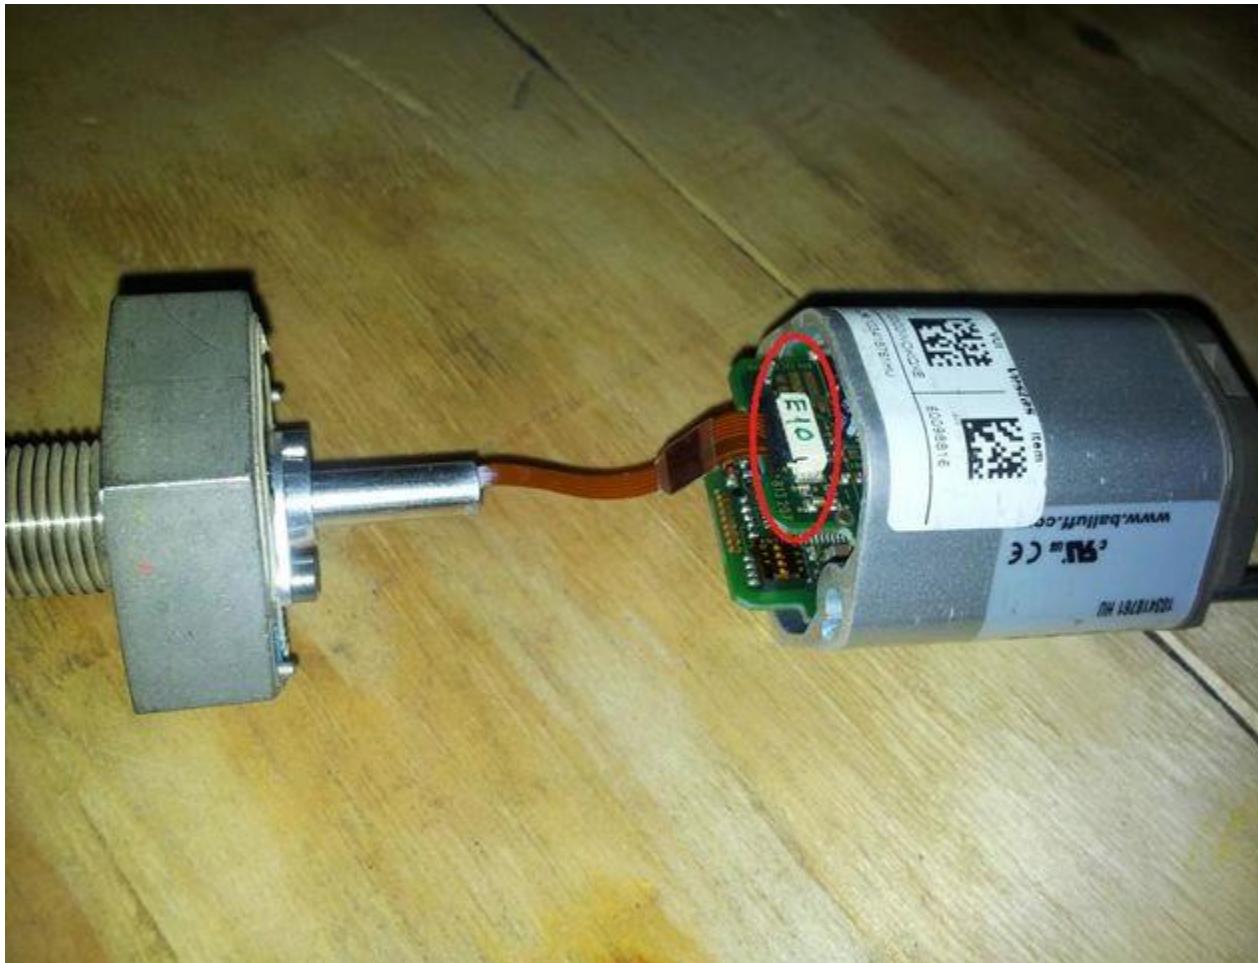
Check the cable for any or short due to the cable rubbing near the hub casting or friction between the cable and the hydraulic hose.

Replace any defective cables.

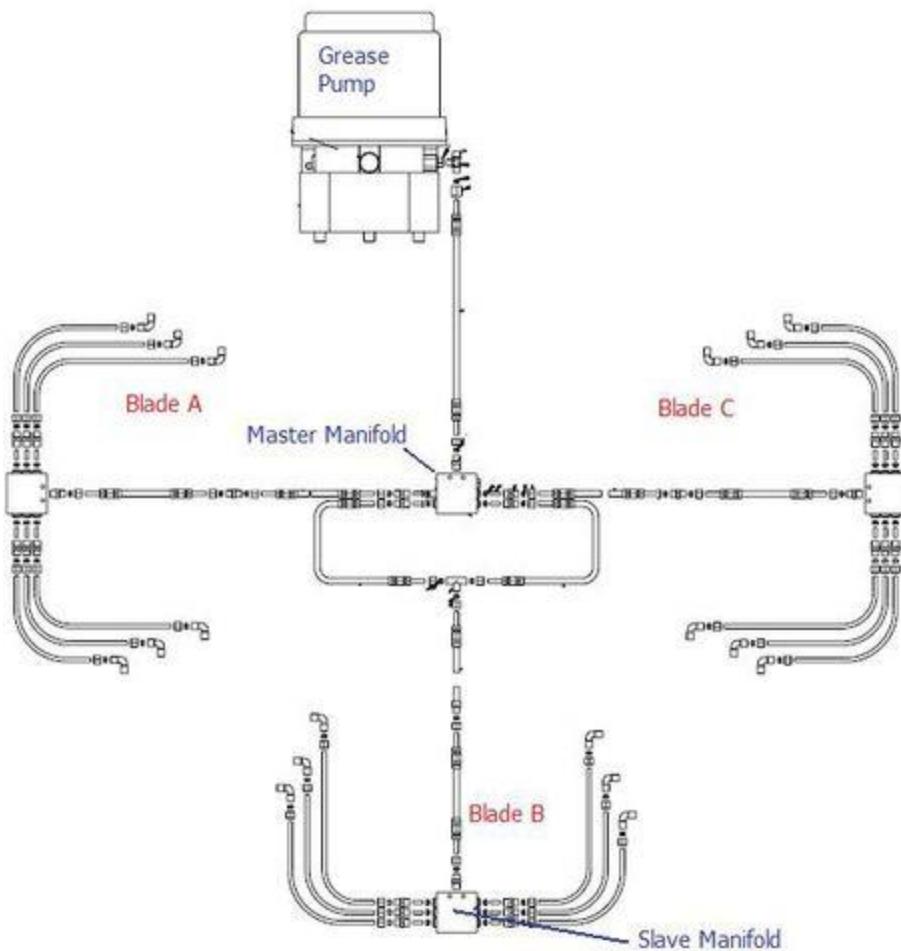
Check that the grease flows from all of the ports:

Inspect for any damaged hose fittings, manifold grease blockage or hose damage.

If necessary replace the manifolds and hoses.

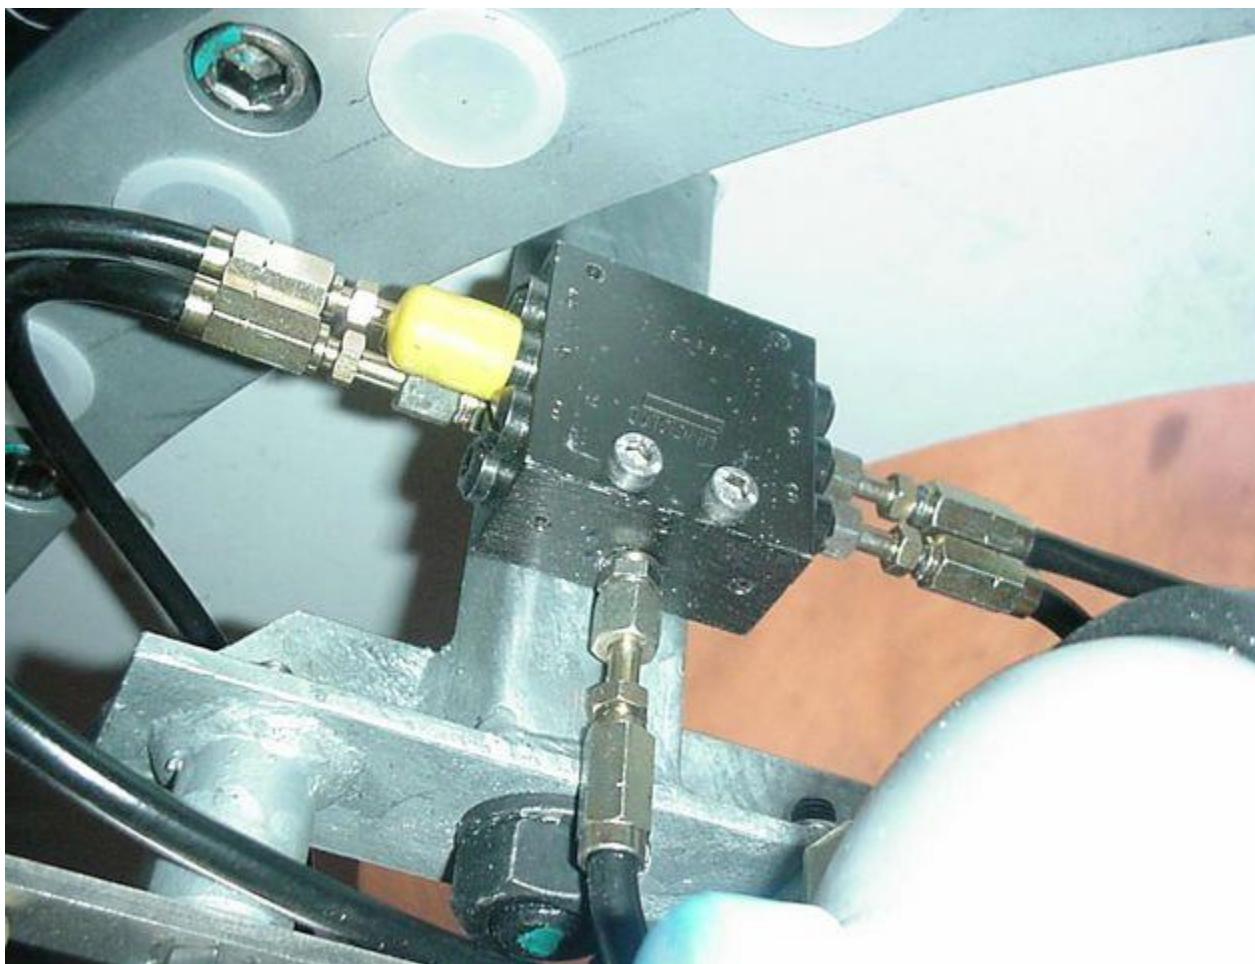
Check for blade bearing grease leaks:

Check blade bearings for any grease leak.

Check for grease or oil stains on the blades and spinner.

Check the grease collector bottles in all blade roots. If there is a large volume of oil in the hub or evidence that oil has penetrated into the bearing, perform a manual greasing operation on all of the blades.

Check the inner and outer blade bearing seals.

If there is any damage or heavy grease leak replace the seals.

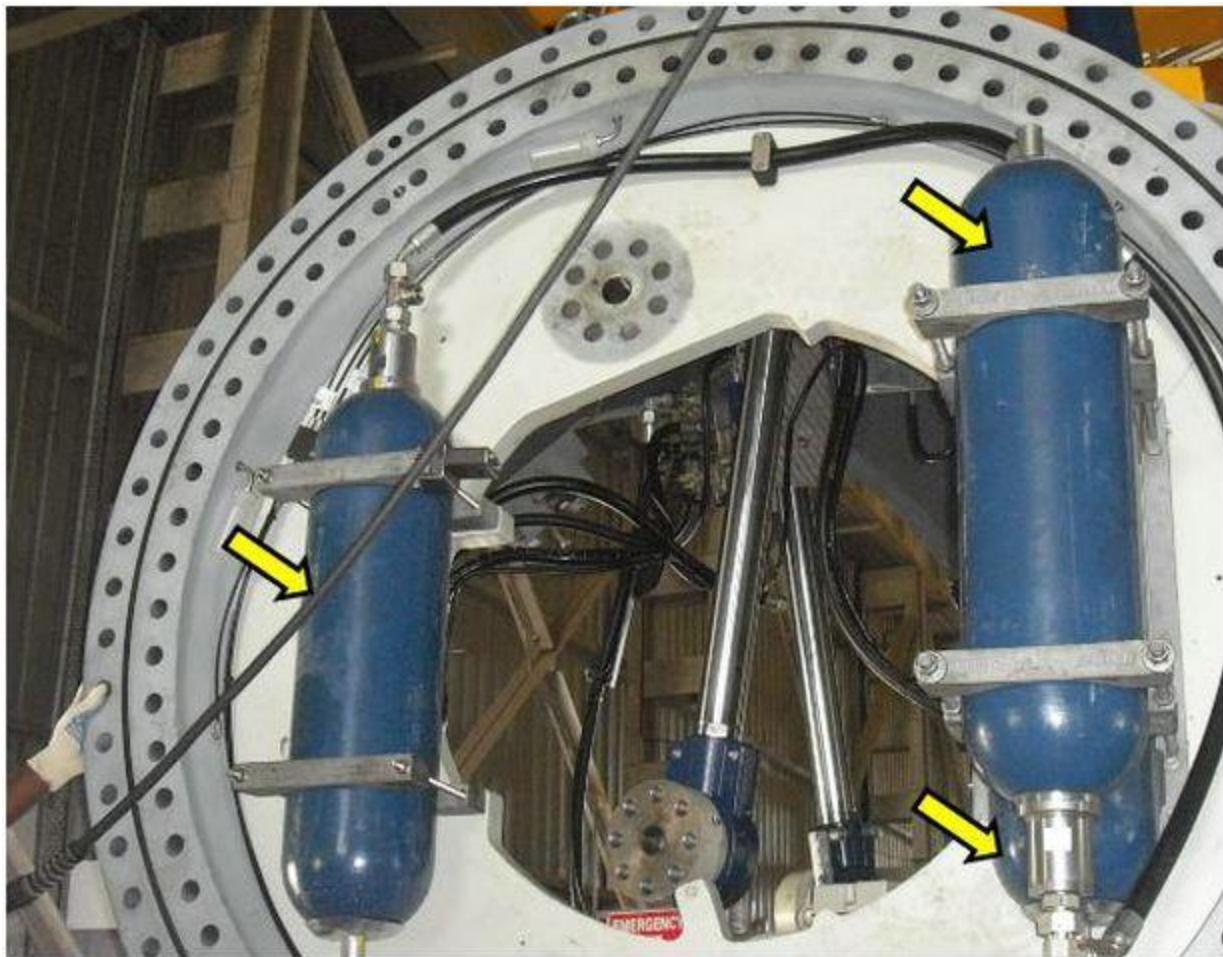
Check all of the pitch accumulator pre-charge pressures.

If any of the nitrogen pressures in the accumulators are low, recharge.

If the bladder in the accumulator has failed, replace the accumulator.

Check accumulator retrofit installation

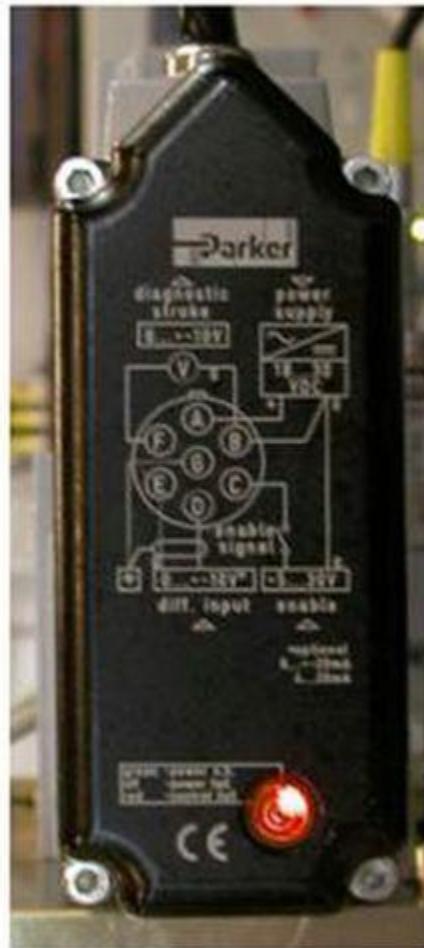
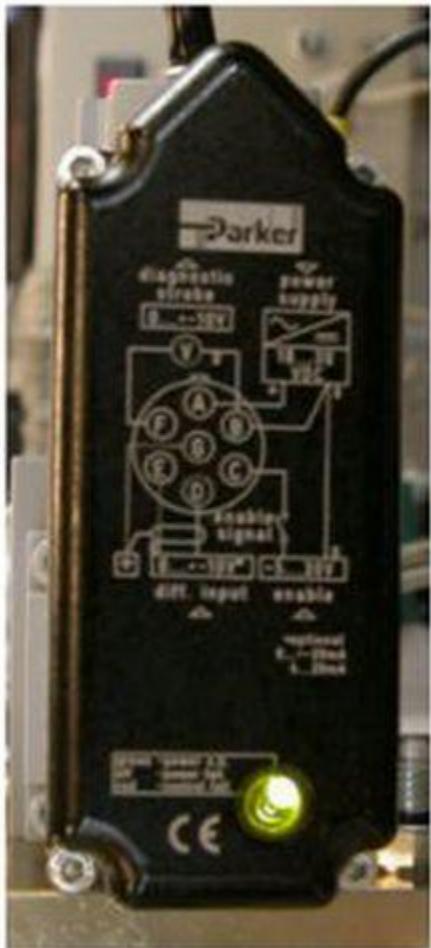
The LED should be green with the pitch system pressurized.

If it is red and there is pressure verified on test port MP, then the valve may also be defective.

Replace proportional valve using SWI below:

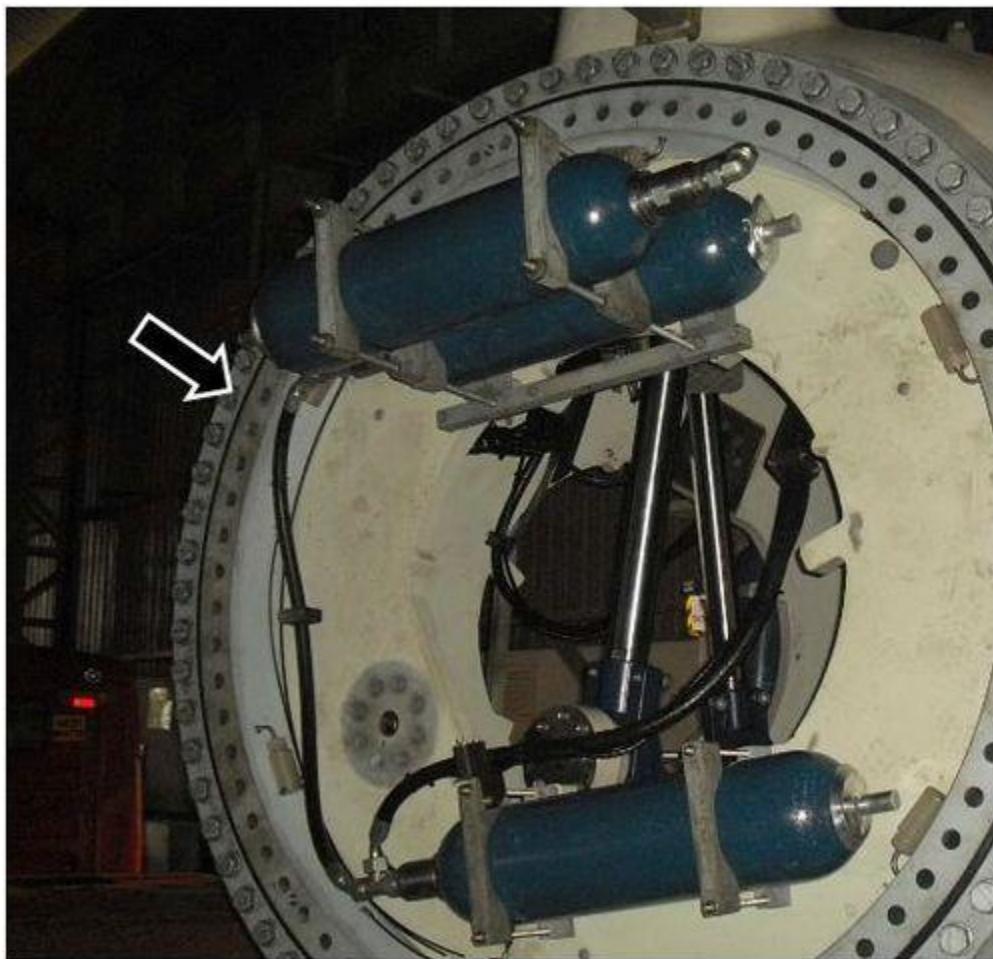
If manual greasing does not solve the issue, likely it is the cause of blade bearing failure. Consult the SBU Engineering group to determine course of action and correct item number for the applicable blade bearing.
