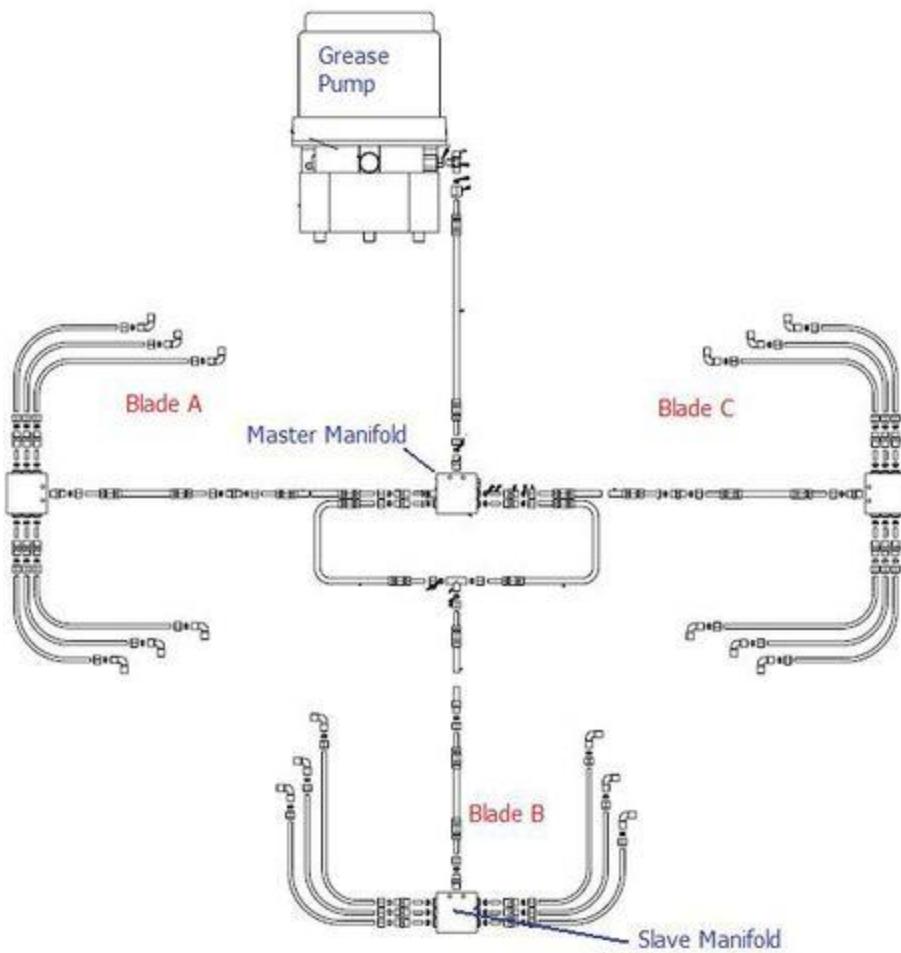
Check that the grease flows from all of the ports:

Inspect for any damaged hose fittings, manifold grease blockage or hose damage.

If necessary replace the manifolds and hoses.

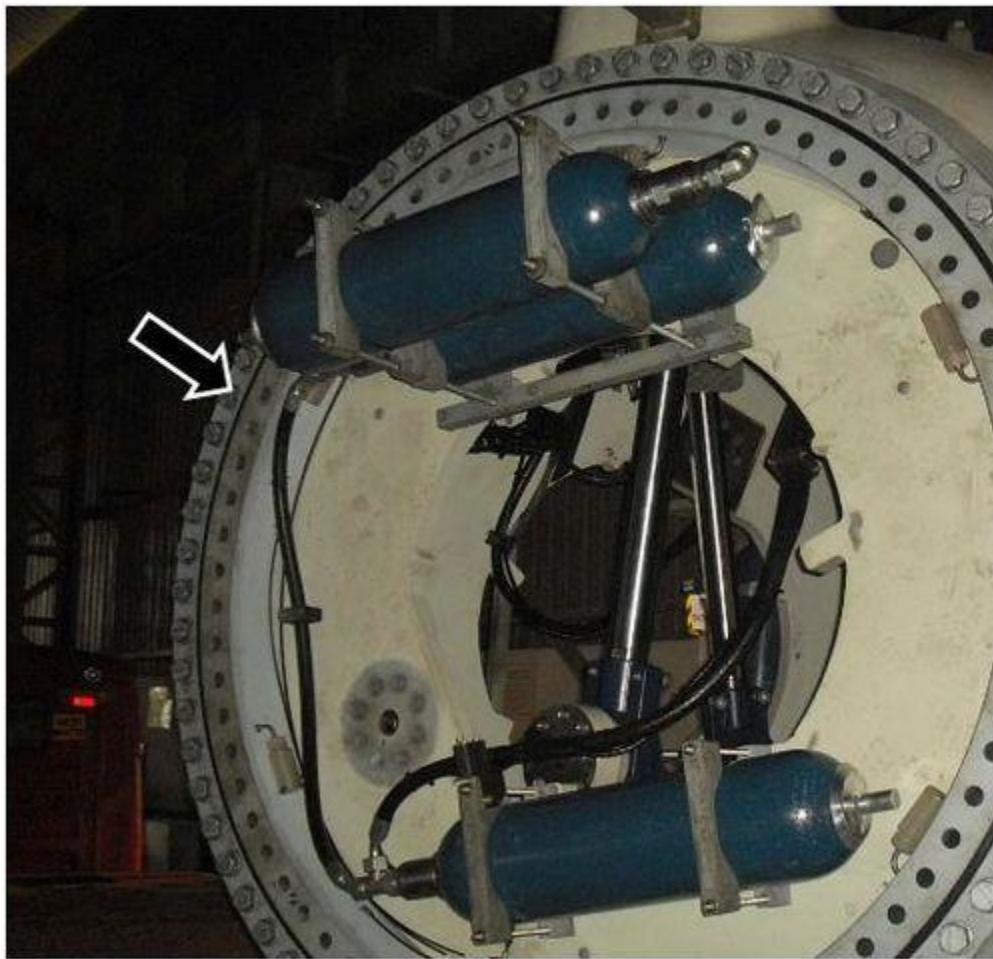
If manual greasing does not solve the issue, likely it is the cause of blade bearing failure. Consult the SBU

Engineering group to determine course of action and correct item number for the applicable blade bearing.
