Check wires between TAC40 and the thyristors

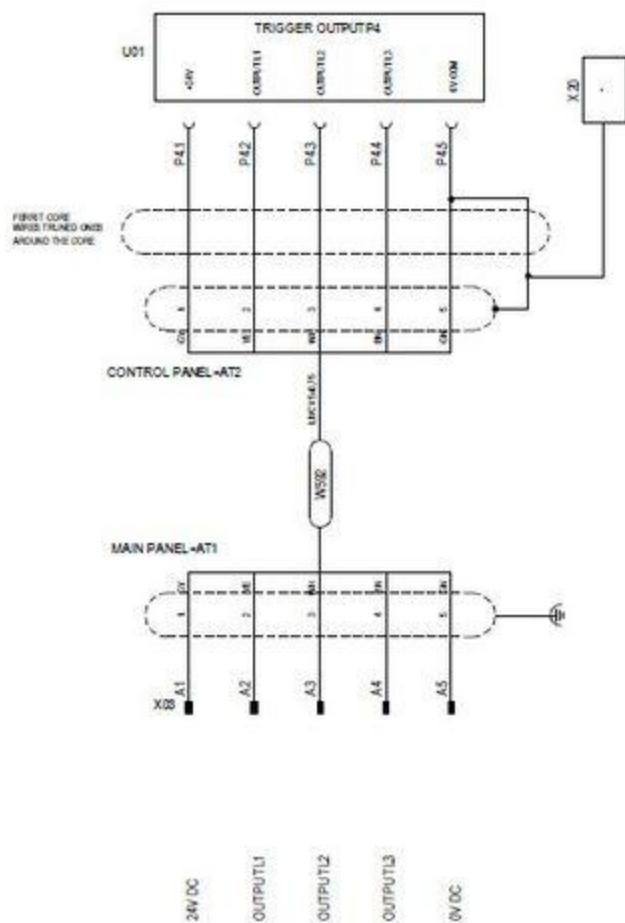
Check the wires in the AT1 that connect to the thyristors, make sure there are no opens or shorts.

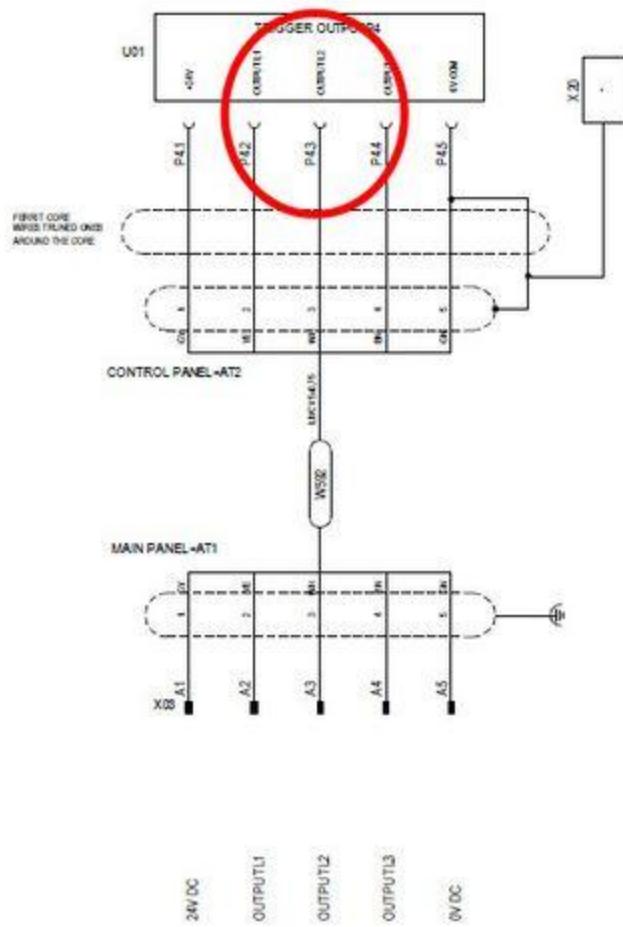
Test points circled

Check the TAC 40 for damage. Replace if it is bad.

You can test the TAC 40 while performing a motor start with the F01 open. Set the amperage on the motor start to 50 and jump the F01 out of the safety line.
