Service Bulletin

Bulletin No.: 19-NA-037
Date: March, 2019

Subject: No Start, Hard Start with Belt Squeal, Belt Break, Loss of Power Steering and/or Power Brake Assist

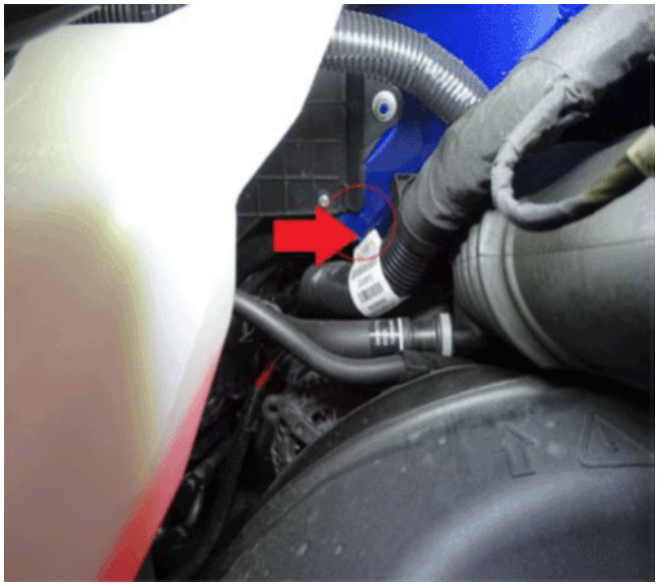
5246048

Note: The common location of the water leak path is shown in the graphics above.

- Seal water leak at cowl with Kent Automotive High-Tech™ Clear Seam Sealer, following the steps in the Service Procedure below.
