ROSEN
API 653 Internal Inspection Preliminary Report

ROSEN Project Number 0-1000-18486

TK 201
Port Everglades, FL (North)
Diameter: 117 ft.
Inspection Date: July 31, 2026
Inspector: J. Bell (Authorized Inspector, API 653 Cert. No. 32508)

Client	TransMontaigne
ROSEN Project No.	0-1000-18486
ROSEN Tank Name	TK 201
Inspection Date	July 31, 2026
Report Date	August 4, 2026

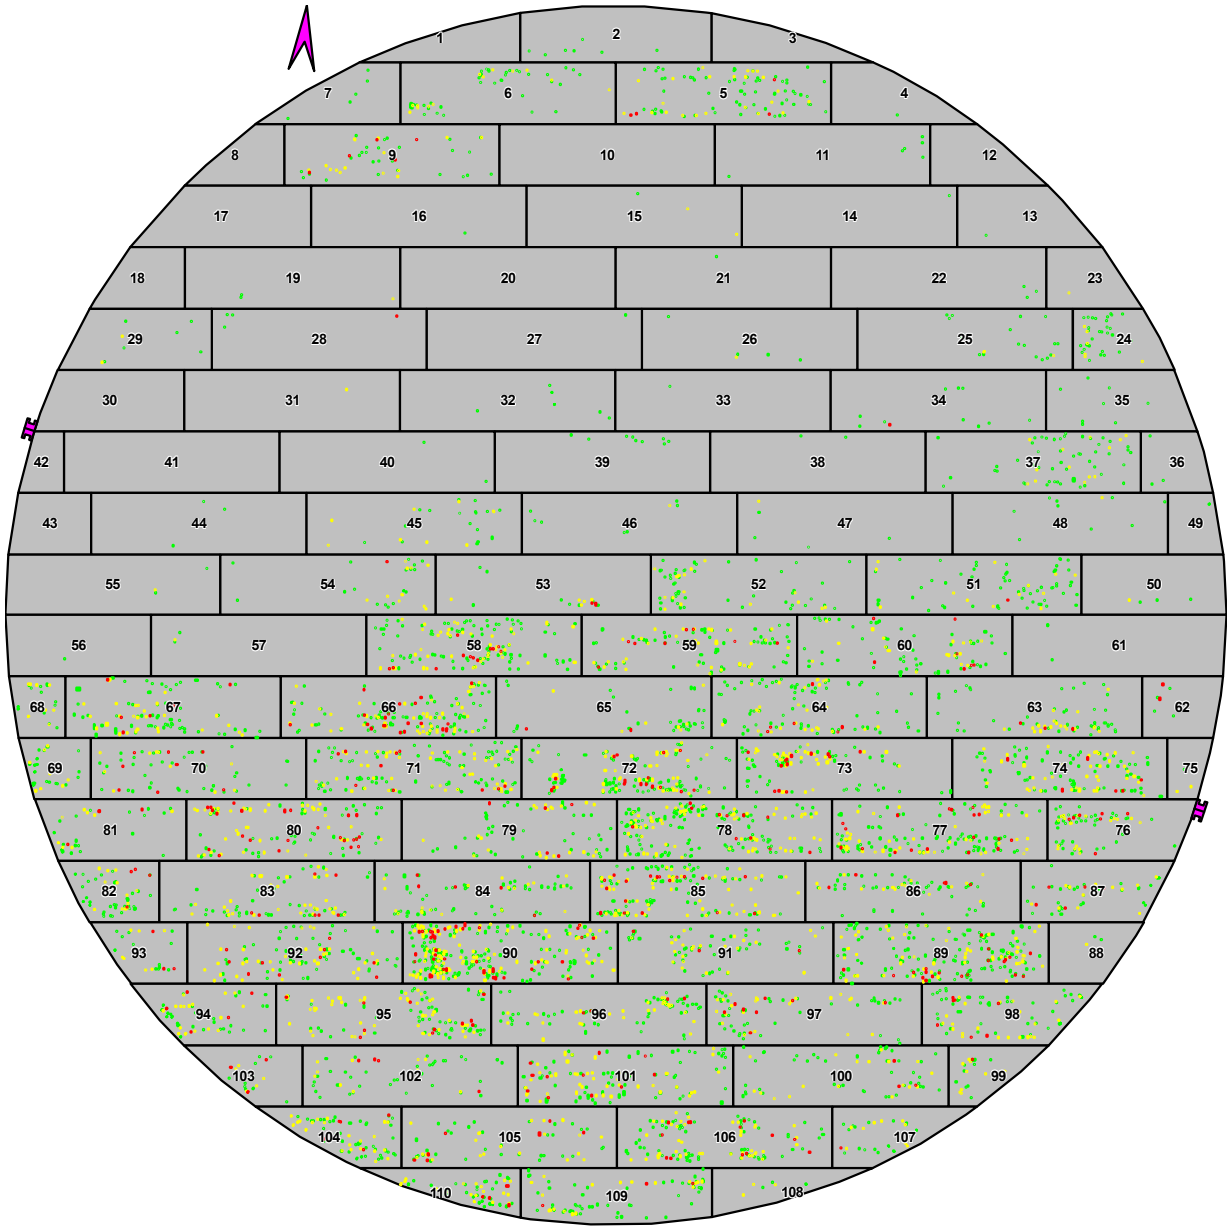
Floor Map (Repair Threshold - 100%)

The inspected area of the tank bottom contained 5,077 anomalies with a metal loss over the repair threshold of 49%. Anticipated repair patches were laid out by the Inspector in order to best cover the features in a manner according to API Standard 653.

The floor map view of indication recorded during the bottom MFL inspection is attached hereafter. Other indications above the marking (repair) threshold are given. Thresholds vary from tank to tank and also depend on remaining life calculation (i.e., 10 yr. or 20 yr.)

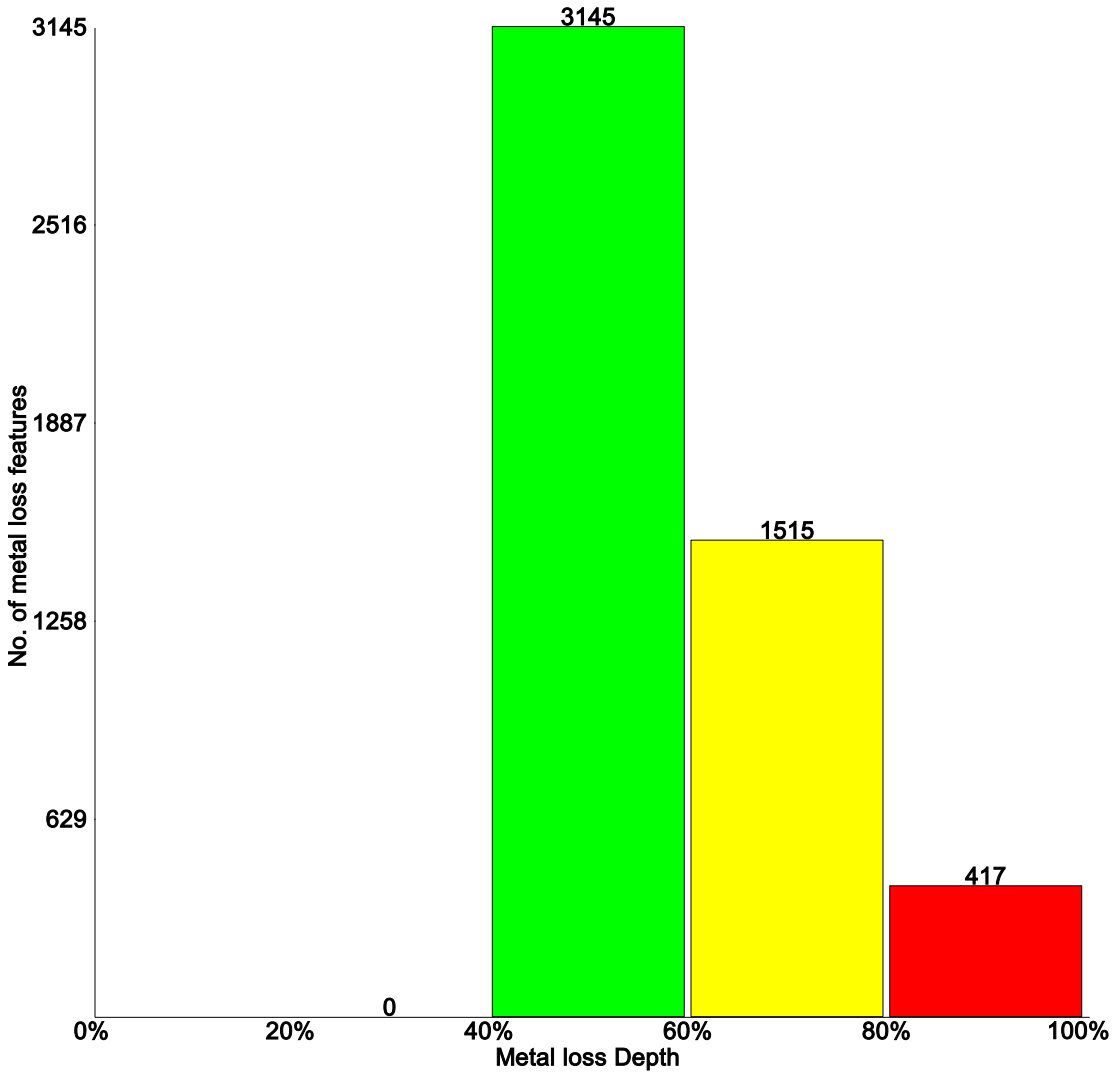
Feature Statistics from Repair Threshold

A statistical view (bar graph) of indication recorded from repair threshold is attached hereafter.

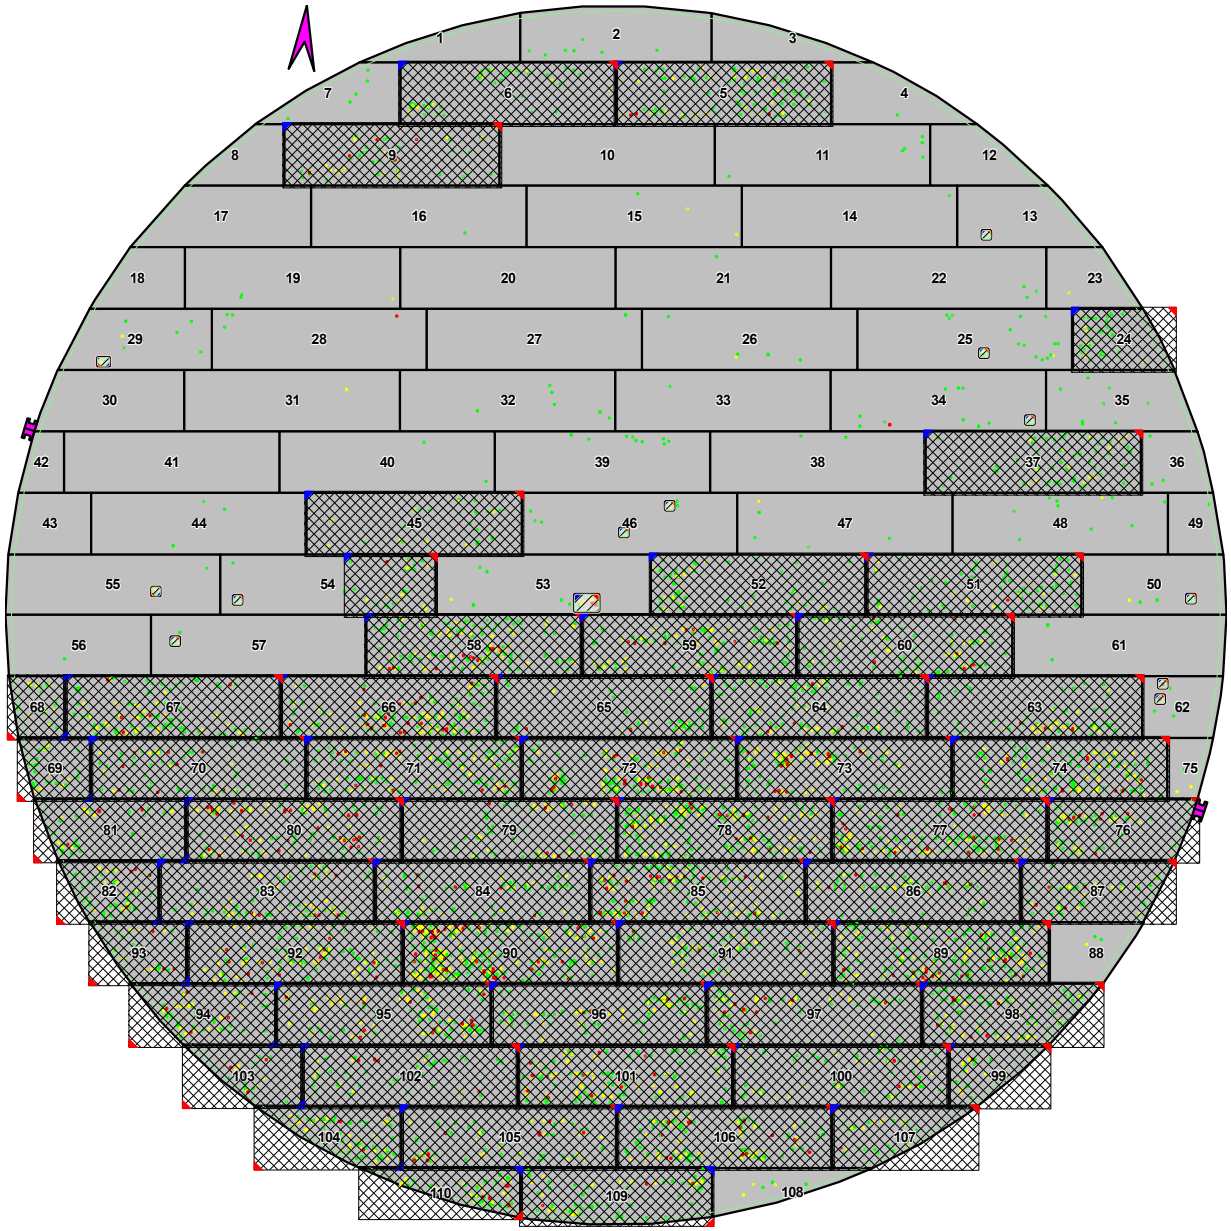
Floor Map (Repair Recommendations)

A floor map view with all repair patch recommendations is attached hereafter. Some indications may not be covered by patch repair(s) since another repair method will be used (i.e., weld overlays or applying an internal coating). These types of repair methods are only applicable to topside indications.

All repairs to the tank bottom should be made in accordance with API Standard 653 guidelines *(API Standard 653, Section 9.10).* Following the installation of repair patches, proper NDT methods should be performed for post repair inspections.

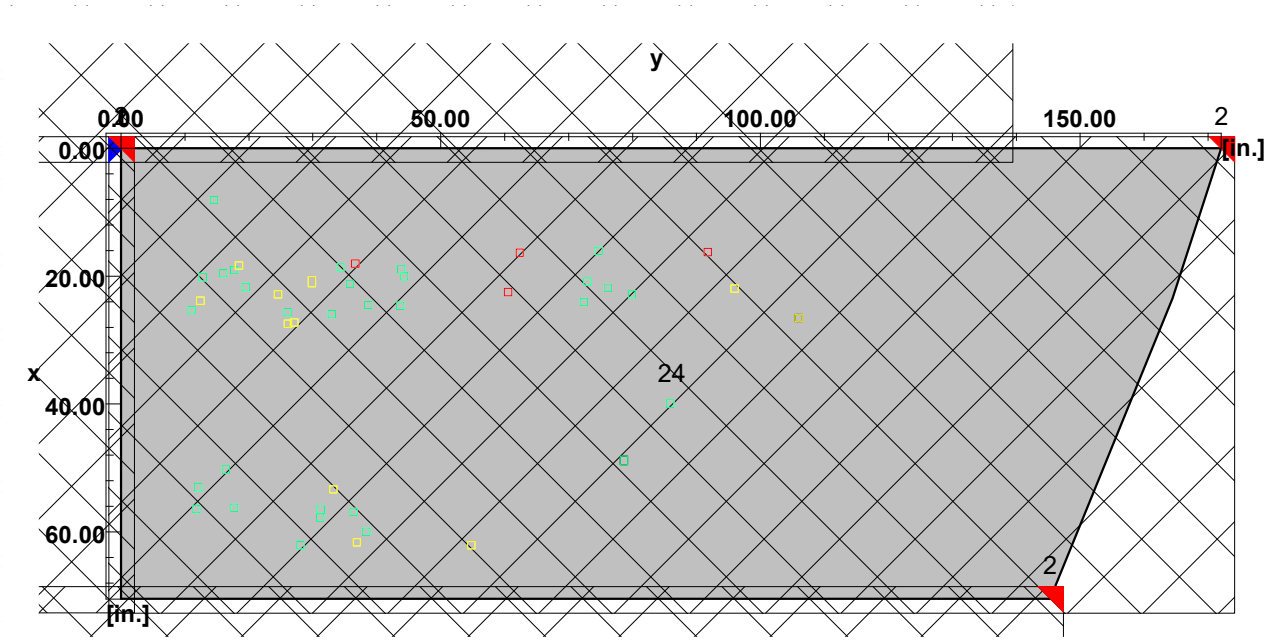
Plate 76 (2 of 2)

1 Replacement plate 75.00 in. * 177.00 in.

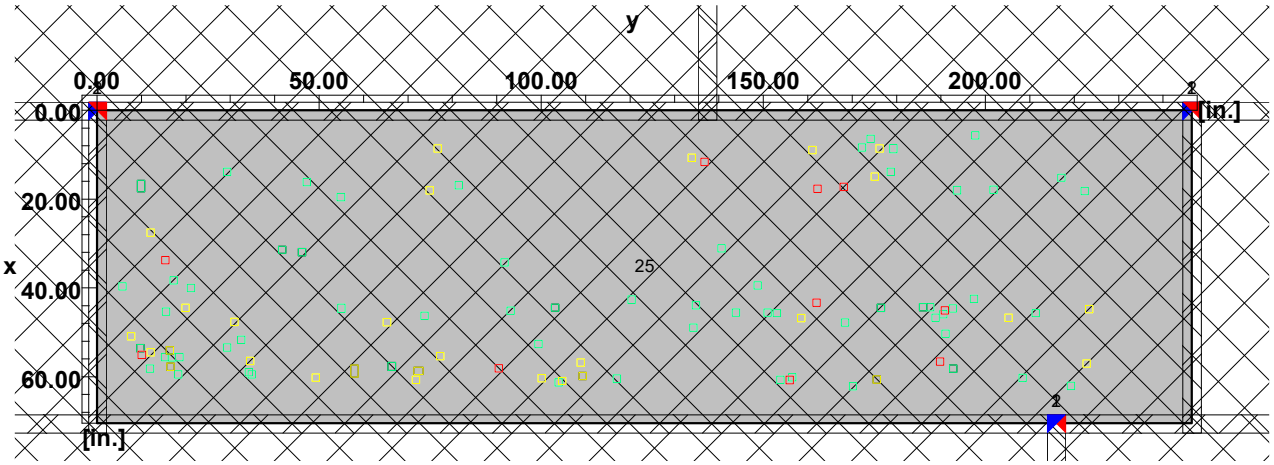
Plate 77 (1 of 2)

1 Replacement plate 75.00 in. * 251.00 in.

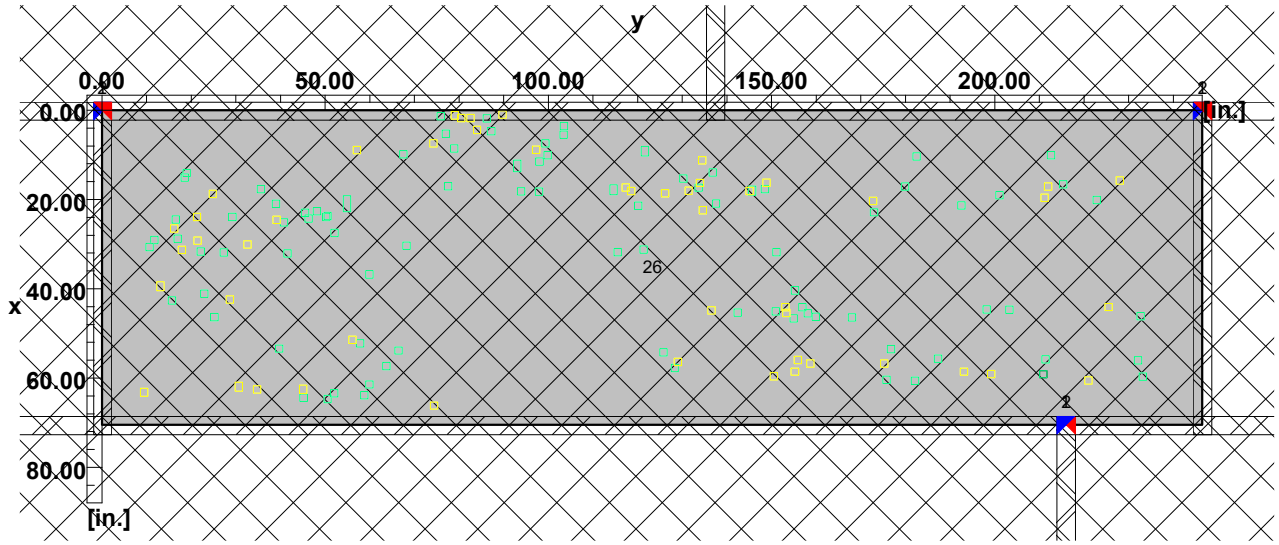
Plate 78 (1 of 2)

1 Replacement plate 75.00 in. * 251.00 in.

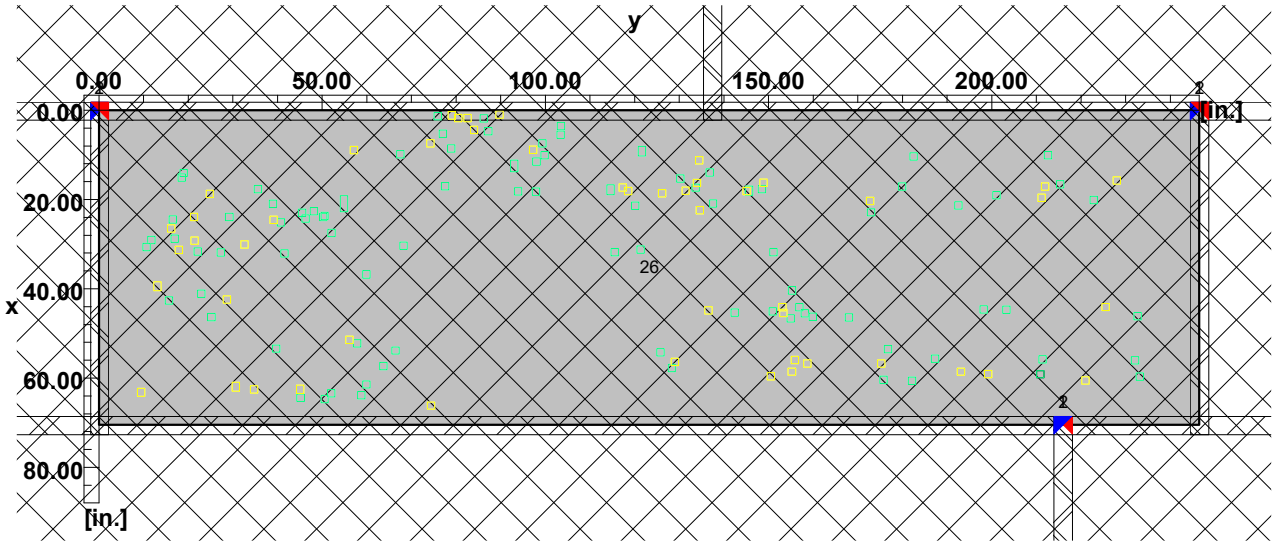
Plate 78 (2 of 2)

1 Replacement plate 75.00 in. * 251.00 in.

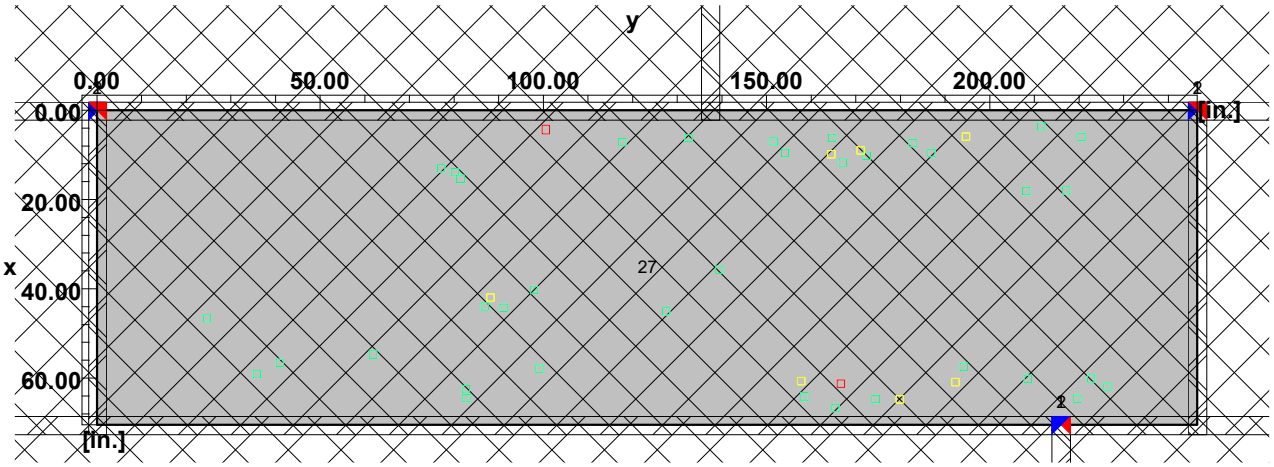
Plate 79 (1 of 2)

1 Replacement plate 75.00 in. * 251.00 in.

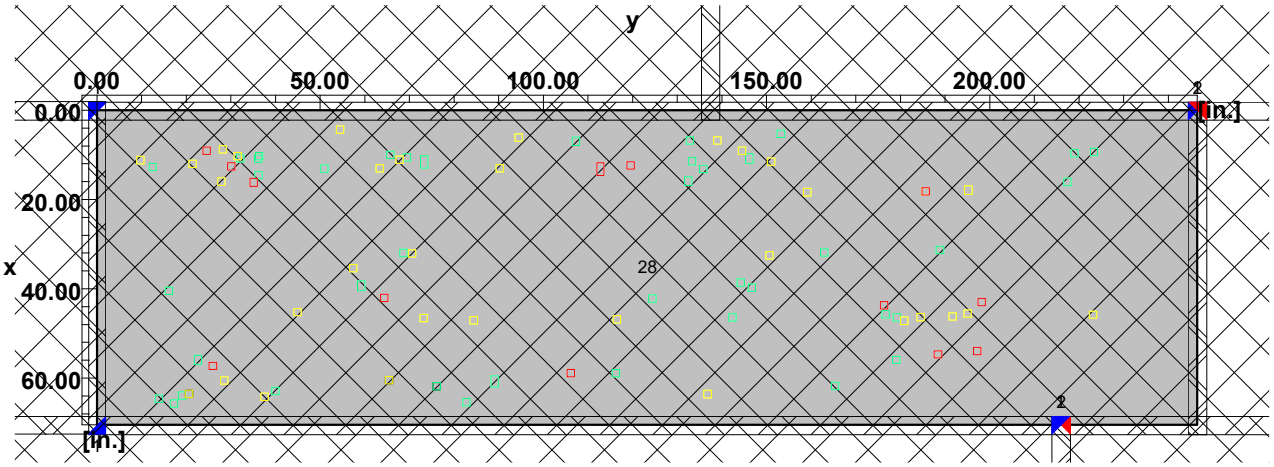
Plate 80 (1 of 2)

1 Replacement plate 75.00 in. * 251.00 in.

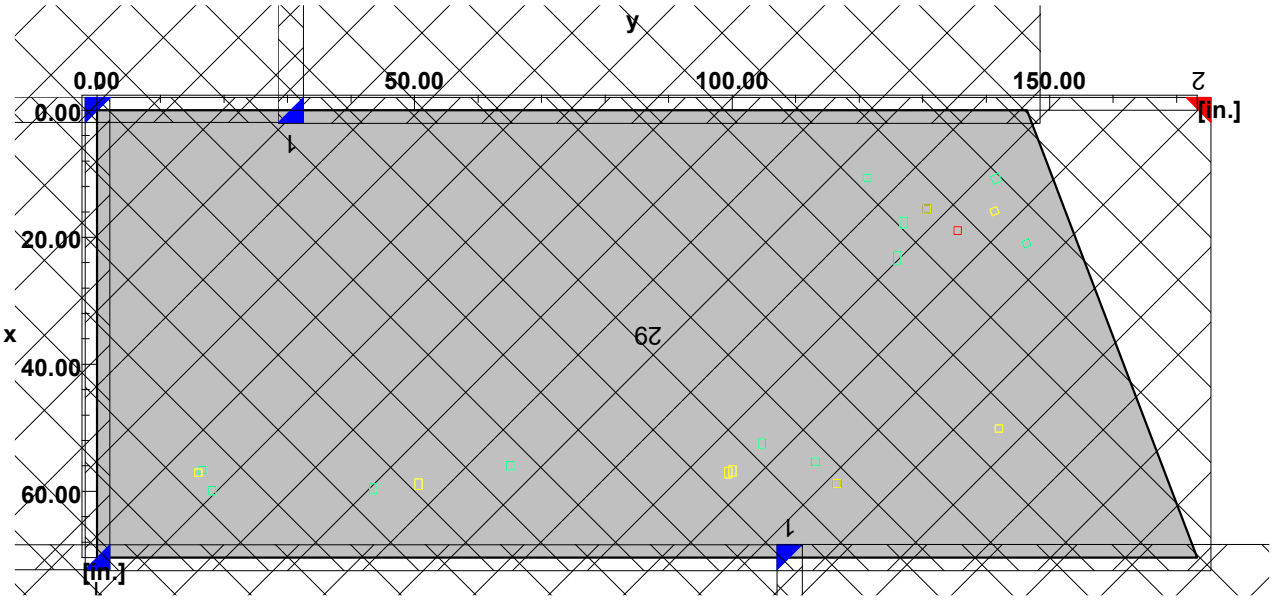
Plate 81 (1 of 2)

1 Replacement plate 75.00 in. * 178.00 in.

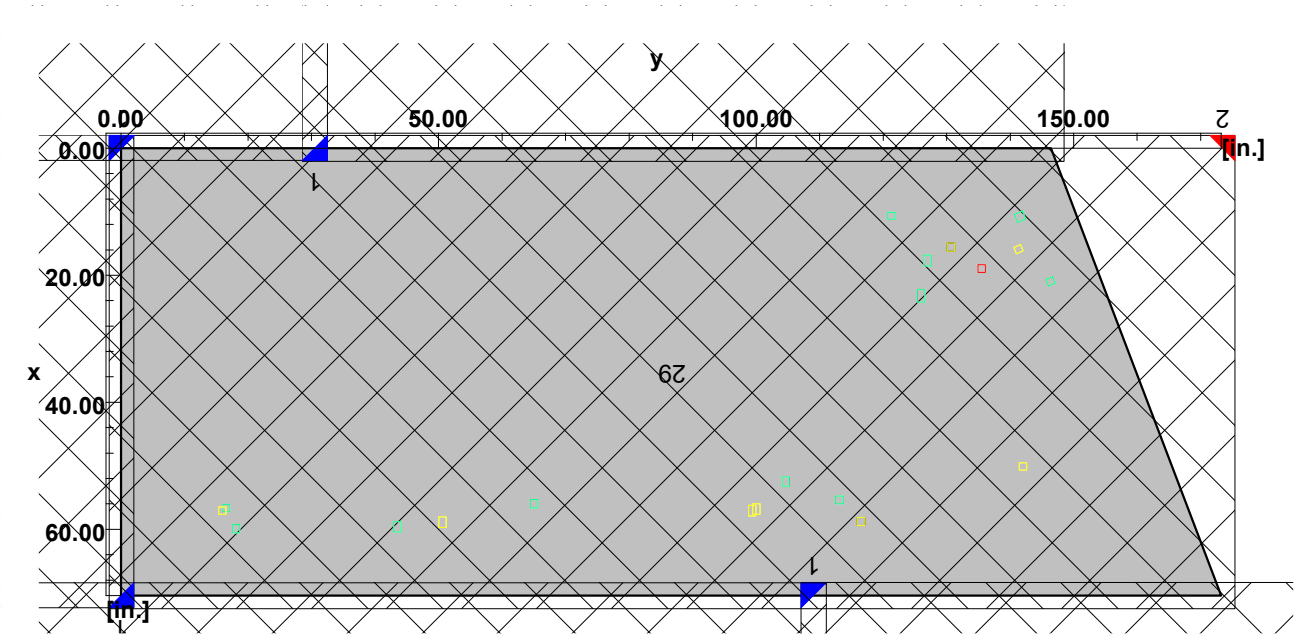
Plate 81 (2 of 2)

1 Replacement plate 75.00 in. * 178.00 in.

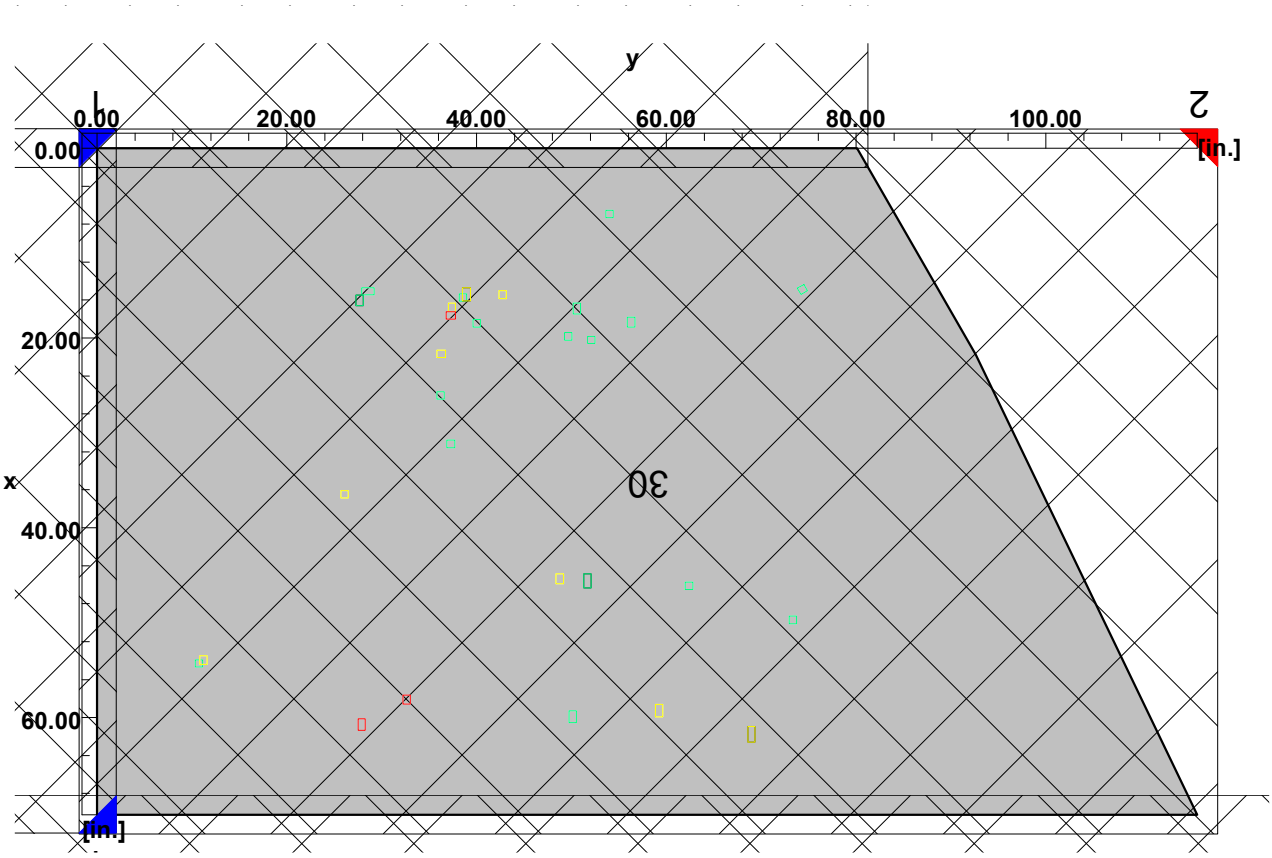
Plate 82 (1 of 2)

1 Replacement plate 75.00 in. * 120.00 in.

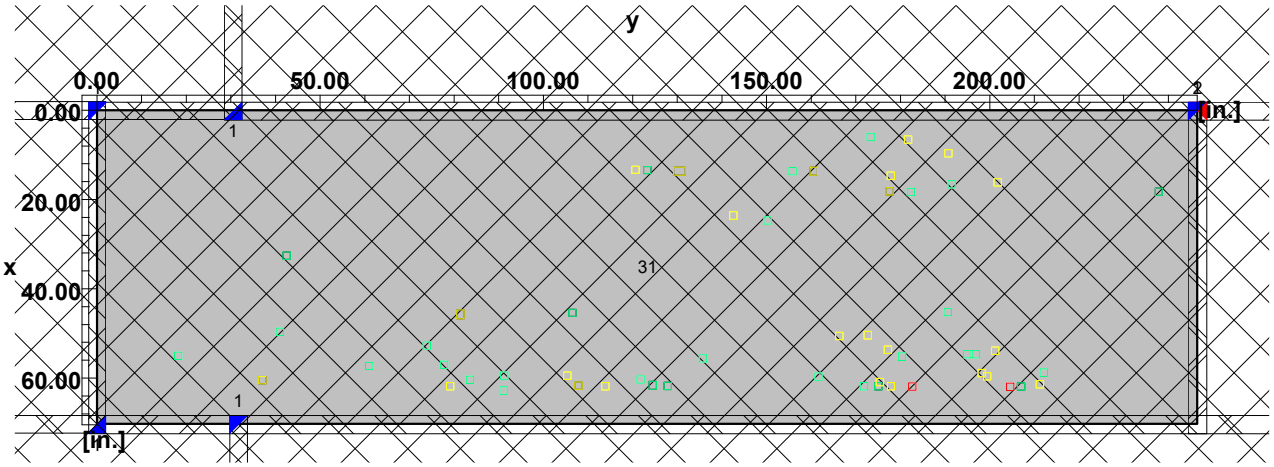
Plate 83 (1 of 2)

1 Replacement plate 75.00 in. * 251.00 in.

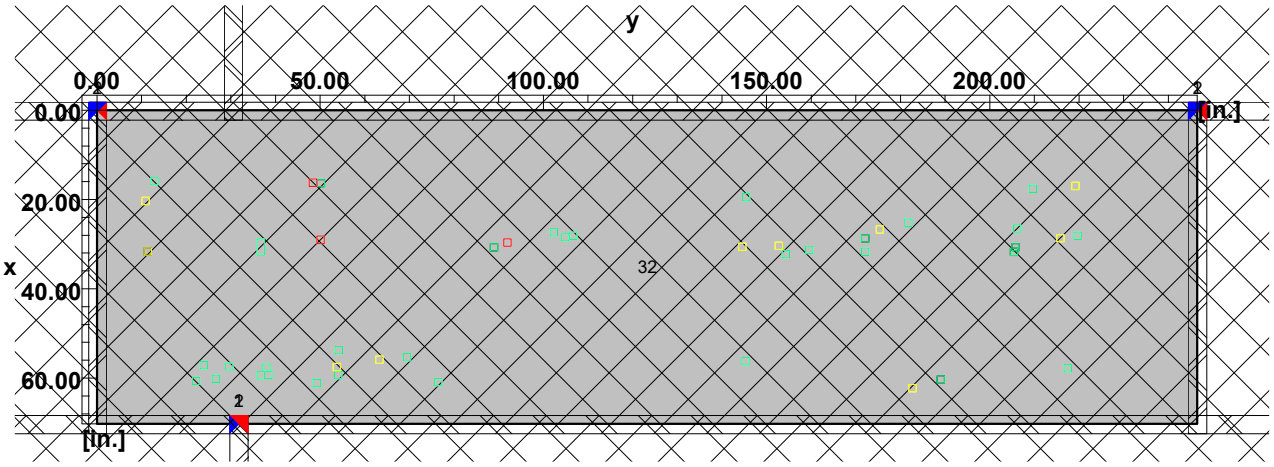
Plate 84 (1 of 2)

1 Replacement plate 75.00 in. * 251.00 in.

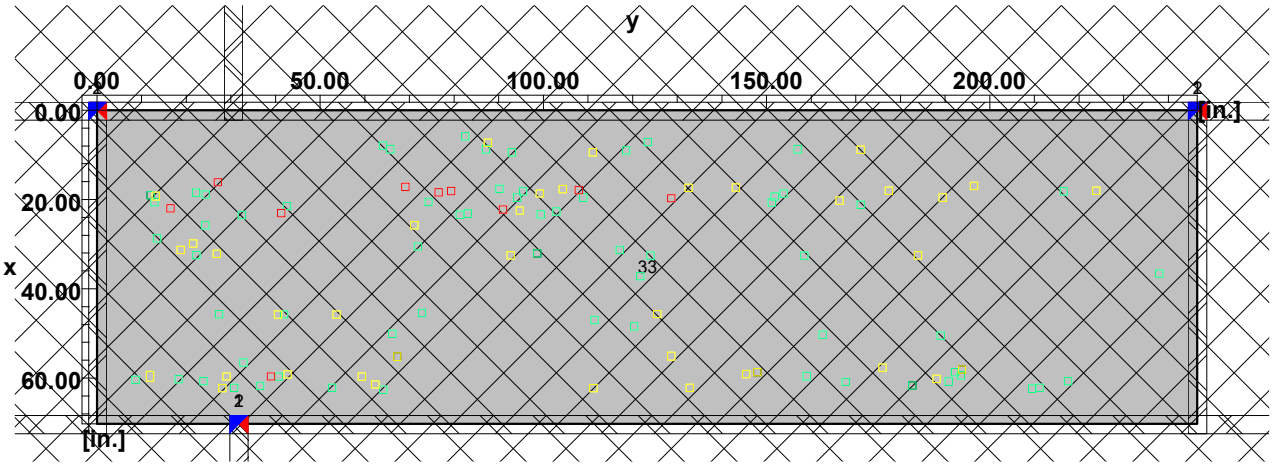
Plate 85 (1 of 2)

1 Replacement plate 75.00 in. * 251.00 in.

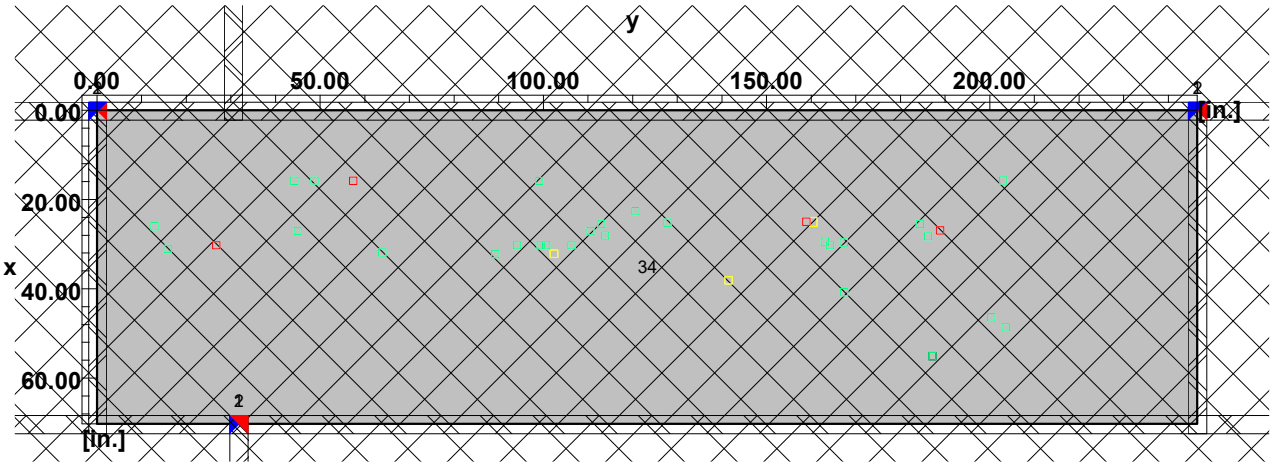
Plate 86 (1 of 2)

1 Replacement plate 75.00 in. * 251.00 in.

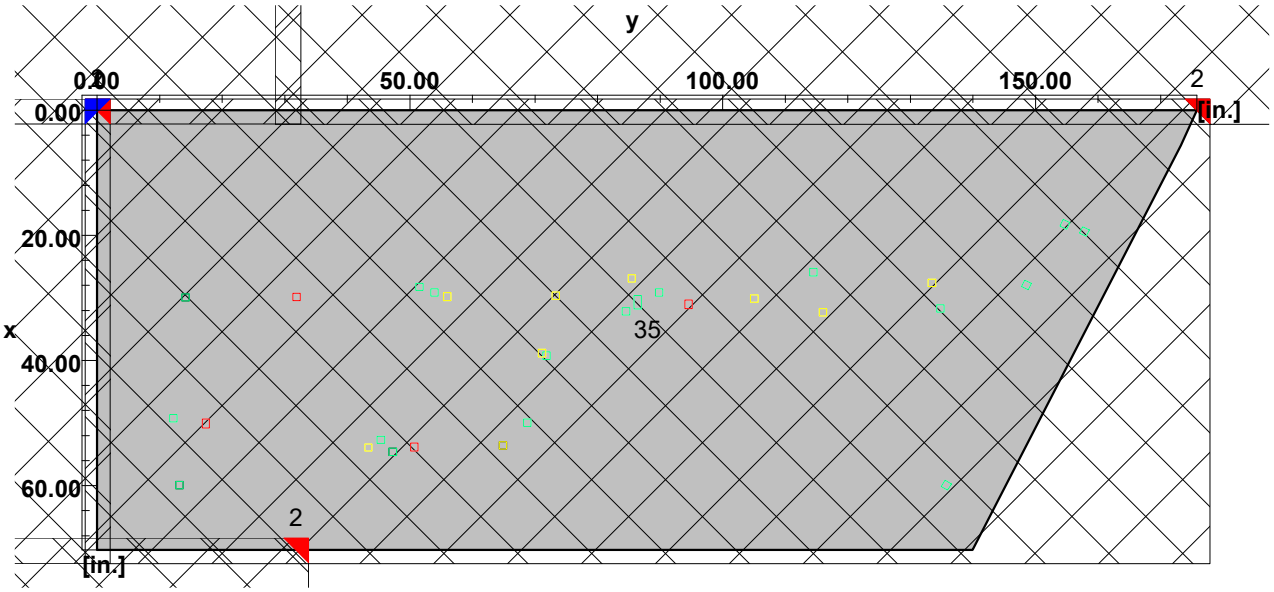
Plate 87 (1 of 2)

1 Replacement plate 75.00 in. * 180.00 in.

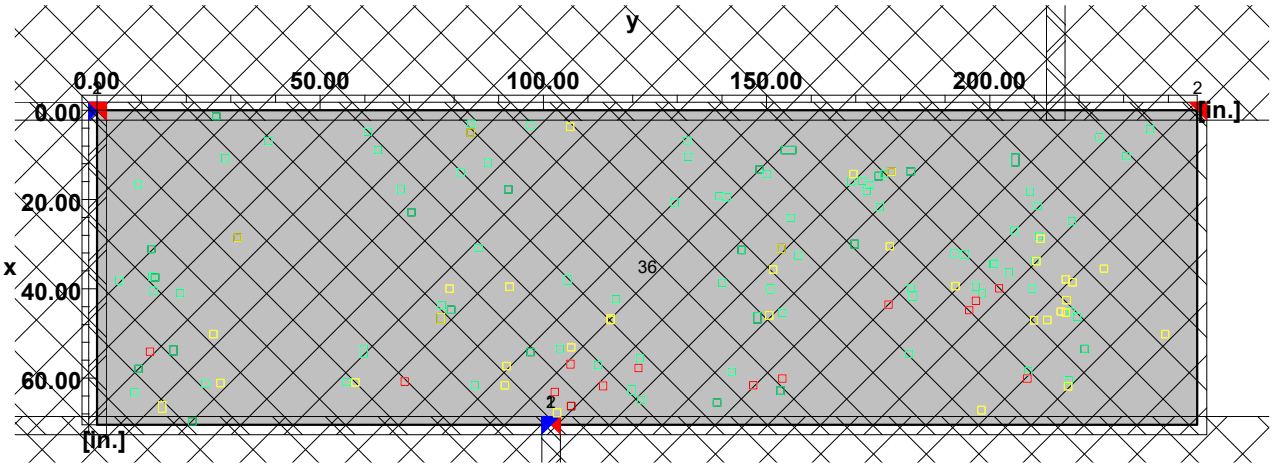
Plate 89 (1 of 2)

1 Replacement plate 75.00 in. * 251.00 in.

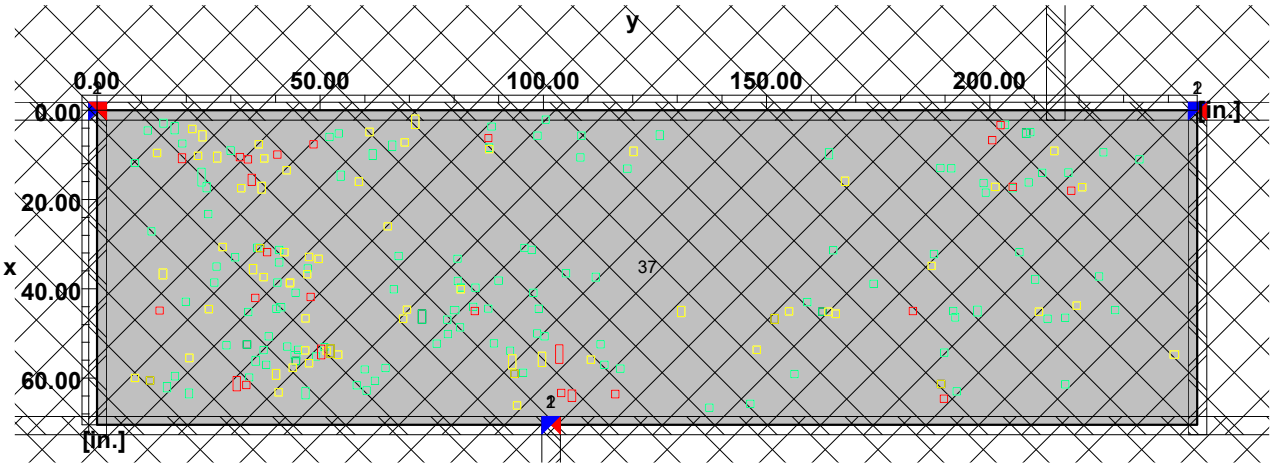
Plate 90 (1 of 2)

1 Replacement plate 75.00 in. * 251.00 in.

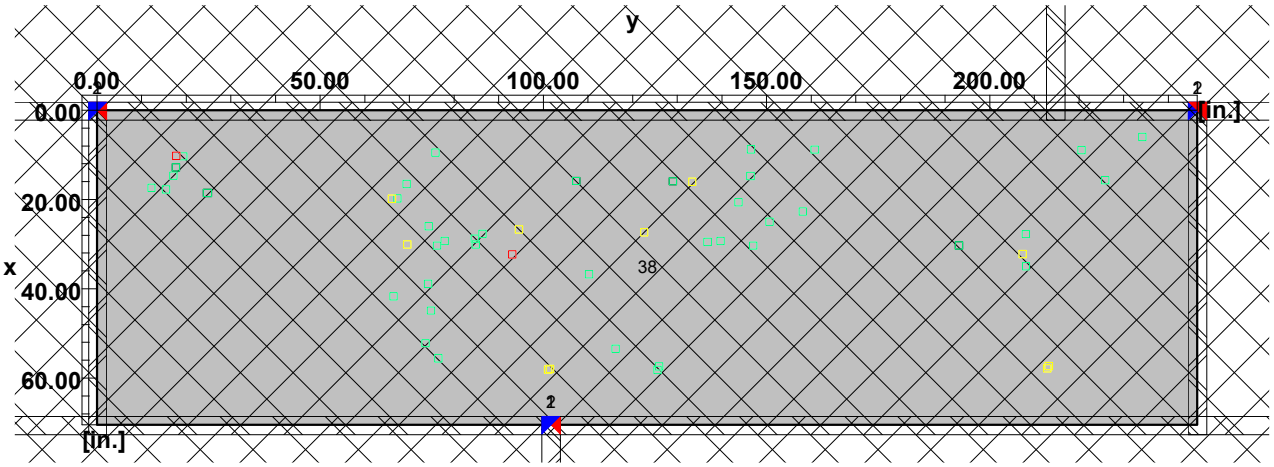
Plate 91 (1 of 2)

1 Replacement plate 75.00 in. * 251.00 in.

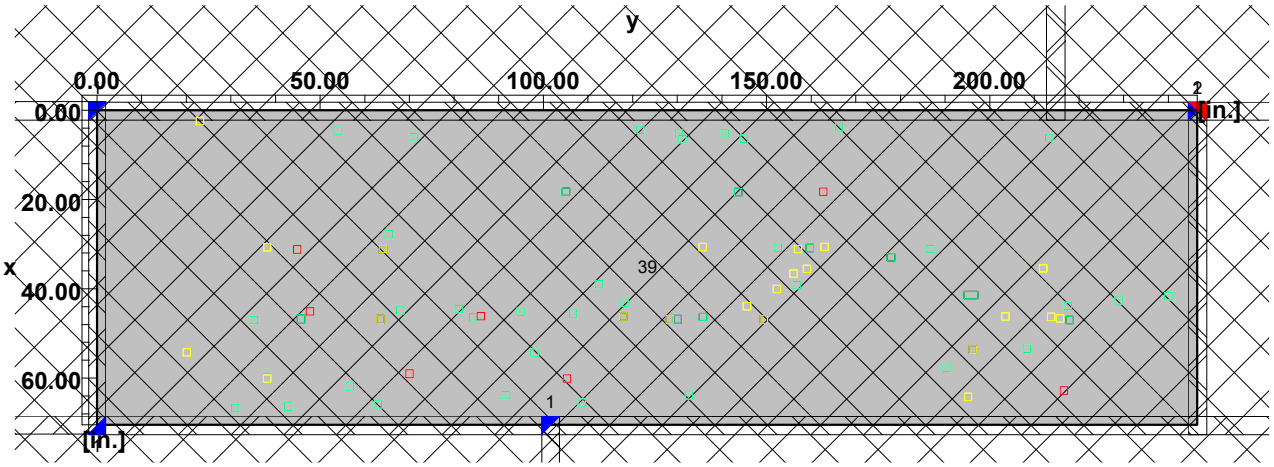
Plate 92 (1 of 2)

1 Replacement plate 75.00 in. * 251.00 in.

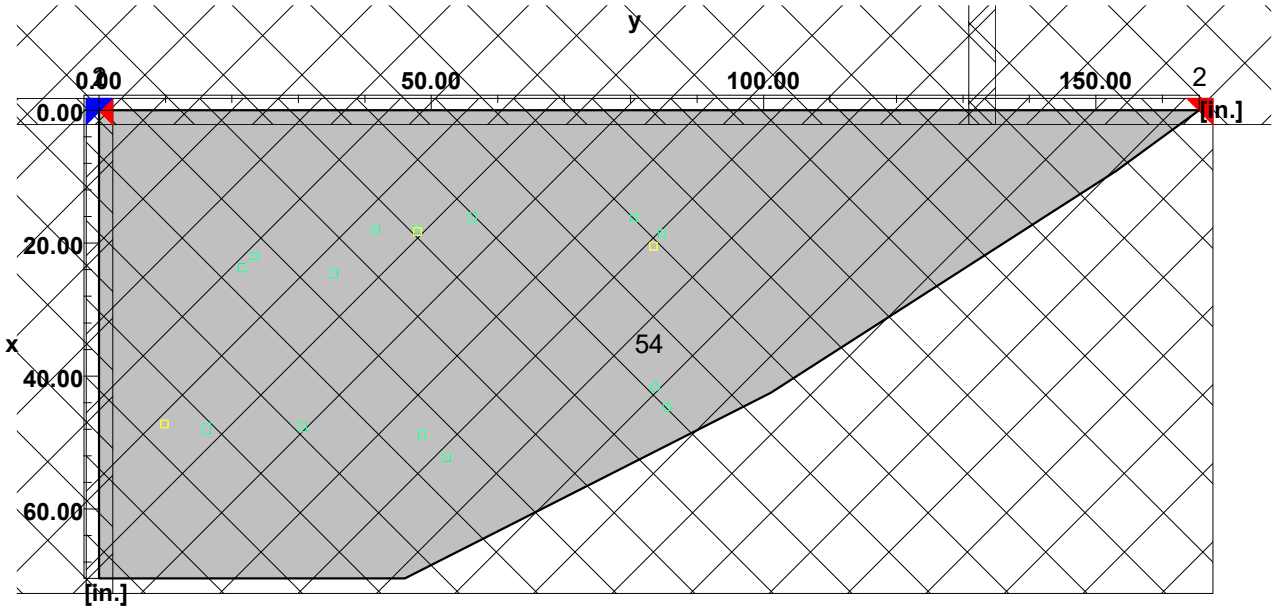
Plate 107 (1 of 2)

Metal loss 49 % - 100 %
Size 0.0 in. - 39.4 in.
All Plates
All Feature Types
All Methods
Repaired Features excluded

1 Replacement plate 75.00 in. * 170.00 in.

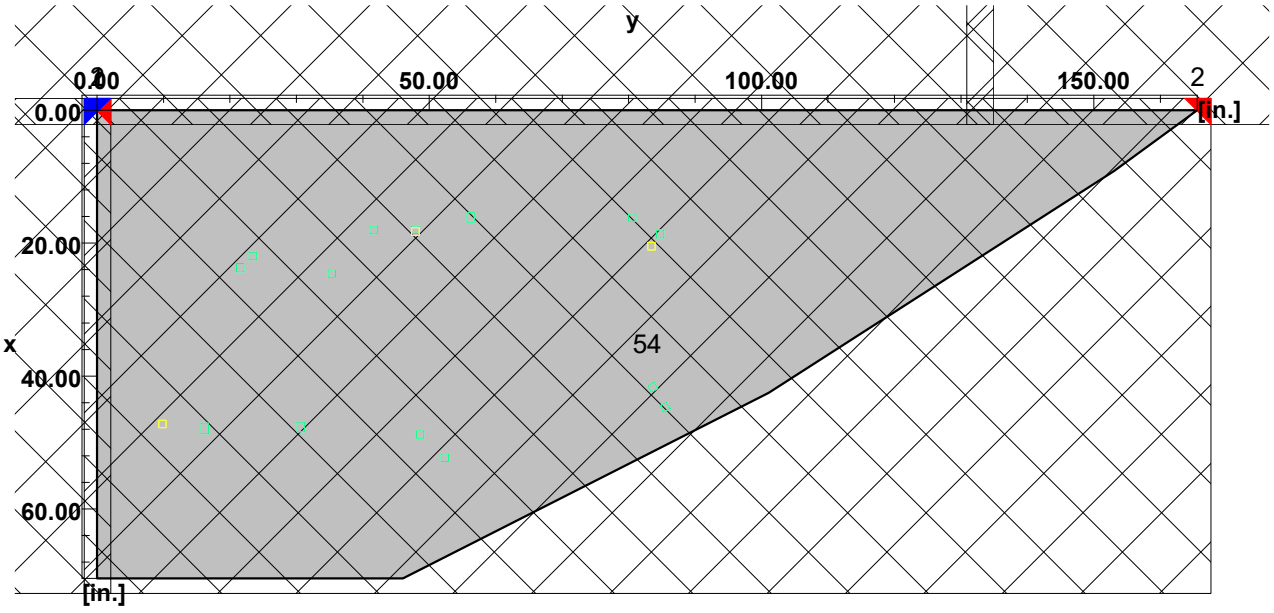
Plate 107 (2 of 2)

Metal loss 49 % - 100 %
Size 0.0 in. - 39.4 in.
All Plates
All Feature Types
All Methods
Repaired Features excluded

1 Replacement plate 75.00 in. * 170.00 in.

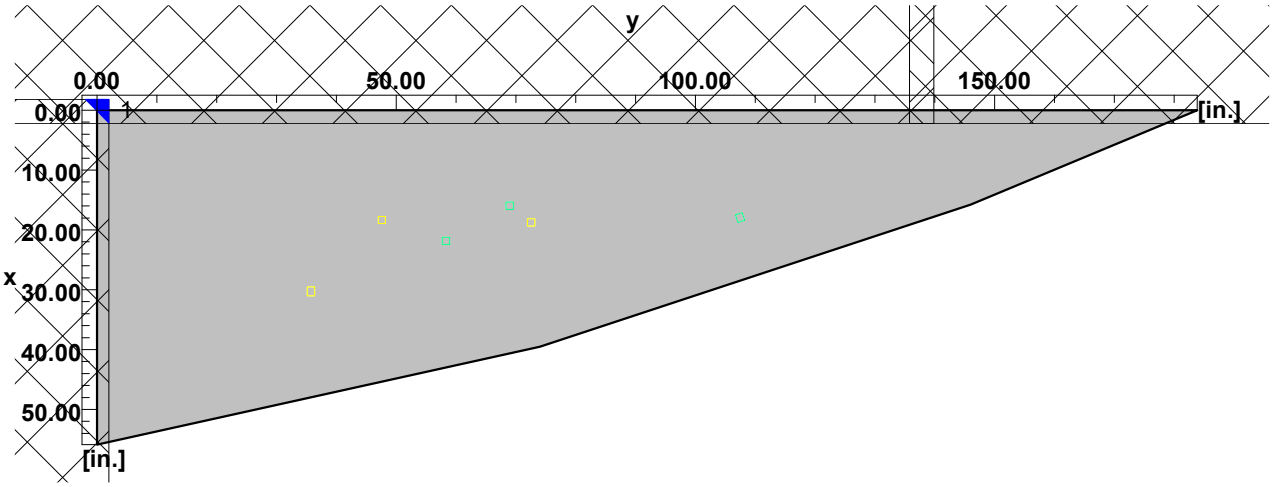
Plate 108 (1 of 2)

Metal loss 49 % - 100 %
Size 0.0 in. - 39.4 in.
All Plates
All Feature Types
All Methods
Repaired Features excluded

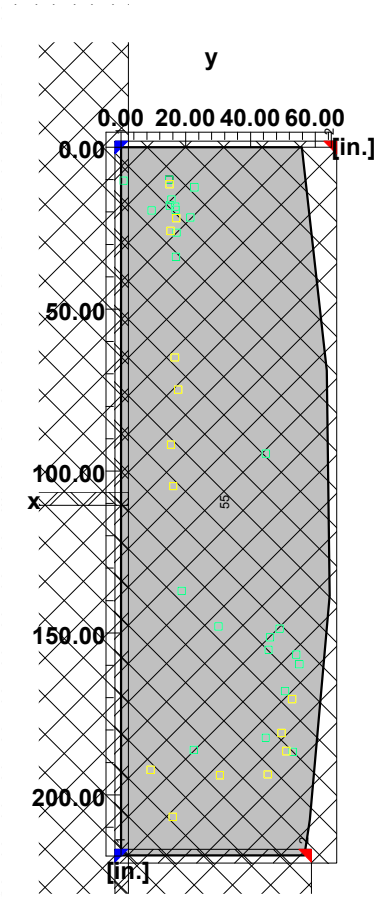
Plate 109 (1 of 4)

Metal loss 49 % - 100 %
Size 0.0 in. - 39.4 in.
All Plates
All Feature Types
All Methods
Repaired Features excluded

1 Replacement plate 223.00 in. * 69.00 in.

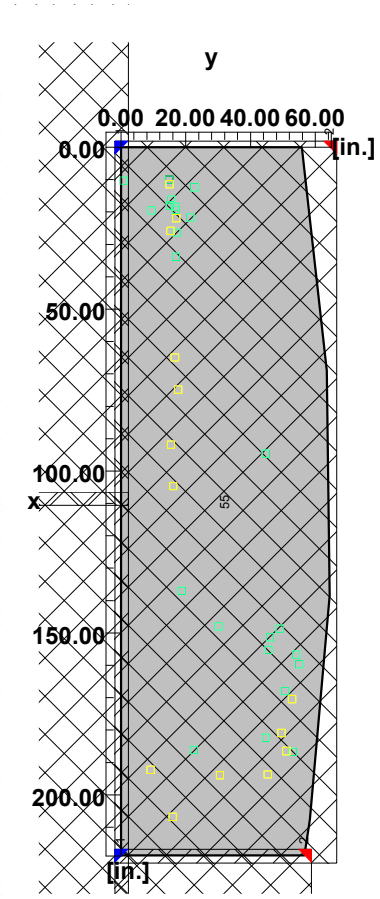
Plate 109 (4 of 4)

Metal loss 49 % - 100 %
Size 0.0 in. - 39.4 in.
All Plates
All Feature Types
All Methods
Repaired Features excluded

1 Replacement plate 223.00 in. * 69.00 in.

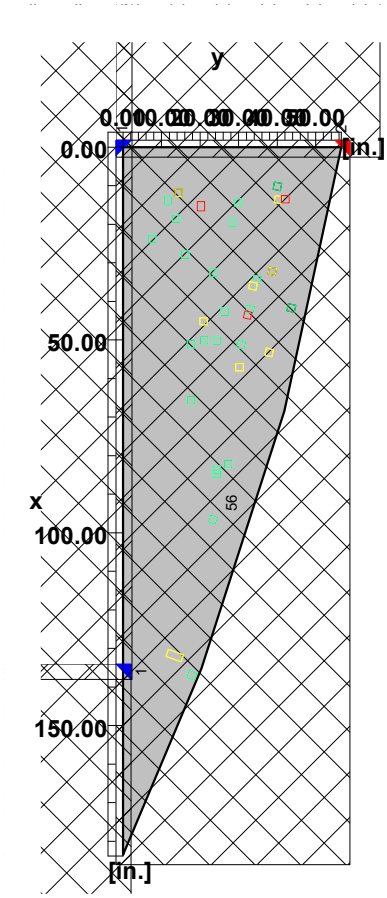
Plate 110 (1 of 4)

Metal loss 49 % - 100 %
Size 0.0 in. - 39.4 in.
All Plates
All Feature Types
All Methods
Repaired Features excluded

1 Replacement plate 188.00 in. * 61.00 in.

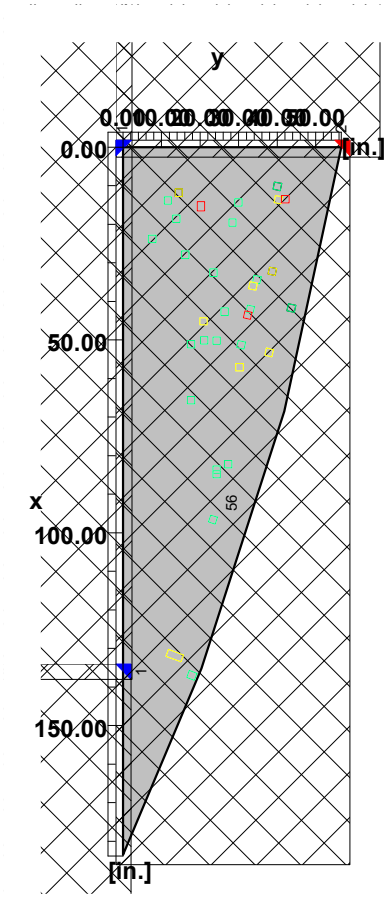
Plate 110 (4 of 4)

Metal loss 49 % - 100 %
Size 0.0 in. - 39.4 in.
All Plates
All Feature Types
All Methods
Repaired Features excluded

1 Replacement plate 188.00 in. * 61.00 in.
