HOME INSPECTION REPORT

Anonymized example for educational use

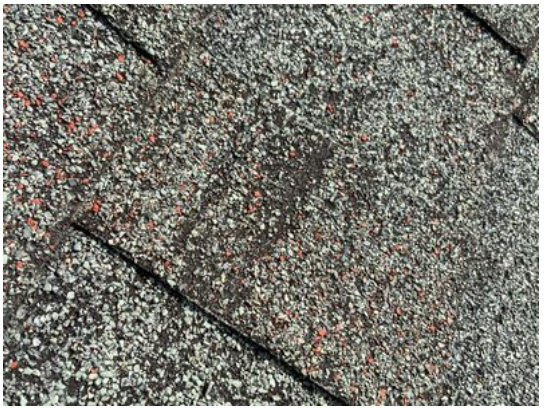
Comment 7
Deficiency

No kick out flashing is installed on the lower front roof section and the back side of the garage roof. This can provide water direct access into the wall area. Recommend further inspection, evaluation, and repairs be completed by a licensed contractor.

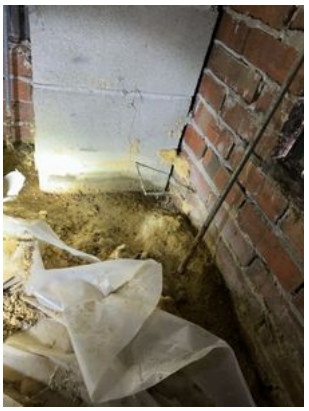
Comment 14
Deficiency

Many sections of insulation are out of place in the subfloor area. This greatly affects the insulation integrity of the subfloor. Recommend further inspection, evaluation, and repairs be completed by a licensed contractor.

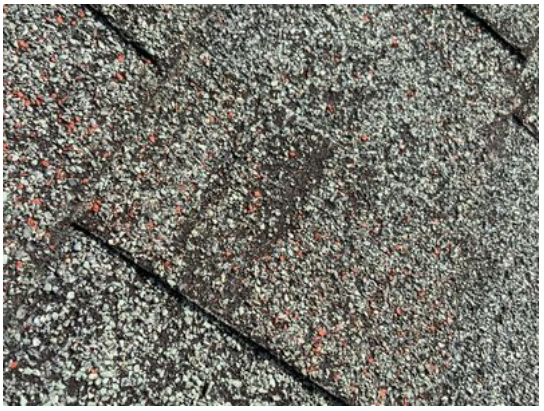
No kick out flashing is installed on the lower front roof section and the back side of the garage roof. This can provide water direct access into the wall area. Recommend further inspection, evaluation, and repairs be completed by a licensed contractor.

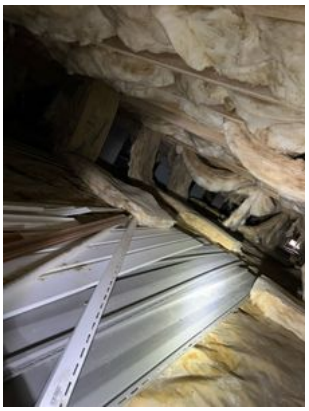
A mildew/fungal type growth is visible in some areas on the subfloor system. Recommend further inspection, evaluation, and repairs be completed by a licensed contractor.

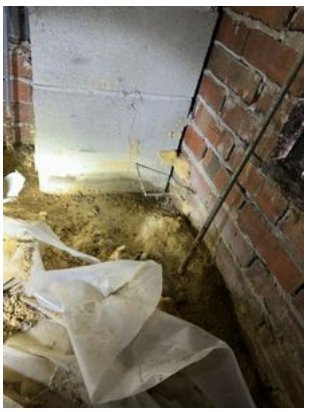
Many sections of insulation are out of place in the subfloor area. This greatly affects the insulation integrity of the subfloor. Recommend further inspection, evaluation, and repairs be completed by a licensed contractor.
