Post-Cleaning Service Report

Kitchen Exhaust System

CONTRACTOR	Cascadia Commercial Vent & Hood Services	SERVICE DATE	November 14, 2026
CUSTOMER	Pinecrest Family Diner	SERVICE WINDOW	9:30 PM - 2:15 AM
SITE	742 Evergreen Way, Suite 100, Olympia, WA 98502	WORK ORDER	WO-88412
SYSTEM	Single exhaust canopy and rooftop assembly | OLY-EXH-01	TECHNICIAN	Derek Sullivan (Lead Tech); Elena Ramos

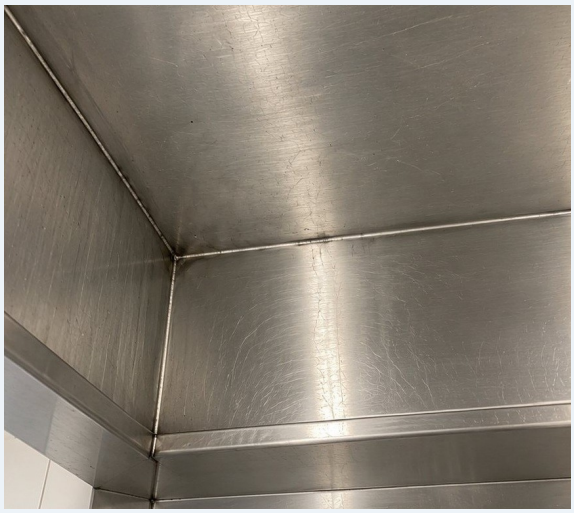
01 Hood interior

Before - Grease residue is visible across the canopy interior before service.
After - Canopy interior is shown after the reported degreasing, power washing, and wipe-down.
