W07 affected yield by die

Etch chamber RCA

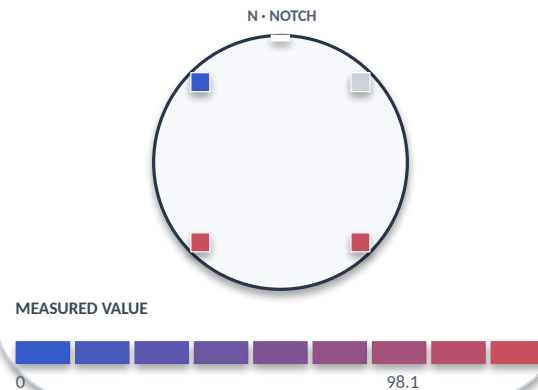
Wafer W07 · Lot L2407 · Tool ETCH-08 · Chamber A · Recipe REC-17 · Process Etch
4 observations · 1 missing · Value 0 to 98.1

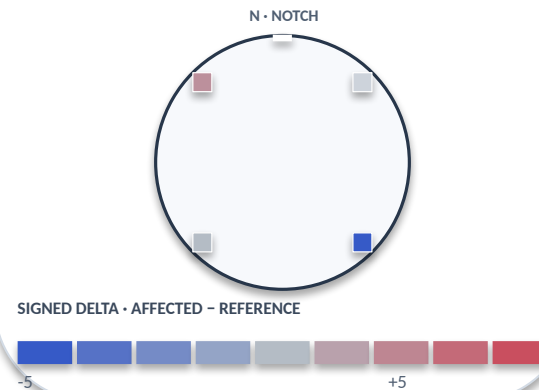
W07 signed affected – reference

Wafer W07 · Lot L2407 · Tool ETCH-08 · Chamber A · Recipe REC-17 · Process Etch
4 observations · 1 missing · Delta -5 to +2
